In-Process Monitoring of Cross Contamination in Laser Powder Bed Fusion (L-PBF) Additive Manufacturing (AM)

M. Jamshidinia, P. Boulware, J. Marchal, H. Mendoza, L. Cronley, S. Kelly, S. Newhouse
EWI
1250 Arthur E Adams Dr., Columbus, OH 43221

Abstract

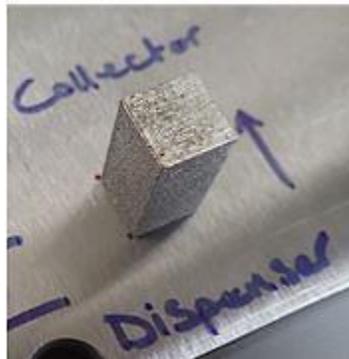
Figure 3. A rectangular specimen made of Inconel 625, containing contamination layers.

Figure 3 shows the rectangular specimen made of Inconel 625, with embedded layers of contamination. Optimum process parameters were developed for the fabrication of Inconel 625 in EWI's test bed.

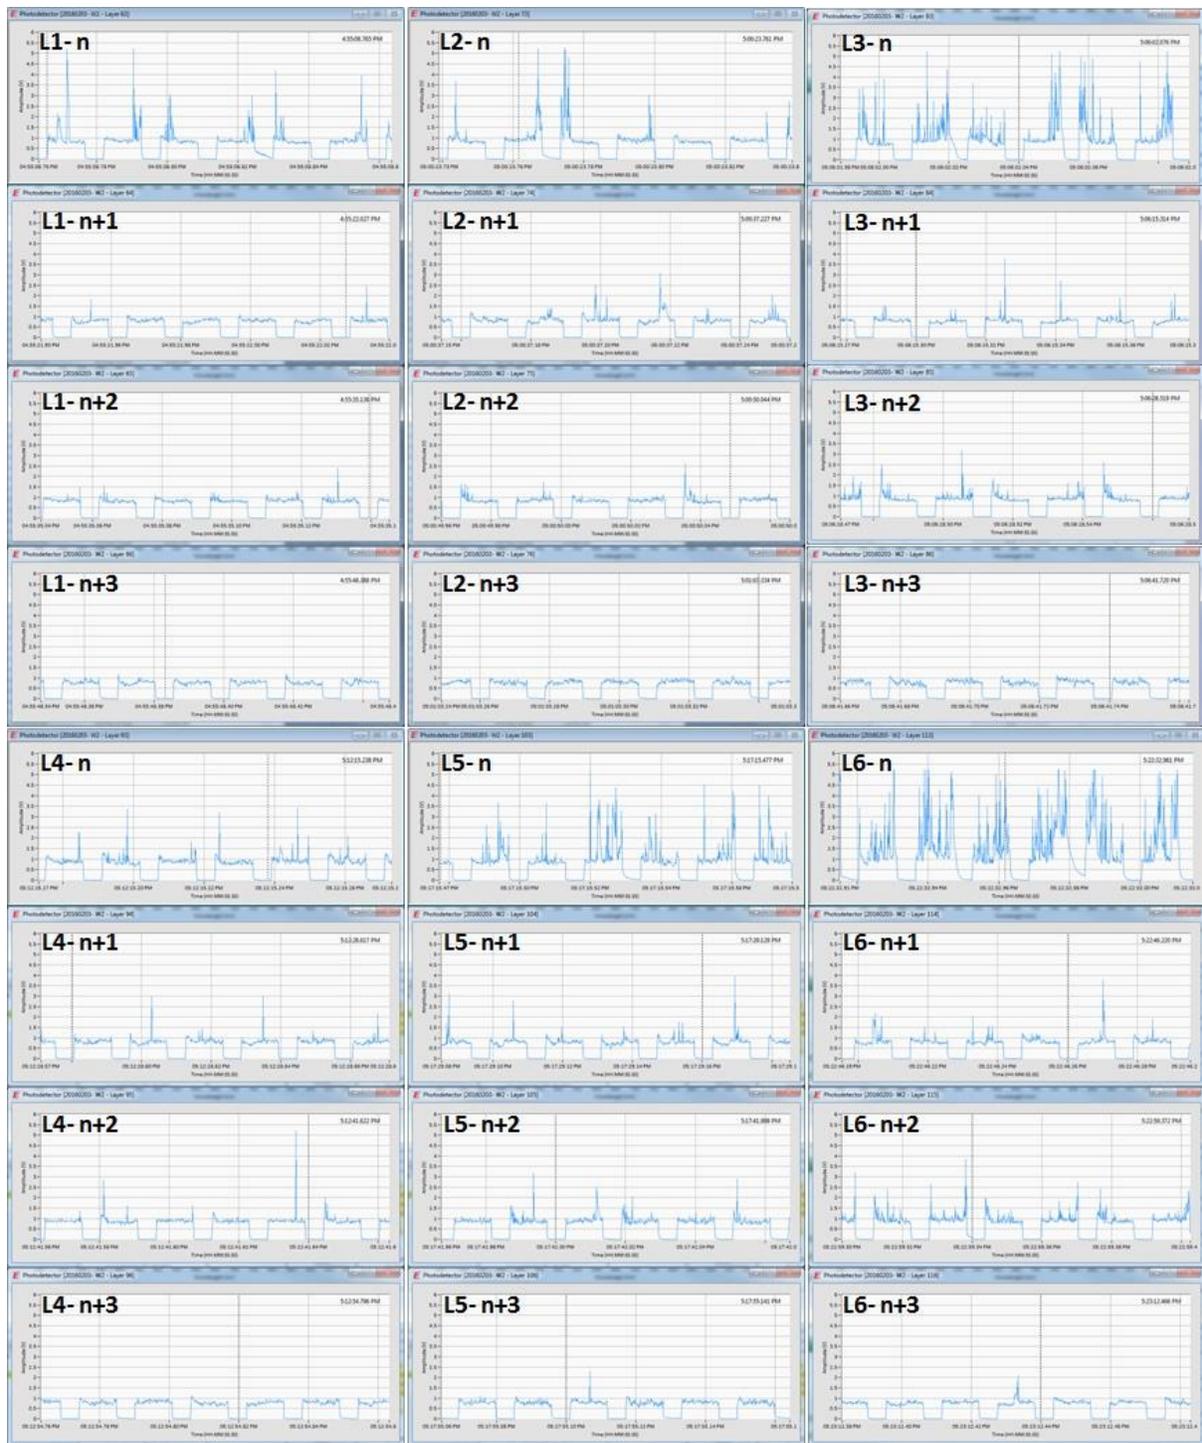
This section investigated the possibility of detecting tungsten contaminations in consecutive layers. Because the photodetector showed the most promising data so far, data collected by the photodetector were analyzed for this purpose. Figure 7 compares the photodetector data collected from four consecutive layers of each contamination levels. The first set of data on the top corresponds to the contamination layers, where a contaminant powder was deposited on it. This layer was identified by n . Layer $n+3$, at the bottom row, represents the third layer on top of a contamination layer. As shown, almost all contamination levels still showed some distinguishable signals on the second layer ($n+1$); however the signals were weaker than those on the first layer. However, by the deposition of two more layers, most of the initially detected signals disappeared. Even at L3, with a high unit volume deposited on the powder bed, almost all signals were faded out on layer $n+3$. L5 and L6 were the only two contamination levels that still showed one signal on layer $n+3$. These results suggest that a contamination with tungsten, even at very high levels, could only be detected for up to three layers (120 μm) on top of where the contaminant powders were introduced. It has to be noted that none of the contamination levels showed any signals on layer $n+4$.

Figure 7. Data collected from photodetector from the six levels of contamination with tungsten. Four layers per contamination level are studied.

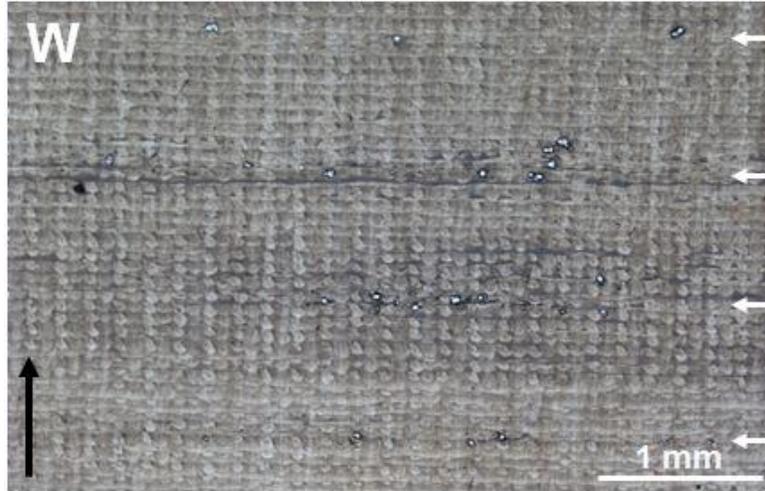
The specimen with embedded tungsten contaminant was sectioned, mounted, and polished, for further metallurgical analysis. An alcohol-based Kalling's etching solution was used for the primary etching. Then specimens were etched using a 10% chromic acid solution at 2.4 volts. Figure 8 shows the low magnification (25X) images of the cross sections. The white arrows indicate the contamination deposition layers. The black arrow indicates the buildup direction. The tungsten particles with a white color could be clearly detected on the matrix of Inconel 625.

Figure 8. Low magnification optical images of the specimens contaminated by tungsten. The white arrows indicate the contamination deposition layers. The black arrow indicates the buildup direction.
