ERROR DETECTION IN LASER BEAM MELTING SYSTEMS BY HIGH RESOLUTION IMAGING

S. Kleszczynski*, J. zur Jacobsmühlen†, J. T. Sehrt* and G. Witt*

*Institute for Product Engineering, University of Duisburg-Essen, Germany

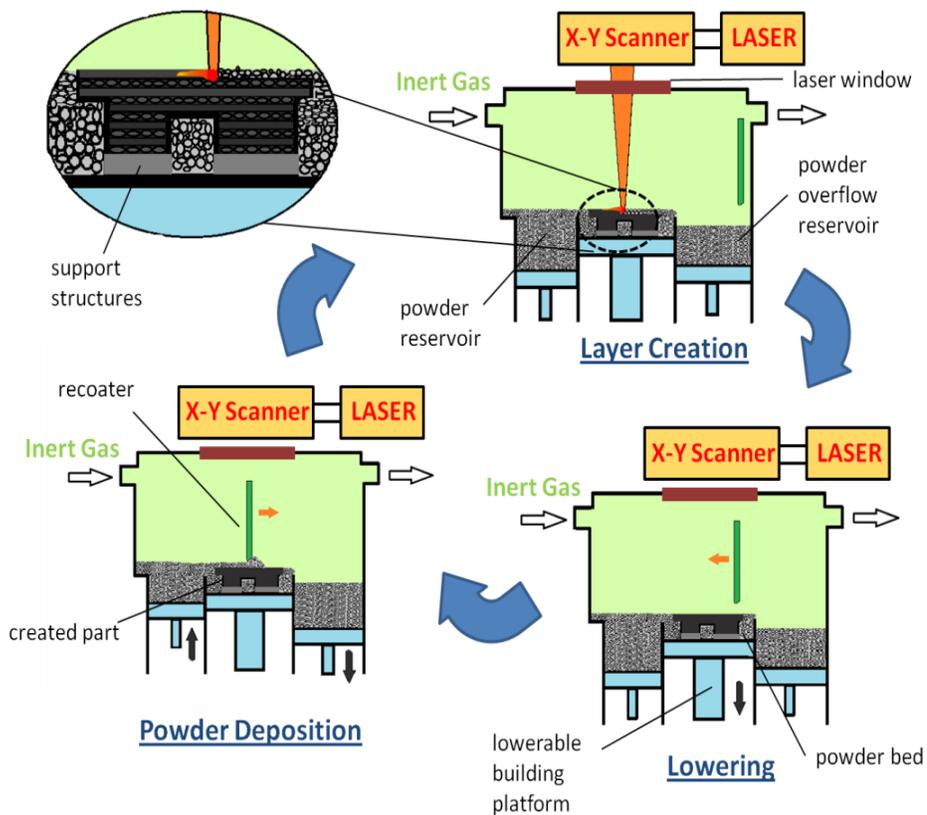
Fig. 1: Schematic representation of Laser Beam Melting.

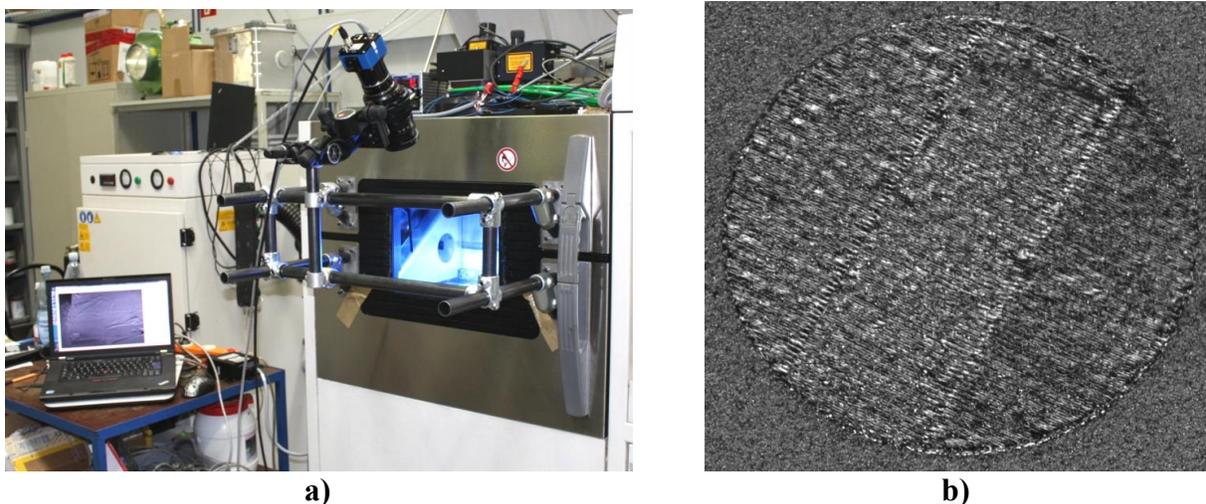
Fig. 2: a) Setup of the CCD camera system in front of machine window. b) Example image.

For visual detection and analysis of errors a monochrome CCD camera system was used. The camera (SVCam-hr29050, SVS-VISTEK GmbH) was mounted in front of the machine window on the outside and captured images of the build platform from an observation angle (**Fig. 2a**). A tilt and shift lens (Hartblei Macro 4/120 TS Superrotator) helped to reduce perspective distortion by shifting the camera back and allowed placing the focal plane on the build platform without stopping down using its tilt ability. A 20 mm extension tube reduces the minimum object distance of the lens. The camera uses a 36 by 24 mm Kodak 29 megapixel sensor (6576 by 4384 pixels, pixel size 5.5 μm by 5.5 μm).

four corners of the field of view. Perspective distortion was corrected by transforming the corners of the work piece carrier to a square in the image using four point homography estimation and warping with bicubic interpolation, resulting in an orthogonal view of the test target with a resolution of about $19 \mu\text{m}/\text{pixel}$ (see **Fig. 3**). The camera system is able to resolve two black lines on white background ($40\mu\text{m}$ wide, $40 \mu\text{m}$ apart) from a distance of 50 cm. All circles on the microscope slide were detected and confirmed the pixel size. As can be seen from **Fig. 2b** this system enables us to inspect the part surface at bead level.

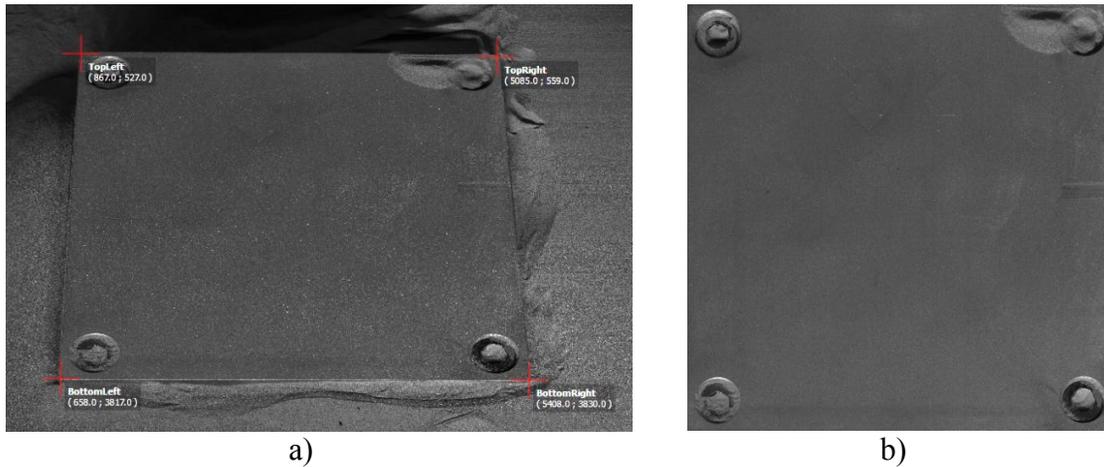
Fig. 3: Example of perspective correction. (a) Building platform with corner markers and some powder in top right corner. (b) Corrected image of work piece carrier provides an orthogonal view of the build platform. Note: images intensities have been rescaled for visualization.

Images presented in this paper were corrected using the same method. The edge length of the target image can be chosen arbitrarily; we used the minimum edge length of the distorted quadrilateral image to reduce the number of interpolated pixels, resulting in an image resolution of 4234×4234 pixels ($\sim 24 \mu\text{m}/\text{pixel}$). The slightly larger pixel size in the object plane compared to the resolving power measurement is due to the larger field of view in the machine.

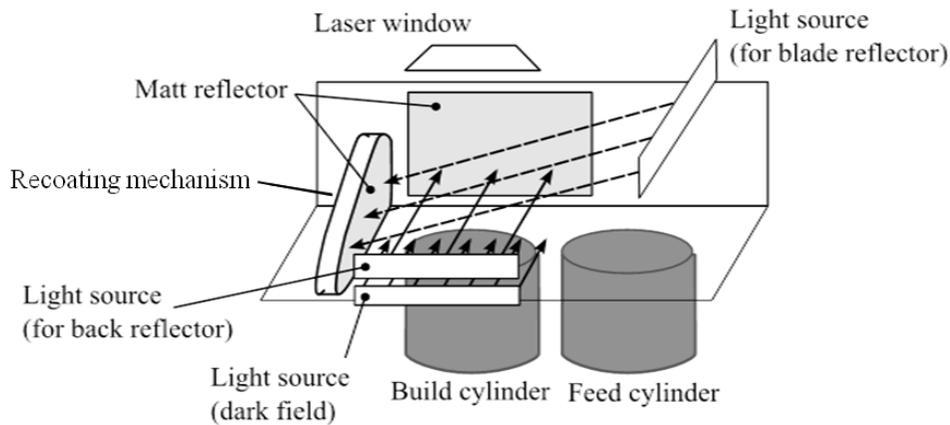
Fig. 4: Lighting setup for surface inspection and detection of elevated areas. Three light sources are used independently based on the current detection scheme. Contrast between adjacent beads is enhanced by illumination from the right side for bead angles from 45° to 135° and illumination from the front for angles from 0° to 45° and 135° to 180° . Reflectors enable diffuse lighting on the work plane; dark field lighting uses parallel lighting to highlight embossments, it is used separately from the other two lighting sources.

In the machine, the powder blade movement prohibits the placement of any lighting component on the back of the machine. Therefore we realized diffuse lighting using matt reflectors on the back of the machine and powder blade (see **Fig. 4**) which are illuminated by two directed light sources from the front and right, respectively. Optimum lighting for alternating scan pattern is provided by two orthogonal light sources, one of which is selected depending on the current bead angle. Dark field illumination, which uses lighting parallel to the building plane to highlight surface disturbances, is applied separately. For each layer we acquire at least two images: one after powder deposition and one after laser beam melting. For lighting evaluation and better illustration we took images of typical errors with all possible lightings.

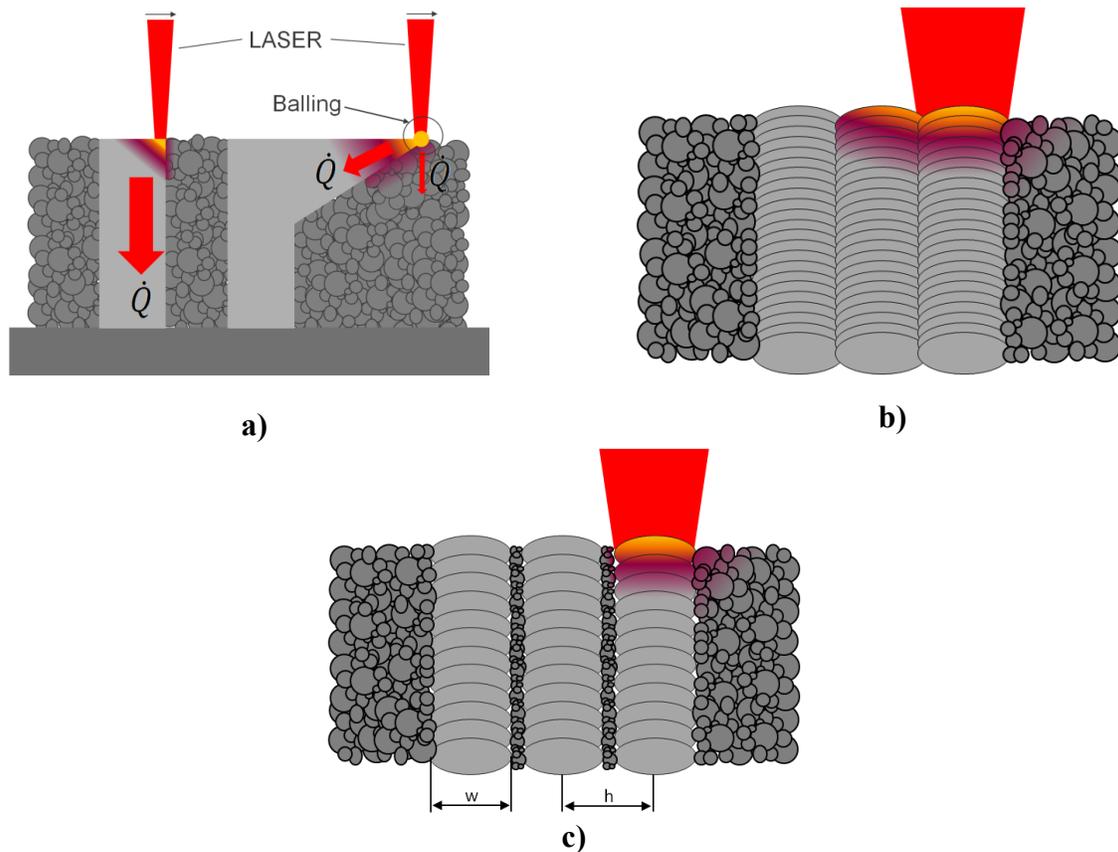
Fig. 5: a) Balling formation due to insufficient heat conduction caused by overhanging structures, b) good composite weldseams, c) poor composite weldseams by a wrong ratio of hatch distance h and width w combined with a high scanning velocity

Part quality is mainly measured by mechanical properties, surface roughness and dimensional accuracy. Depending on the utilized material and the heat input per second, hot cracks could eventually harm product quality. The formation of cracks is mainly the result of high cooling rates during the Laser Beam Melting process. Brittle materials are particularly susceptible to this error type. Most materials available for Laser Beam Melting process show a good weldability and are assigned to ductile metal alloys. However, powder contaminations or different concentration of elements within the powder particles could cause these defects. To ensure proper mechanical properties of the created parts, the creation of good composite weldseams is essential. For this purpose a defined ratio between width and distance of melt traces has to be achieved (**Fig. 5b**). The width of melt traces depends on laser beam diameter, laser scanning velocity, powder layer thickness and laser power. If the distance of melt traces – so called hatch distance – is too large, the compound of the respective melt traces will be deranged, which will finally cause porosities, resulting in poorer mechanical properties. A sudden decrease in laser power, e.g. caused by laser window pollution due to condensate deposits, a technical defect in the build platform actuator or an uneven platform resulting in a thicker powder layer at constant laser power leads to the same error type (**Fig. 5c**). Laser scanning velocity influences how much energy per second is conducted into the powder layer. A technical defect in the scanning system could therefore cause superelevations if scanning speed is too low, or poor composite weldseams if scanning speed is too high.

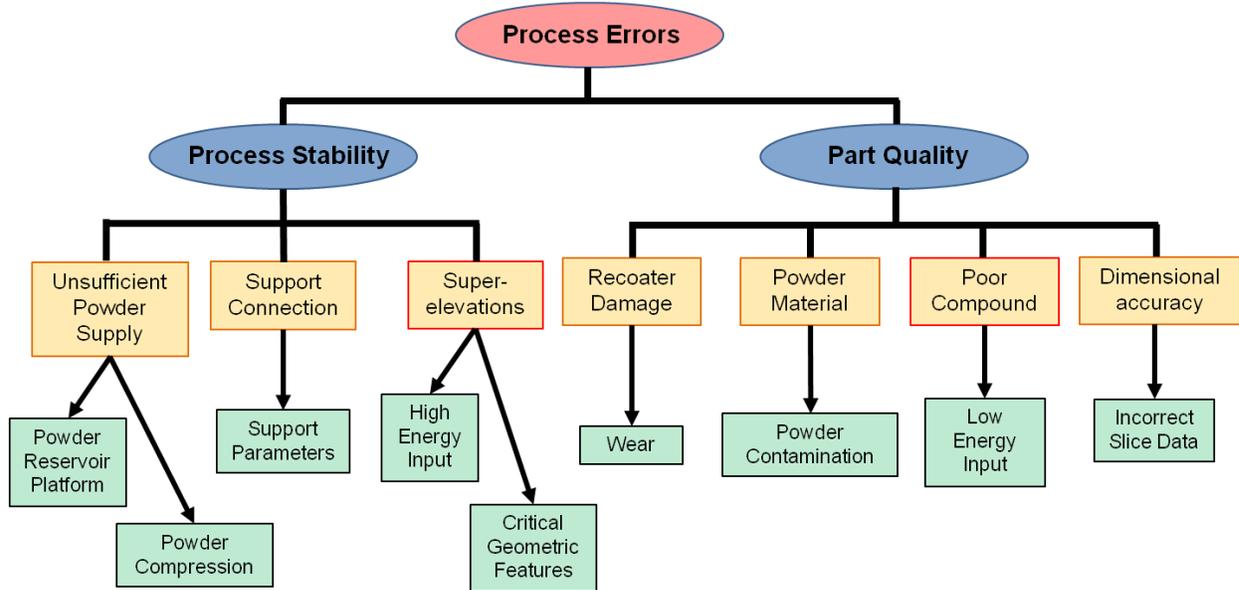
Fig. 6: Typical Process Errors in Laser Beam Melting categorized by influence, type and cause.

created layer. A contamination of powder could be caused by non-metallic or coarse particles. Due to these foreign particles the necessary heat of fusion is locally different and therefore causes irregularities after solidification. Dimensional accuracy is another quality feature, which is influenced negatively by material shrinkage after solidification and incorrect geometrical slice data. **Fig. 6** presents a systematic summary of all mentioned process errors.

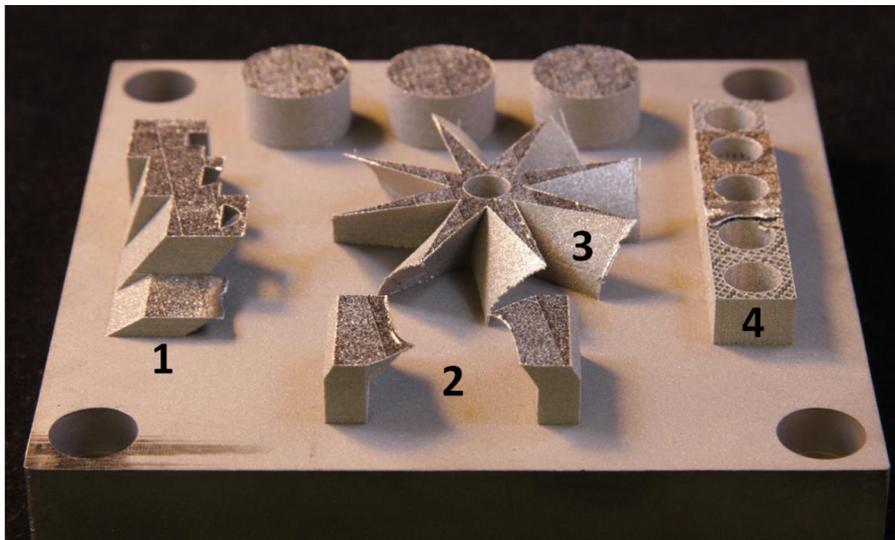
Fig. 7: Test samples built for examination of critical geometrical features and powder contamination

As can be seen in **Fig. 7** three test geometries have critical overhanging angles and were not connected to support structures. Part one and part two were placed parallel to the recoating mechanism which is unfavorable, due to the fact that in case of superelevation there is a large contact area between recoater and elevated part areas. This might cause a jam of the recoating mechanism. Part one furthermore features holes on the right side, which are critical when they are growing together. Part two features a critical overhanging area without support structures. Part three was inspired by turbine impellers, which feature overhanging blades. Support structures in these areas are difficult to remove. In consequence these parts are often built without any support structures which endangers process stability.

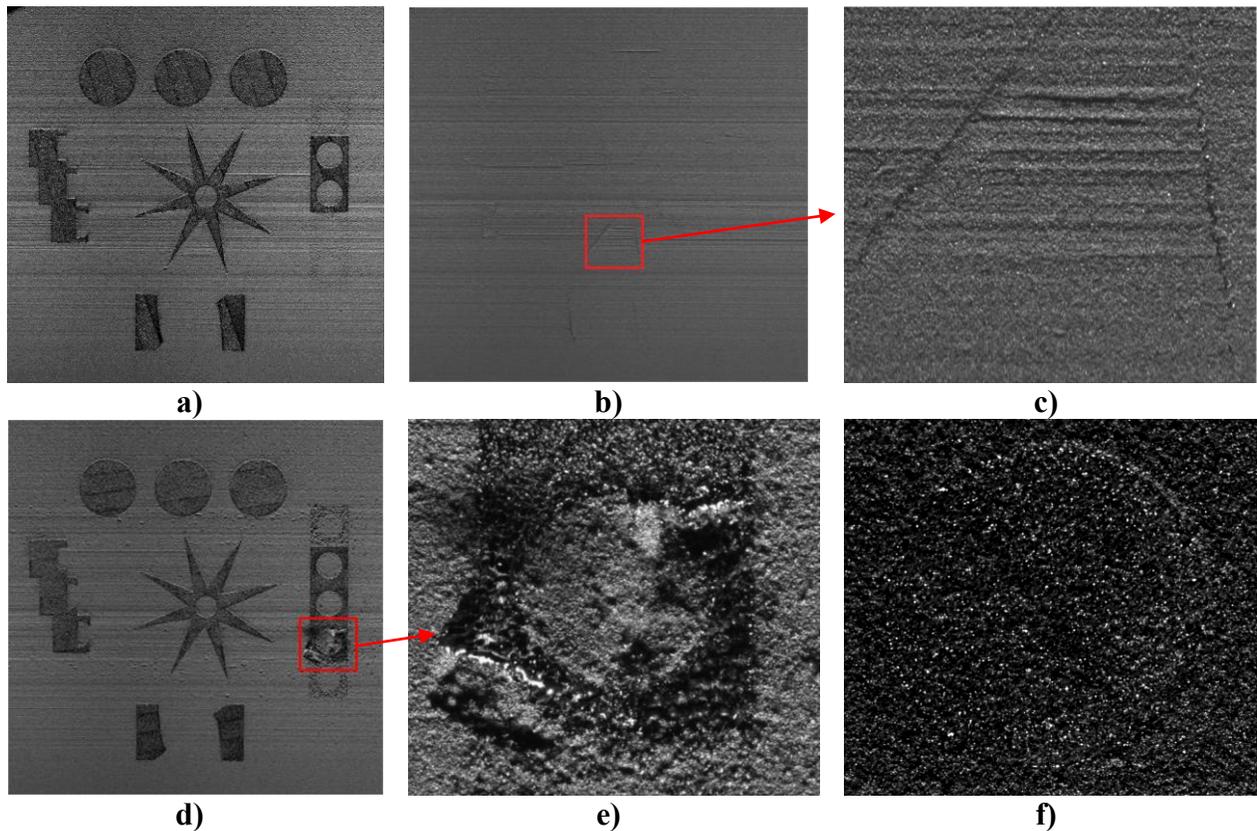
Fig. 8: Various types of errors influencing process stability. See text for full description. All pictures were taken with the described high resolution imaging system. Note: image intensities have been rescaled for visualization purposes.

Fig. 8a shows an image of this first test process taken in a z-built position of 5 mm after layer creation. **Fig. 8b** shows the same setup after powder recoating. As can be seen some areas of part one to three are superelevated and had contact to the recoating mechanism. **Fig. 8c** shows a detail of **Fig. 8b**. Depending on part geometry the superelevated areas will rise after each created layer. Furthermore there are horizontal lines visible in **Fig. 8c** which were caused by a damaged recoater blade. Part four in **Fig. 7** features supported overhanging surfaces in different

levels. The influence of different support connection parameters was investigated by this test sample. To achieve poor support the stability laser power used for support creation was decreased. After recoating some support particles were torn away by the recoater blade. These particles are also visible in **Fig. 8d**. The marked area in **Fig. 8d** shows the first part layer created on the poor support structures. **Fig. 8e** shows a magnified view of this area. Support connection was not stable enough to avoid curling effects of the created layer. With the next recoating procedure the recoater would tear off the created layer or even cause a jam. Finally **Fig. 8f** shows a magnified image of one cylindrical test sample after being exposed with contaminated powder. Comparing this image with **Fig. 8e** shows that the powder particles seem to be much darker and coarser than those of **Fig. 8e** (note that all images presented have been brightened for printing in the same manner). The solidified area in **Fig. 8f** shows a much more irregular surface. Melt traces are much more difficult to observe.

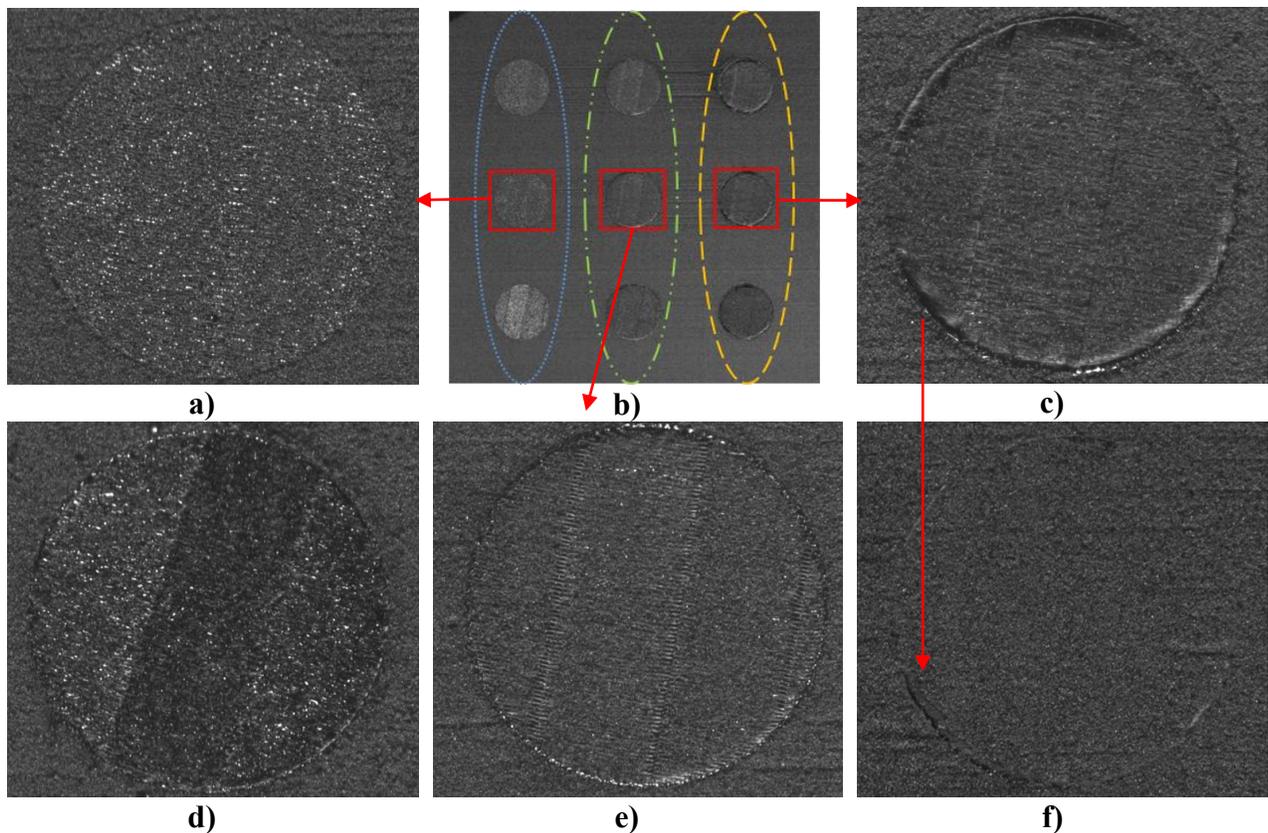
Fig. 9: Various types of errors influencing product quality. See text for full description. All pictures were taken with the described high resolution imaging system. Note: image intensities have been rescaled for visualization purposes.

In a second built process nine cylindrical test sample were built as shown in **Fig. 9b**. Herein the influence of energy input was examined. The three cylindrical test samples on the left side were assigned with process parameters that cause a low energy input. In detail the upper test sample was built using a laser power decreased by approximately 40 %. The middle test sample was built with a hatch distance increased by approximately 30 %. Finally the lower test sample was built using a scanning velocity increased by 40 %. According to this, the test samples on the right side were built using high energy input parameters. The three samples in the middle were

build using optimized parameters. After taking images as a reference, the laser beam diameter was enlarged for these samples. Through this energy input was decreased. **Fig. 9a** shows the test sample with enlarged hatch distance. The part exhibits a rough surface and irregularities. According to the remarks at the beginning of this section the image shows a poor compound of melt traces. It is remarkable that the upper and the lower samples nearly show the same appearance. **Fig. 9c** shows a representative sample with high energy input. The sample shows a smooth surface with superelevated areas at the sample edges. The superlevation of the edge regions can be better seen after powder recoating in **Fig. 9f**. Finally **Fig. 9e** shows the surface of a cylindrical sample built with optimized parameters. Herein good composite weldseams are visible. No regions of superlevation can be recognized. After enlarging the laser beam diameter the same sample is again illustrated in **Fig. 9d**. As can be seen the surface is quite similar to those of **Fig. 9a**; it has become more rough and coarse particles are visible due to some reflections at the particle's surface. The same error appearance would occur for increased powder layer thickness.
