Optical, layerwise monitoring of powder bed fusion

B. K. Foster, E. W. Reutzel¹, A.R. Nassar, B. T. Hall, S.W. Brown, C.J. Dickman

Center for Innovative Material Processing through Direct Digital Deposition (CIMP-3D)
Applied Research Laboratory, The Pennsylvania State University

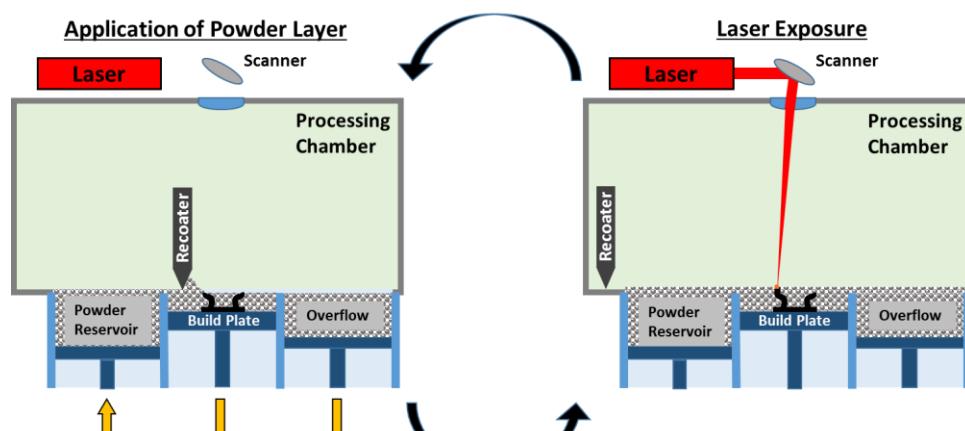
Figure 1. Illustration of the powder bed AM process.

The powder coating system comprises a powder reservoir, a build platform, a recoater blade (or roller), and a powder overflow reservoir, as shown in Figure 1. Metal powder, with typical mean particle diameter less than 50 μm , is packed into the powder reservoir and leveled. At process initiation, the platform under the reservoir is raised by a predetermined amount, selected to ensure complete powder coverage over the previous layer, with a deposition thickness that is married to the defined laser processing parameters. The recoater blade (or roller) spreads the powder across the build plate leaving behind a uniform layer, with excess powder pushed into the powder overflow reservoir. The thickness of each layer, typically in the range 20–60 μm , is also governed by the volume reduction that occurs during melting, consolidation, and solidification.

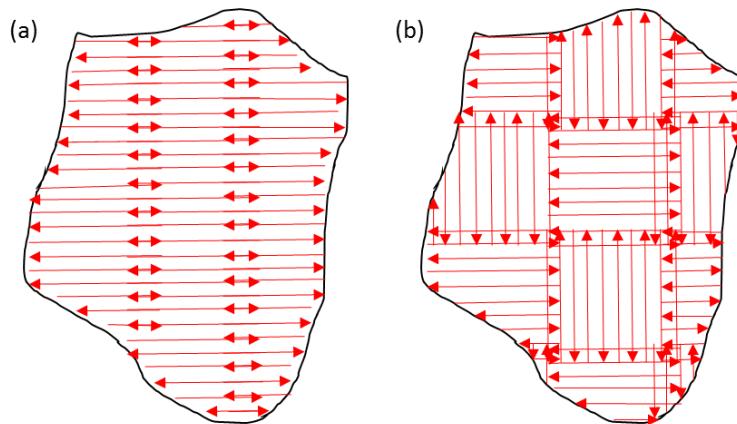
Figure 2: (a) Stripes hatching strategy. (b) Chess or island hatching strategy

Once a layer of powder is atop the build plate (or previous powder layer), the laser scanning system rasters the laser beam across the powder layer to selectively melt powder according to an exposure path created from a 2D slice of a part. Typically, the laser processing parameters are carefully tuned in a preliminary set of experiments, or are prescribed by the system manufacturer for a specific powder and layer thickness. Along each slice, contours represented by poly-lines are exposed along, or offset from, exterior and interior boundaries. The part interior is exposed along line segments called hatches. The order, arrangement, length, and spacing of hatches is prescribed depending upon the material and desired part quality. Two hatching strategies, stripe hatching and contour hatching, are shown in Figure 2.

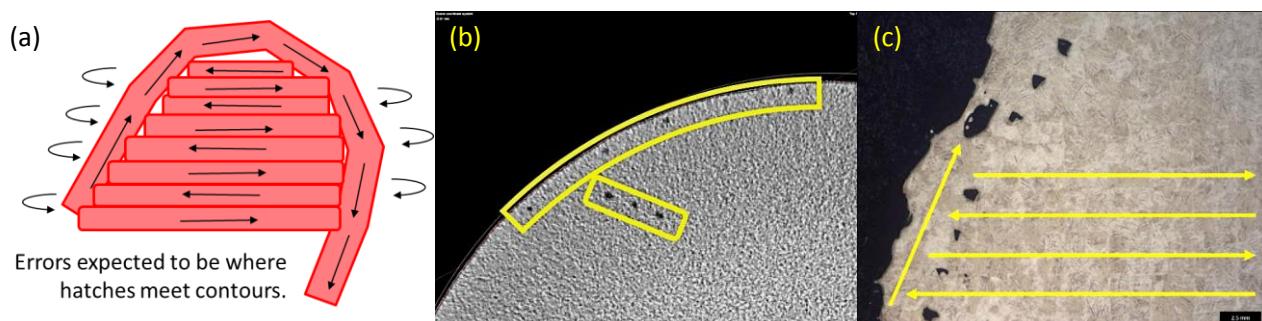
Figure 3. (a) Schematic that illustrates mechanism by which lack-of-fusion defects can occur at the overlap of hatch with contours due to position or temporal inaccuracies in the scanning system, (b) an X-ray CT scan highlights defects found in a test coupon built with laser power set to 70% of nominal, and (c) macroscopic image illustrating similar lack-of-fusion defects in a part built using the equipment supplier standard processing recipe (courtesy of Moog, Inc.).

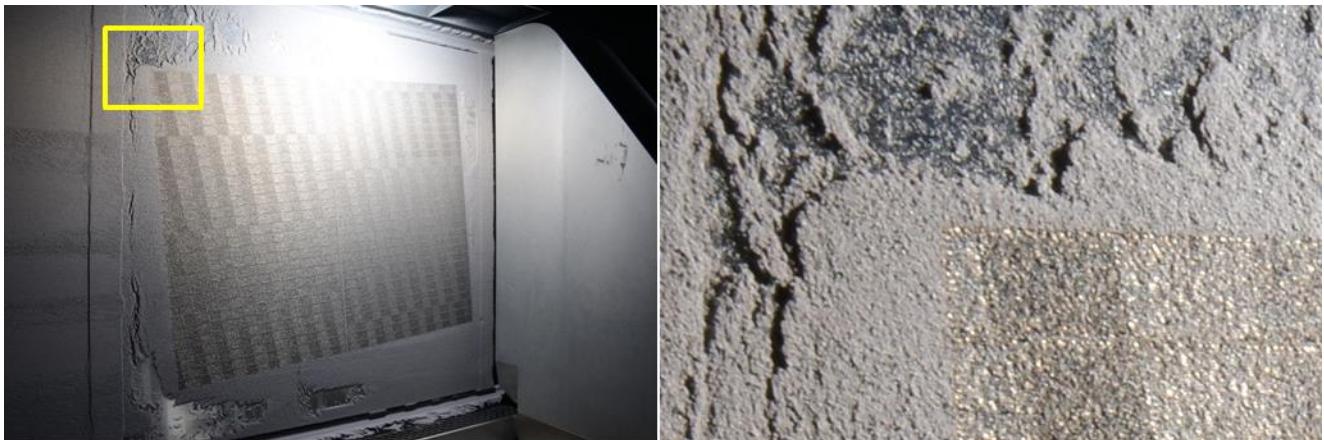
Figure 4. Image highlighting an example of powder shorting within the process chamber.

If the powder reservoir is insufficiently packed before the build process or the so-called “charge amount” (i.e. the amount of powder swept across the bed during each pass of the recoater blade) is set too low to account for powder consolidation during processing, powder shorting may occur. This results in a non-uniform powder layer as seen in Figure 4.

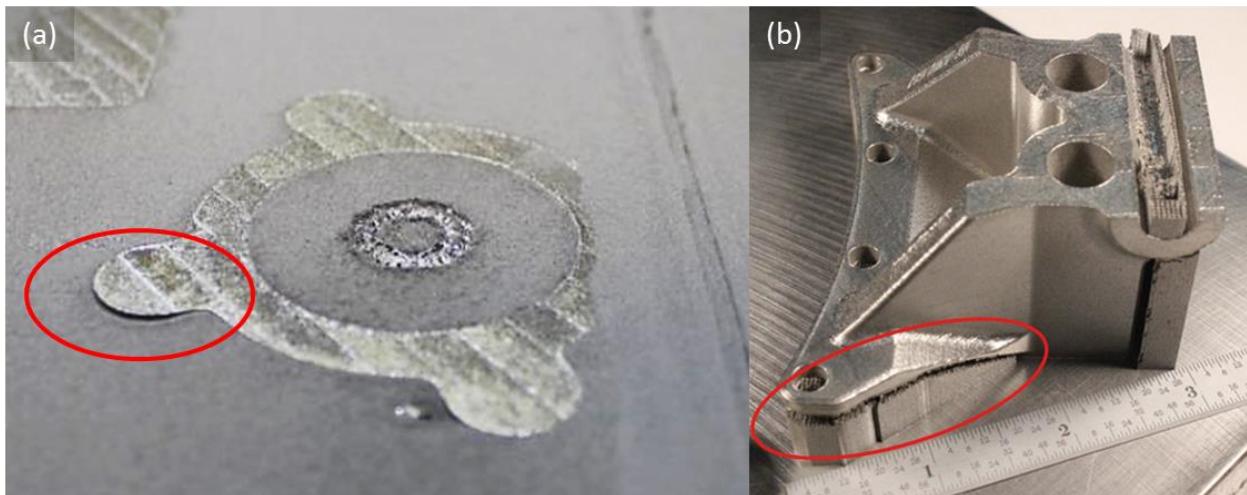
Figure 5. (a) Example of thermal distortion during the build resulting in disturbance above the plane of the powder bed. This distortion resulted in interference with the recoater blade that causes this build to be aborted prior to completion. (b) Photograph of a different component illustrating how support structure may fail before the build is complete (CAD model courtesy Honeywell, Inc.).

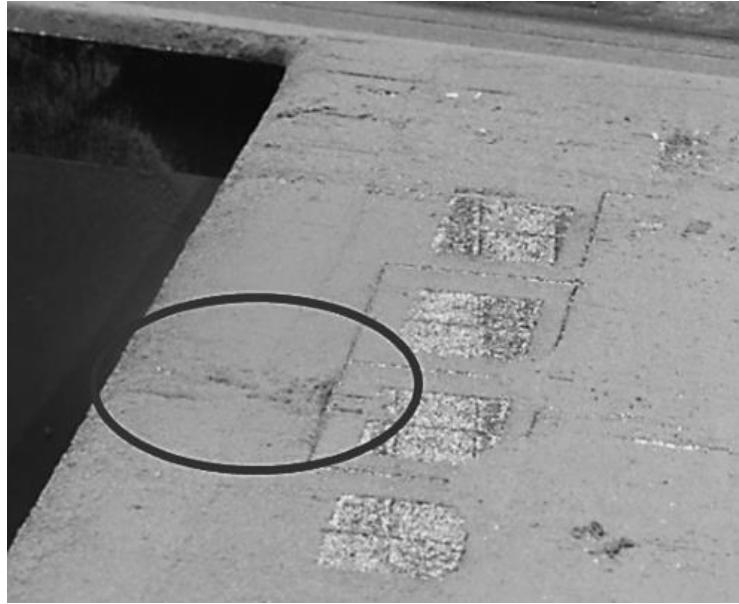
Figure 6. Image taken during PBFAM build highlighting powder flicking due to recoater blade spring-back.

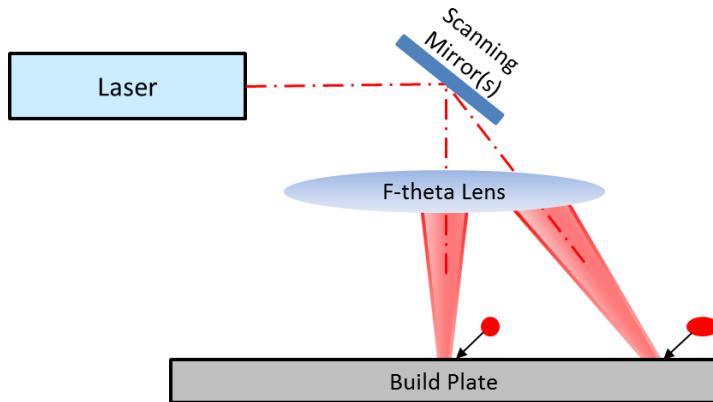
Figure 7. Illustration of how exposure location impacts the shape of the laser beam spot.

Another source of defects related to the build plan is part location on the build plate. Laser spot elongation occurs near the edges of the build plate due to high scanner deflection angles, as shown in Figure 7, and any angular inaccuracy of the galvanometers has a larger effect further from the center of the build plate. This type of error in the build process can lead to lack of fusion, porosity, and geometric variations in the final part.

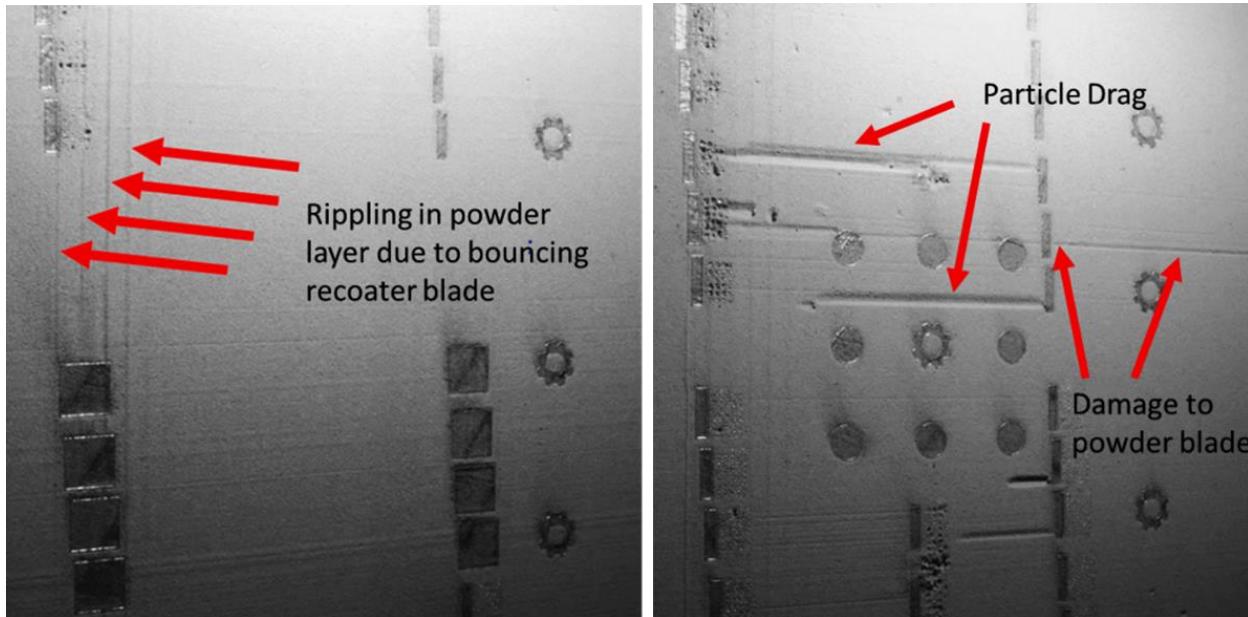
Figure 8. Image taken during a PBFAM build showing defects in the powder layer from recoater blade bouncing, particle drag, and damage to the recoater blade.

The third defect category covers issues that result from damage, misalignment, or other errors within the PBFAM system. Partially fused clumps of powder or spatter from the melt pool may adhere to the recoater blade or be plowed across the powder bed during recoating. This leads to troughs within the powder and a non-uniform powder layer, as shown in Figure 5. The recoater blade may also impact distorted parts and “bounce” before settling, leading to regular perturbations in powder thickness, also shown in Figure 8. Defects may result from damage to the recoater blade or roller, a

miscalibrated laser or stage position, or damage to the laser optics. Thermal deformation can lead to damage to the recoater blade or roller, and such nicks and gouges may result in striations and variations in thickness of the powder layer, shown in Figure 8. Uneven powder layers lead to changes to the physical interaction of the laser beam with the material resulting in inconsistent processing and, in some cases, porosity. A miscalibrated stage or laser scanner/galvanometer can also result in parts with inaccurate final dimensions. Damage to laser optics may result from contamination or reflected energy from the powder bed, and can influence the local laser beam spatial energy distribution.

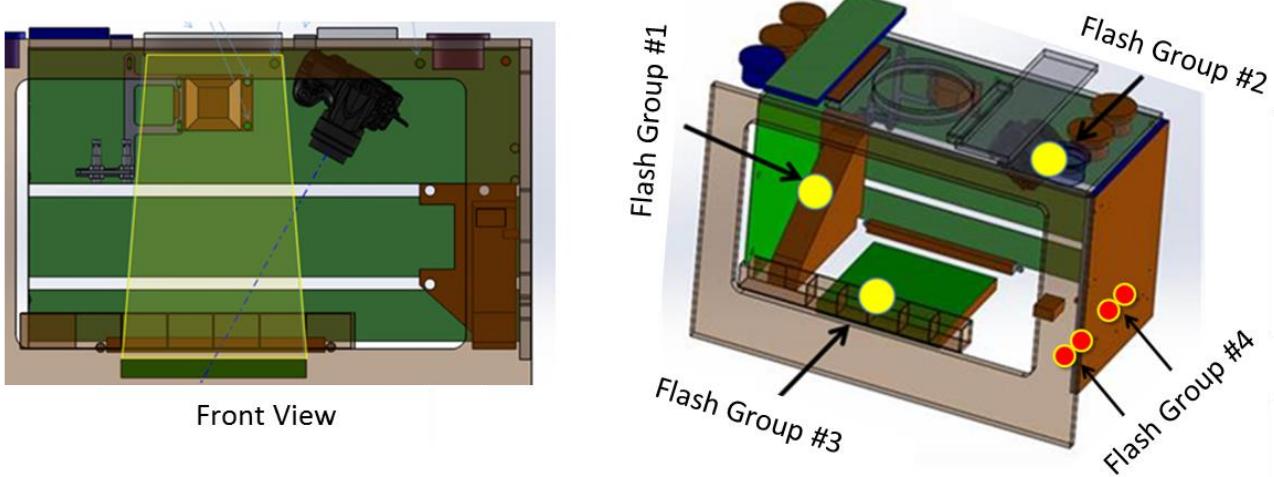
Figure 9. Schematics that illustrate the mounting locations of the camera and flash groups within the build chamber. (The camera enclosure is not shown to avoid confusion).

The flash groups are custom modules based off of Holga manual shoe-mount flashes with a guide number (GN) of 22 m that are strategically located at various locations within the build chamber, as shown in Figure 9, to provide high image contrast for a range of surface anomalies. Diverse lighting options are considered an important part of the imaging system in order to simplify automated defect detection.

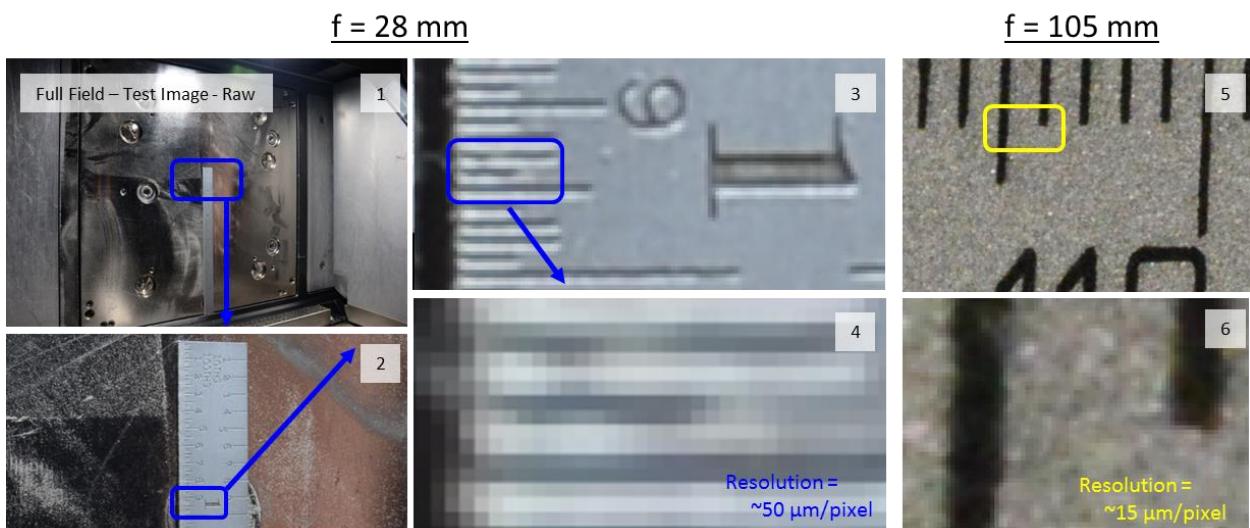
Figure 10. Image resolution measurements of both lens employed in this study.

Two lenses have been employed in testing to achieve different resolutions and fields of view. The original lens, which was used for all build images in the remainder of the paper, was a Nikon 28 mm f/2.8D AF Nikkor lens, achieved a resolution as fine as approximately 50 $\mu\text{m}/\text{pixel}$ across the 250 x 250 mm build plate. The second lens, a Nikon 105 mm f/2.8D AF-Nikkor, achieved a resolution as high as approximately 15 $\mu\text{m}/\text{pixel}$ across a trapezoidal region of the build plate 135 x 62/78 mm. These estimates were achieved by imaging a machinist rule, as shown in Figure 10.

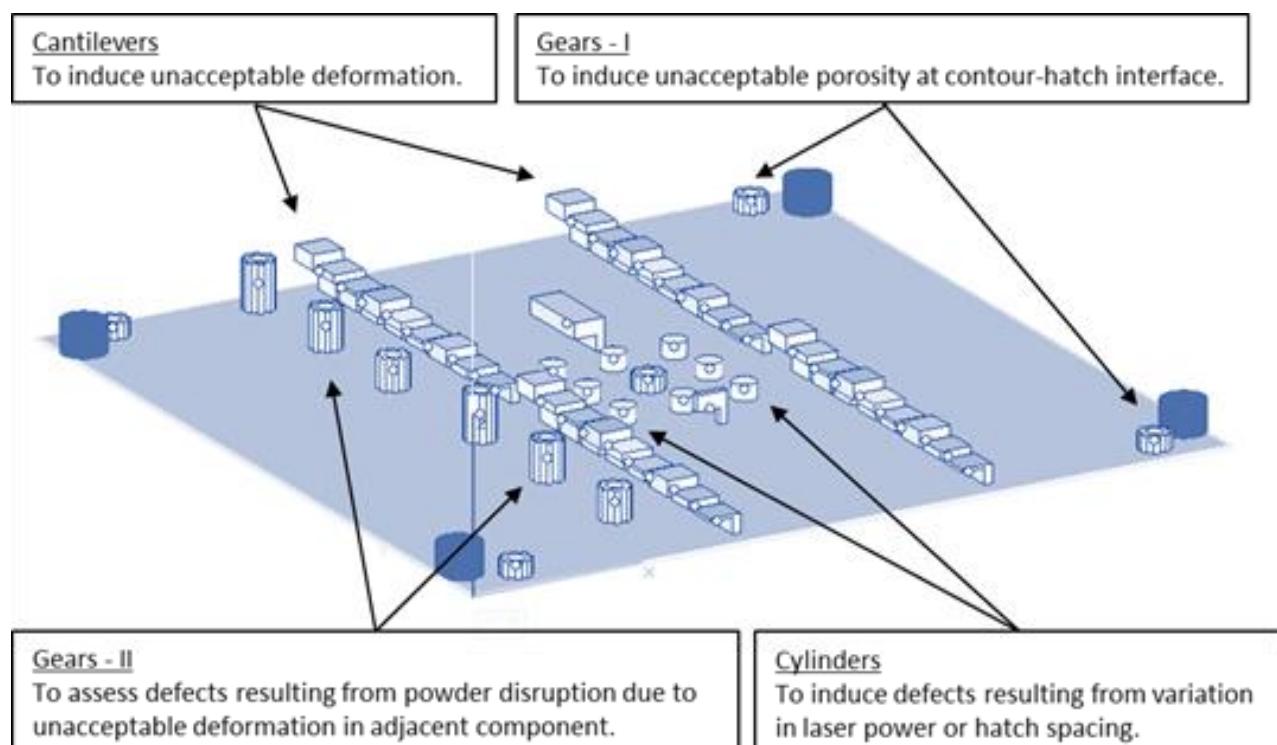
Figure 11. "Intentional Defect" build plan.

To assess the ability of the camera system to detect defects, a build was fashioned to intentionally generate a range of defects. A sketch of the build is shown in Figure 11. Cantilevered “diving boards” were included with a range of different support structures to induce various levels of deformation. Gear-like shapes were utilized to stress the control system in an attempt to generate

defects near the contour-hatch interface. Gears were also placed “downstream” of diving boards to generate defects by the expected powder disruption caused during distortion. Finally, a series of cylinders was included with intentional variation of laser power, scan velocity, and hatch spacing to create embedded lack-of-fusion defects. The objective of this build is to enable comparison of acquired images to parts with actual characteristic defects generated during PBFAM processing.

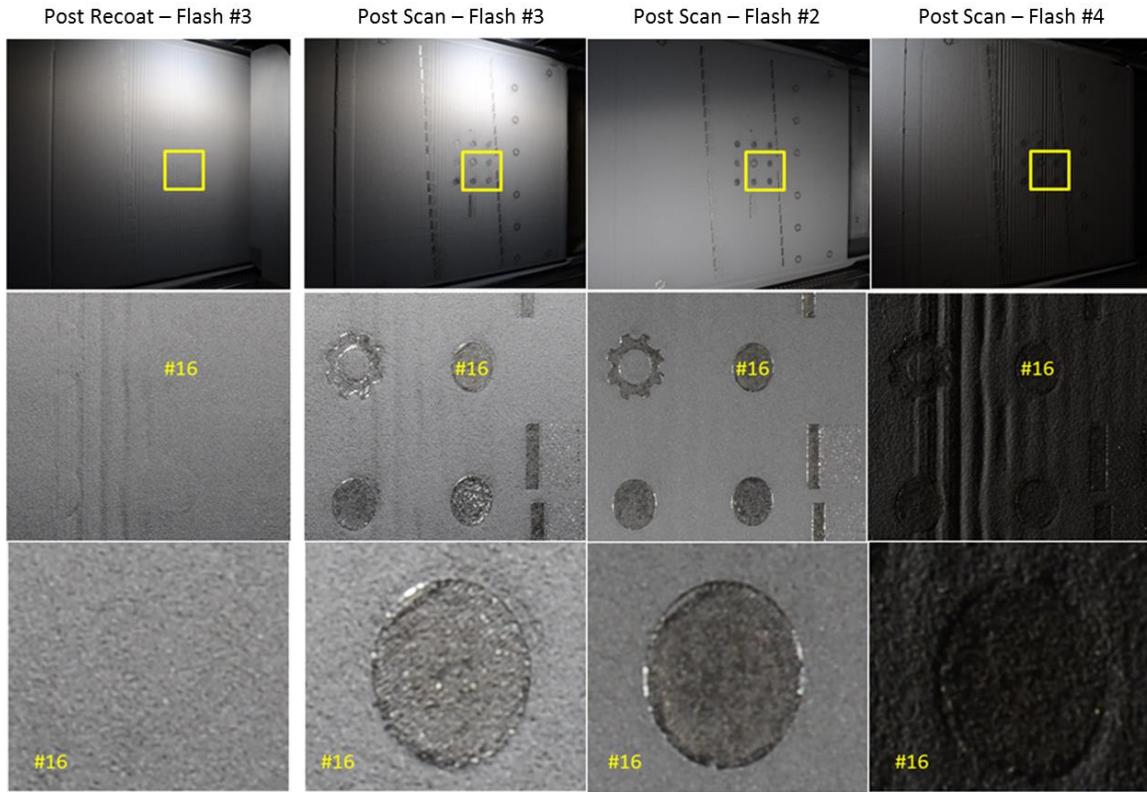
Figure 12. Images collected with various lighting schemes throughout a build demonstrate how the lighting location can be used to enhance surface perturbations.

Examples shown in Figure 12 illustrate how the various lighting schemes enhance the contrast of different features on each layer. Comparing these images highlights the need for multiple lighting scenarios to identify a range of possible defects. For example, non-uniform linear perturbations in the powder layer are readily revealed with Flash Group #4, but are nearly impossible to detect with Flash Group #2. Higher contrast will simplify development of algorithms for automated feature extraction.

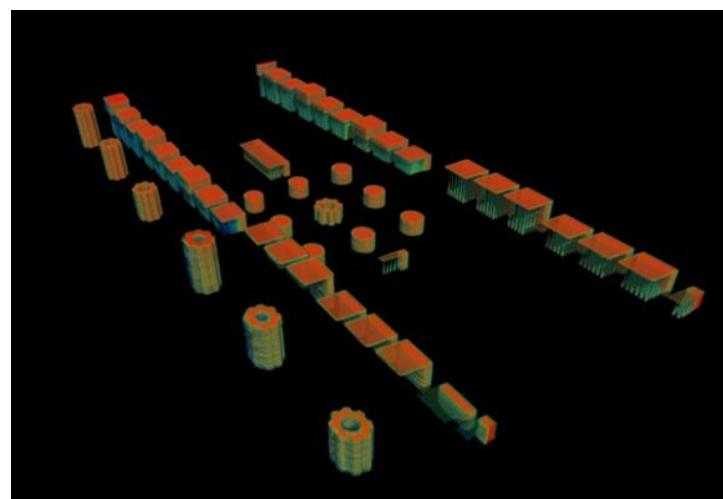
Figure 13. Images acquired at each layer can be stacked to create a 3D representation of the sensor data.

Post-processed and analyzed images can be stacked to create 3D models, an example of which is shown for the “intentional defect” build in Figure 13. Ongoing efforts will attempt to correlate internal defects embedded within these components detected by 3D X-ray computer tomography of built parts to the sensor data.

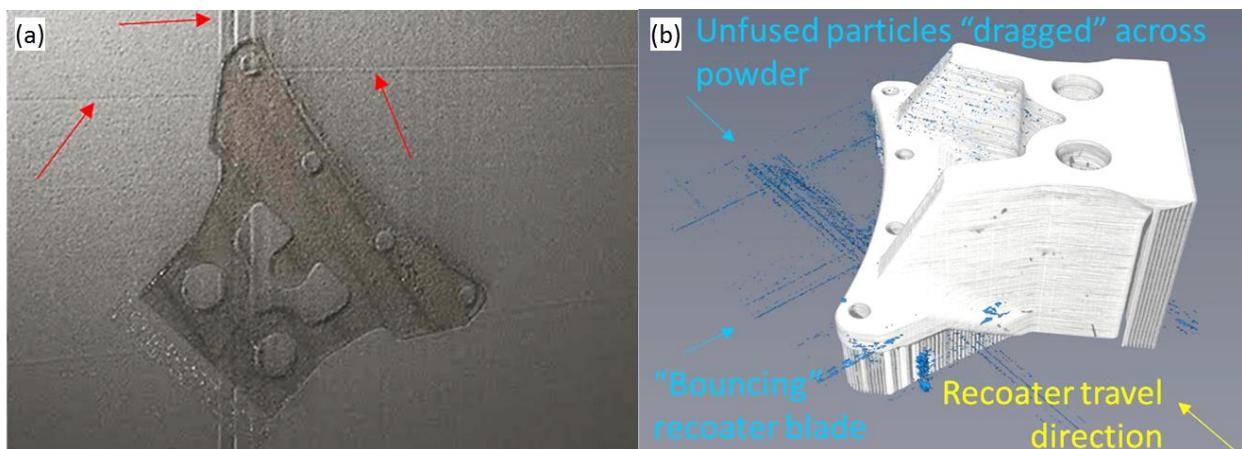
Figure 14. Images collected from each individual layer, example shown in (a), can be stacked to generate 3D models of the sensor data, as shown in (b). (CAD model courtesy Honeywell, Inc.).

In separate testing, analysis of acquired images for a specific test component reveals numerous anomalies in the surrounding powder layer partway through the build. Raw images from each layer, Figure 14a, were analyzed and stacked into a 3D image, in Figure 14b. The analysis included fusion of data from multiple flash groups and subtraction of consecutive images, show clear evidence of a bouncing recoated blade and dragged agglomerated powder. By viewing the data in 3 dimensions, it is straightforward to assess when these phenomena occurred, and also 3D location within the component that may be affected. This part is known to have generated enough residual stress during the build that it failed the support materials that held the component to the build part partway through the AM process (see Figure 5), resulting in an aborted build. It is apparent from the 3D sensor data that the failure occurred some layers after the supports had been completed.
