EXPERIMENTAL CHARACTERIZATION OF A DIRECT METAL DEPOSITED COBALT-BASED ALLOY ON TOOL STEEL FOR COMPONENT REPAIR

Xinchang Zhang*, Tan Pan*, Wei Li*, Frank Liou*

*Department of Mechanical & Aerospace Engineering, Missouri University of Science and
Technology, Rolla, Missouri, 65409, USA

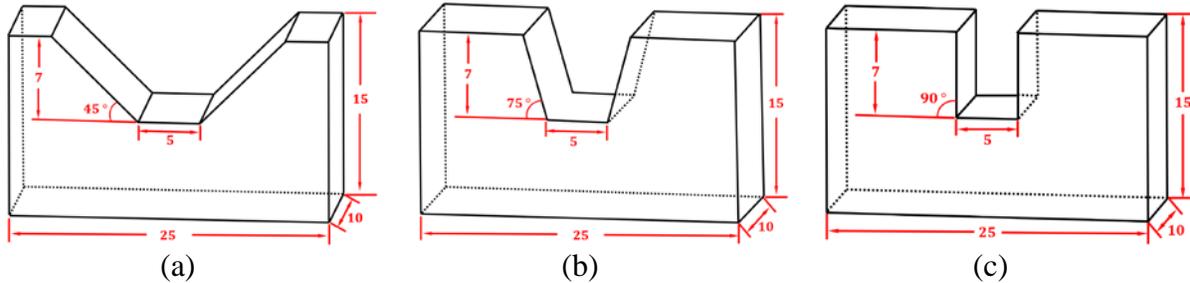
Fig. 1 Dimensions of the prepared substrates with (a) 45°, (b) 75° and (c) 90° sidewall inclination angle

H13 tool steel is usually used for manufacturing die casting dies owing to its great thermal fatigue cracking resistance. Therefore, H13 tool steel plate with dimensions of 25 mm × 10 mm × 15 mm was selected as the substrate material. In order to perform repair experiments, several V-shaped grooves with different sidewall inclination angles were machined on the substrates. Three sidewall inclination angles of 45°, 75°, 90°, were chosen which are depicted in Fig. 1a-c. The depth of each groove is 7 mm and the width of defects at the bottom is 5 mm. The chemical compositions of H13 tool steel are listed in Table 1.

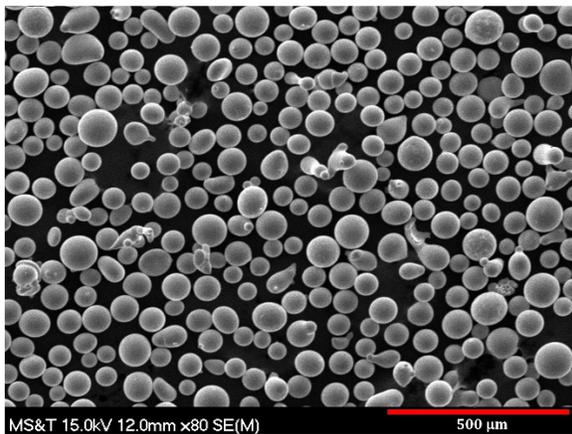
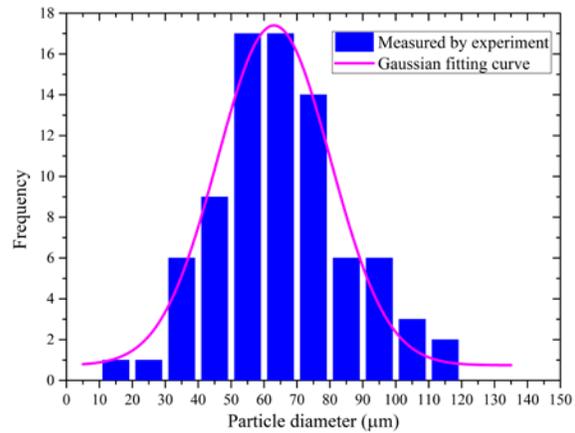
Fig. 2 SEM micrograph (a) and particle size distribution (b) of Wallex 50 powder

using Wallex 50 as a deposition material. The chemical compositions of Wallex 50 are collected in Table 1. Wallex 50 alloys powder was characterized to analyze particle shape and size distribution. An SEM micrograph of Wallex 50 alloys powder was obtained and presented in Fig. 2a. The image reveals that most powder particles are spherical although a few of them have irregular shapes. Particle size distribution analyzed using ImageJ shows the average particle diameter is 65 μm (Fig. 2b).

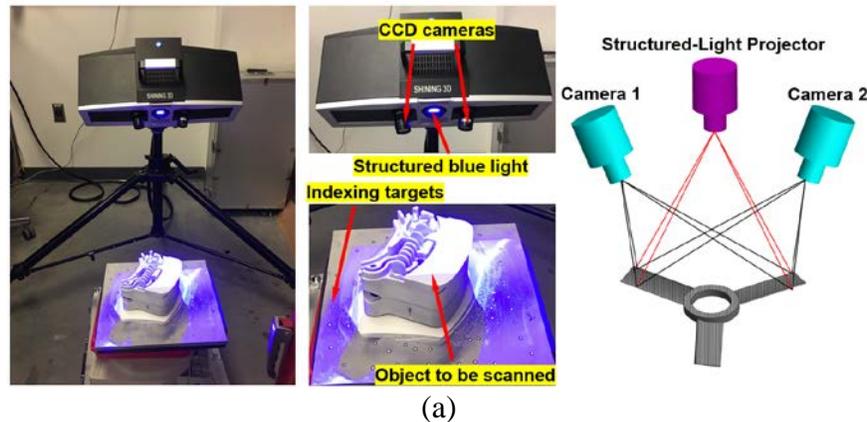
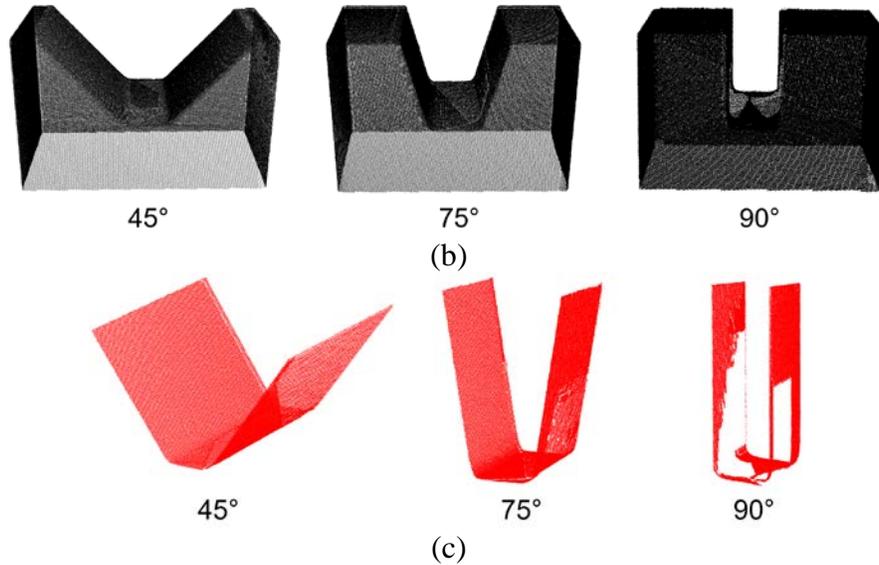
Fig. 3 Model reconstruction for repair volume determination; (a) 3D scanning setup; (b) Reconstructed point cloud data; (c) Extracted damaged point set

structured-light metrology 3D scanner (OptimScan 5M from Shining 3D Tech. Co. Ltd., Fig. 3a) to reconstruct its three-dimensional model. The principle of the structured-light scanner is shown in Fig. 3a where a pattern with stripes was projected on an object by the structured-light projector and two CCD cameras on the left and right of the scanner capture the distortions of the pattern. The distortion of pattern reveals the three-dimensional geometry of the object. A complete scan of the part requires scanning of the geometry in different orientations and therefore, indexing targets were randomly marked on the part so that multiple scans can be registered into a single model.

Substrates with different sidewall inclination angles were scanned using the configuration and the scanned point cloud was presented in Fig. 3b. Defining the point set in the damaged region is simply conducted by calculating the distance between each point to the top surface. The points on peripheral surfaces around the substrate are not considered as damage. After damaged point searching, the missing geometry can be defined, which is depicted in Fig. 3c. One can see in Fig. 3c that the damage for the sample with 90° sidewall defects was not completely scanned because the vertical sidewall combined with narrow slot blocks the two cameras from capturing projected pattern simultaneously. However, this uncomplete scanned point data has no effect on the additive tool path generation because the tool path generation algorithm relies on the convex-hull of the data set, which is described below.

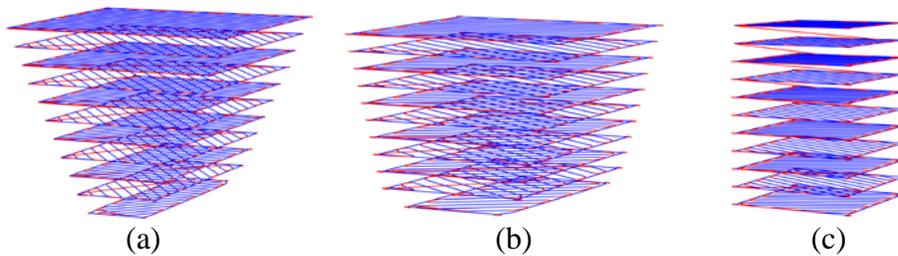
Fig. 4 Repair tool path for substrates including defects with (a) 45°, (b) 75° and (c) 90° sidewall inclination angle

After the damage was extracted, tool path was generated based on damaged point cloud utilizing the algorithm introduced in [21]. The damaged point set was sliced into 11 layers with a layer thickness of 0.6 mm. For each layer, deposition tool path was planned which comprises outline contour and raster infill pattern, indicating laser moves along the enveloping boundary and then along the zigzag pattern to acquire fully dense deposits. The tool path for three scenarios was shown in Fig. 4a-c.

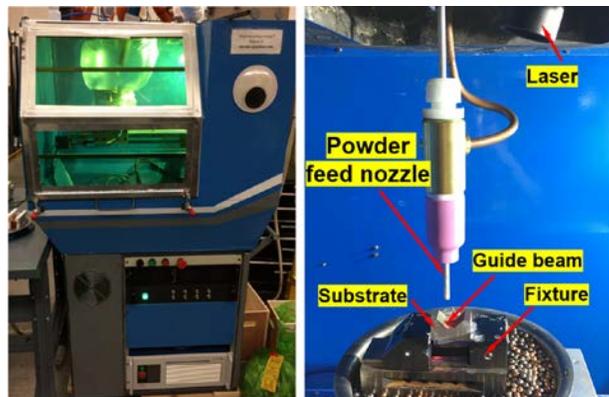
Fig. 5 DMD system and setup

After additive tool path was acquired, the damaged substrates were loaded to DMD system for material deposition. The DMD cell employed in this study (Fig. 5) includes a 1000 W peak power continuous wave fiber laser, gas-assisted blown powder feeder (Model 1200, Bay State Surface Technologies, Inc.), 3-axis work table and Argon gas feeding unit. The laser has a beam diameter of 1.8 mm. The laser beam is tilted while the powder feed nozzle is vertical with a stand-off distance of 10 mm. The welding was performed in argon gas environment to keep weld beads from oxidization. The processing parameters were summarized in Table 2.

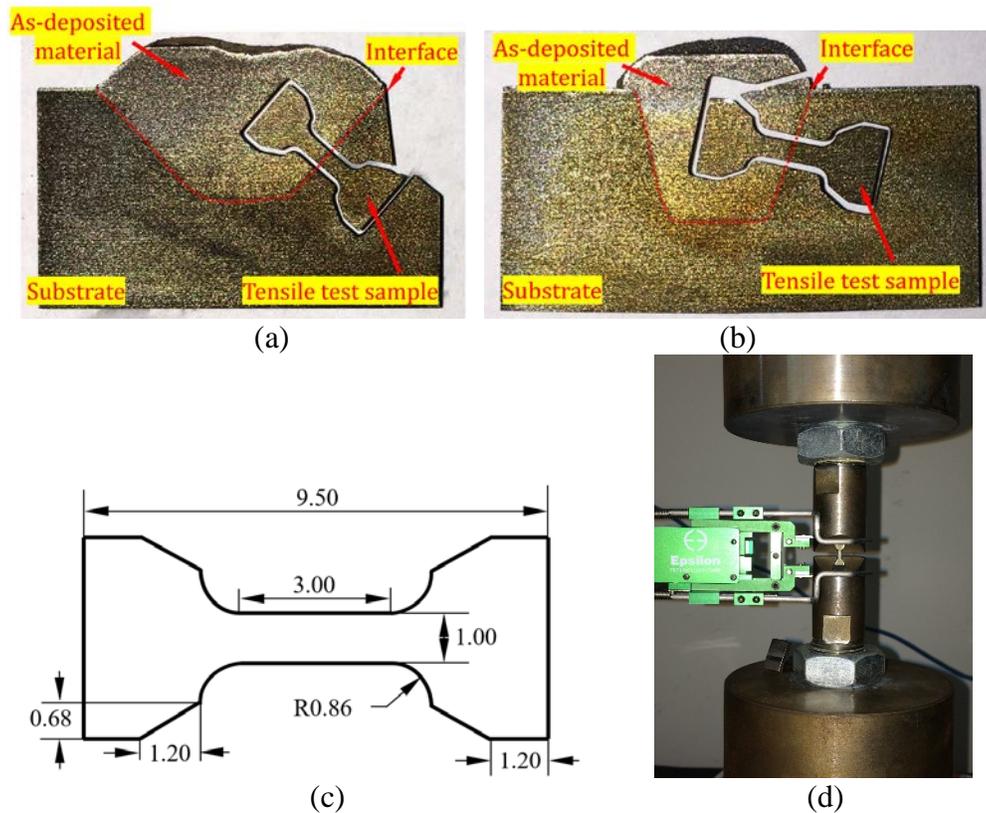
Fig. 6 Tensile test specimen preparation and setup; Tensile specimen over the sectioned repaired substrates with 45° (a) and 75° (b) sidewall inclination angle damage; (c) Dimensions of the tensile test specimen (Dimensions in mm, 1mm in thickness); (d) Tensile test setup

In order to test the mechanical properties of the repair coupons, tensile test and hardness measurement were conducted. For tensile test, the samples were cut into thin layers with a thickness of 1 mm as shown in Fig. 6. Tensile specimens were cut from each thin slices using EDM. The dimensions of tensile specimens are shown in Fig. 6c. The position and orientation of tensile samples were depicted in Fig. 6a-b. Each tensile specimen consists of deposits and substrate, with interface locating at the middle of the specimen. The tensile test was conducted using Instron tester (Model 3300) with a crosshead speed of 0.015 mm/min (Fig. 6d). Ultimate tensile strength was obtained and then, tensile fracture surface was analyzed. Vickers hardness was measured using Struers Duramin hardness tester with a press load of 9.81 N and dwell time of 10s.

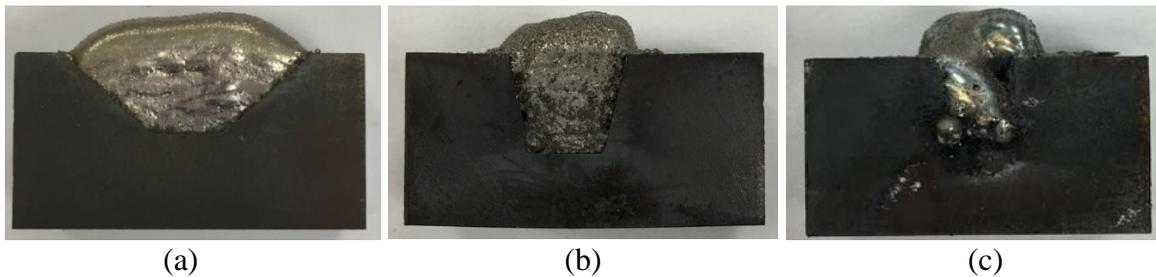
Fig. 7 Overview of the repair samples with 45° (a), 75° (b) and 90° (c) sidewall inclination angle

The overview of the repaired samples is shown in Fig. 7. It seems that missing volumes on all substrates were refilled successfully. However, by deeper visual observation, one can see the refilled region on the sample with 90° sidewall defects was not fully dense. A big hole was observed slightly at the right portion of deposits. This is because when the laser was melting the materials on the side vertical surface, filler material was not able to bond with the substrate and fell down, which caused the hollow space inside the deposits. This is validated by observing the cross-sections of samples discussed below.

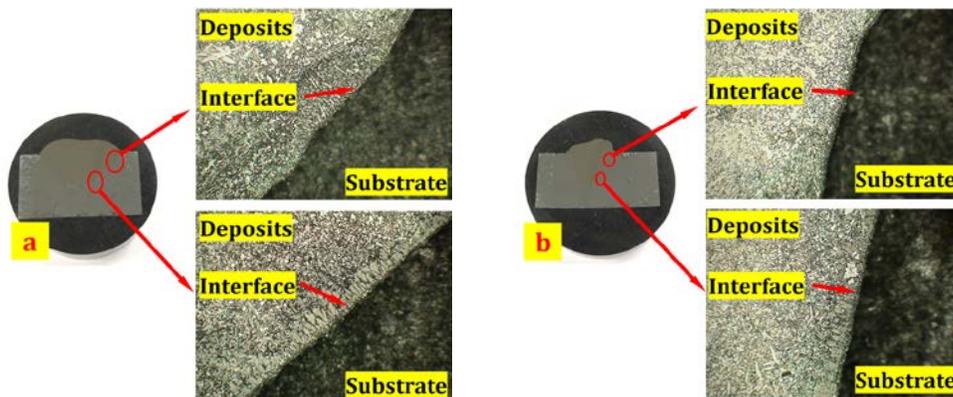
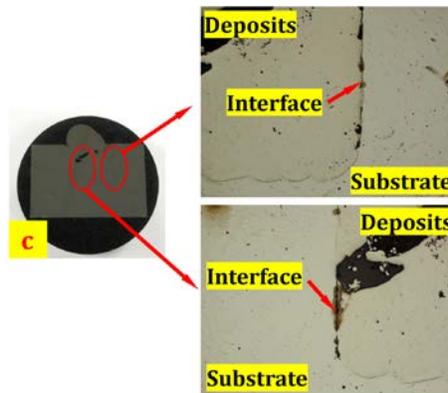
Fig. 8 Optical micrographs of cross-sections of the repaired samples with 45° (a), 75° (b) and 90° (c) sidewall inclination angle damage

The optical micrographs of cross-sections of the repaired samples are depicted in Fig. 8a-c, which has sidewall inclination angle of 45° , 75° , and 90° , respectively. Micrographs were taken at the boundary of deposits and substrate. One can realize that the bonding line is free of defects for 45° and 75° samples, while a large number of porosities and lack of fusion were observed in the sample with 90° tilt sidewall damage. Those defects were almost entirely located along the sidewall boundaries. The bottom region of the 90° tilt sidewall sample, however, is well bonded. This phenomenon is expected because, for a vertical sidewall, the laser cannot continuously melt the materials at the vertical side of the defects but can still effectively melt materials on the bottom region. Thus, melt pool cannot be successfully formed at vertical regions and filler materials were not able to be melt and deposited. This situation might be addressed by using 5-axis DMD system by rotating the substrate so that the sidewall is relatively accessible to the laser beam. However, this is not always working if the defects are deep and narrow. Besides, toolpath planning for 5-axis DMD system is much complicated and only desired if really required.

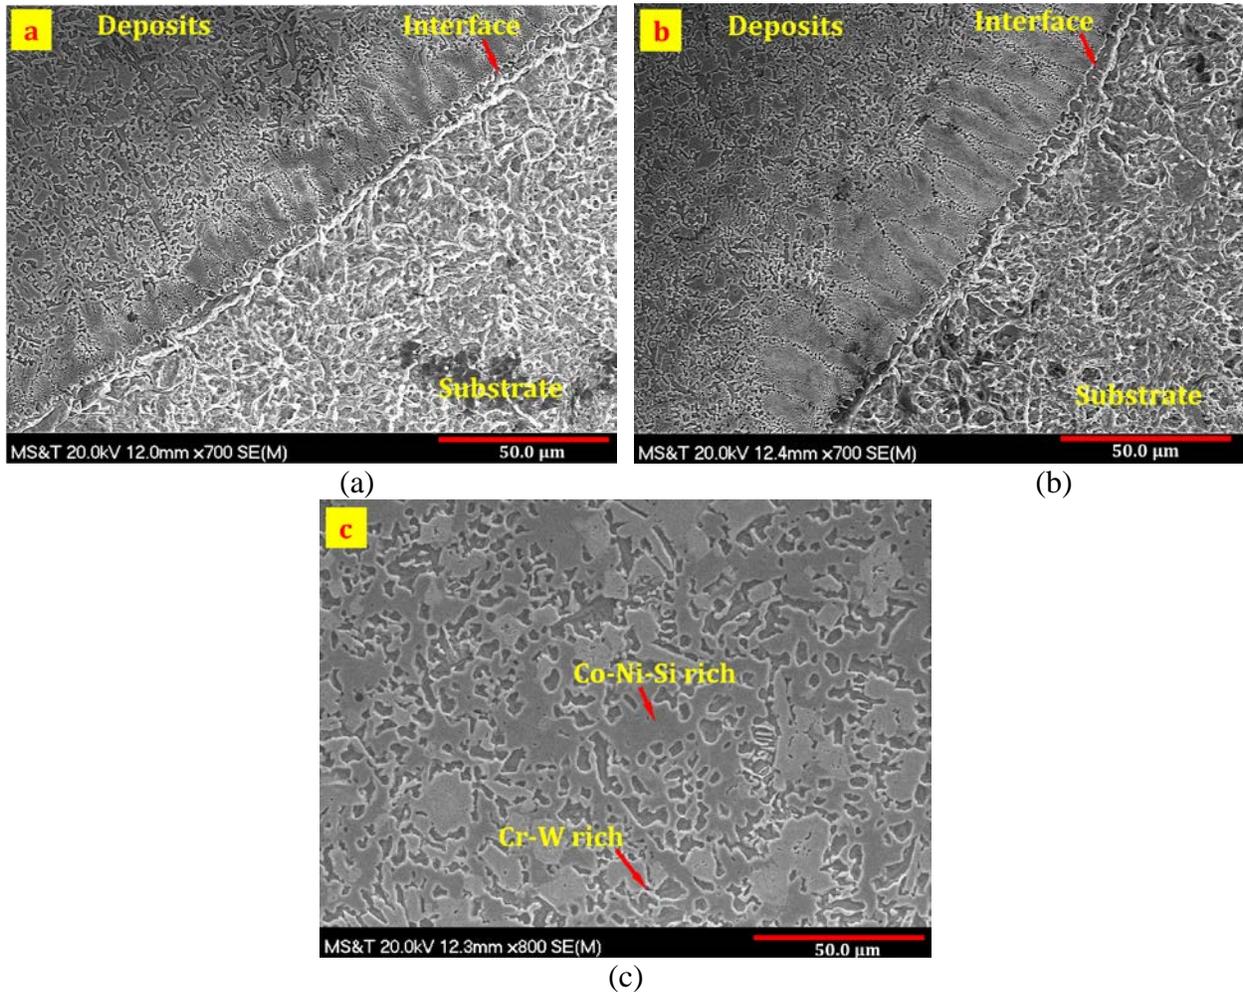
Fig. 9 SEM micrographs of the boundary area of repaired samples with 45° (a) and 75° (b) sidewall damage; (c) Micrographs of top layers of the repaired sample with 45° sidewall damage

Because the defective substrate with 90° sidewall inclination angle was failing to repair, only samples with 45° and 75° sidewall damage were further analyzed in terms of microstructure and mechanical properties. Microstructure images were taken at the boundary of deposits and substrates, as shown in Fig. 9. The images distinctly show the bi-material boundary line. The microstructure changed sharply from the substrate to deposits. This is no smooth transitional region between two materials. By observation, one can see there are no defects such as cracks, pores, or delamination observed along the interface, confirming the solid bonding condition. The SEM images reveal that deposits were metallurgically bonded with the substrate. The tensile test in the following of this paper also validated the sound bonding.

The SEM micrographs in Fig. 9 also shows that the microstructure of deposits near the interface mostly consists of columnar structure stretched towards to the center of deposits. Those grains were growing parallel to the heat flow direction during solidification. When starting to deposit the first few layers, the damaged substrate was at room temperature. The laser melted a tiny amount of material on the substrate, forming a melt pool, and when materials were injected into such region and laser moved away, the cooling rate at such area is extremely high, which caused the grain to grow in the columnar direction. The cooling is so fast that leaves not sufficient time for grains to form secondary dendrites. As materials were deposited layer by layer, the microstructure of deposits gradually changed to dendrite with interdendritic eutectics. This results from the dropped cooling rate when depositing the above layers.

The microstructure of top layers of as-deposited Wallex 50 alloy is presented in Fig. 9c, which consists of mostly interdendritic eutectics. It was observed that the gray region was enveloped by bright phases. EDS spectrum shows the bright region in Fig. 9c was rich in Cr and W and the gray area is dominated by Co, Ni, and Si.

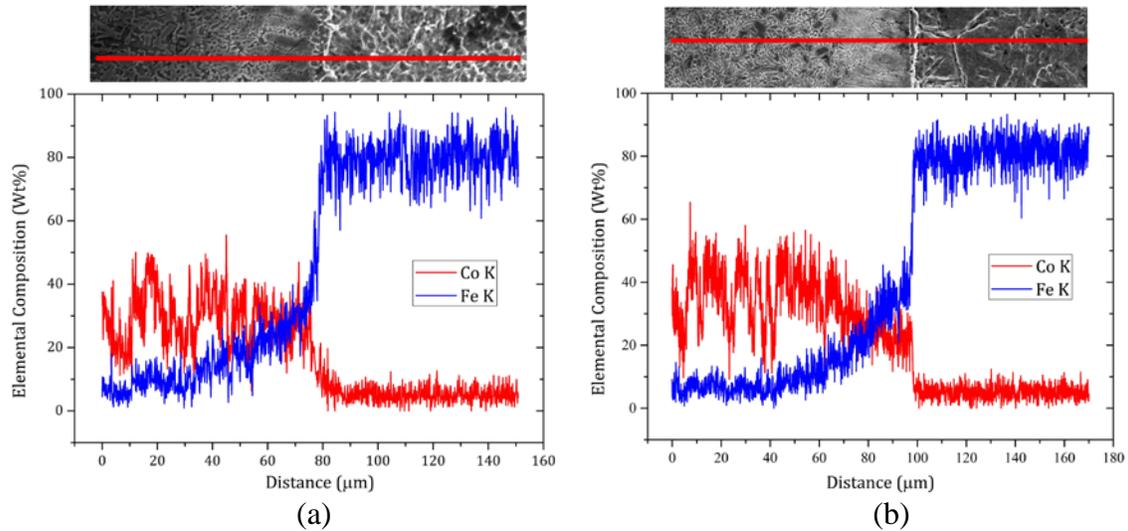
Fig. 10 EDS line scan analysis results for samples with 45° (a) and 75° (b) damage

EDS line scan was performed on the repaired samples to study elemental composition and distribution. The obtained data are plotted in Fig. 10. The scan was started from the deposits and ended in the region of the substrate, passing through the bi-material interface. Major elements of Co and Fe were quantified along this path. Dwell time for each scanned point was 200 ms.

EDS line scan exhibits the major elements like Co and Fe were gradually changed when passing the interface. This is because, when a melt pool was created on the substrate, Co-based alloy Wallex 50 was filled in the melt pool and mixed with the melted H13 tool steel material. Such mixed regions caused the elemental distribution changing near the interface. Relatively large amount of Fe exists in the first few layers of deposits, showing the dilution of Fe into Wallex 50. Therefore, Fe contributes to the phase transformation over the interface. The EDS line scan result confirms that excellent metallurgical fusion was created through the interface.

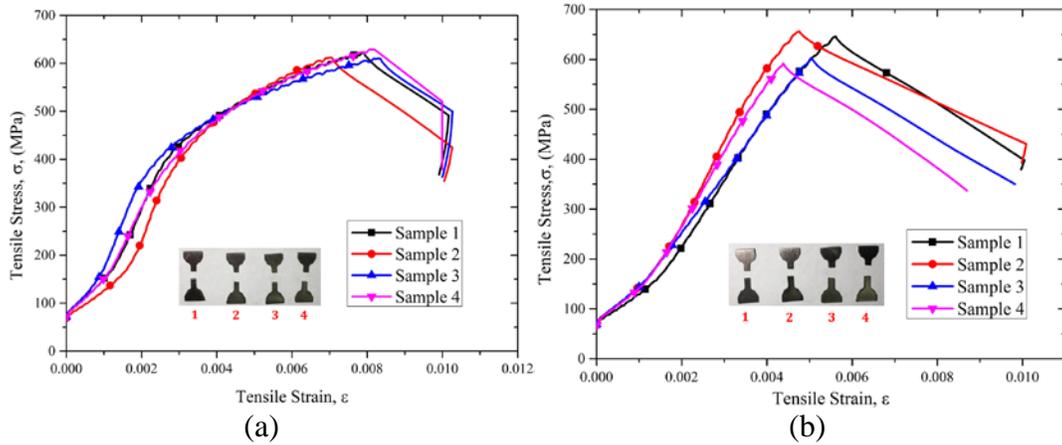
Fig. 11 Tensile stress-strain curves for repaired samples with 45° U-shaped defects (a) and 75° U-shaped defects (b)

The tensile stress-strain curves for two repaired samples were plotted in Fig. 11 and the Ultimate Tensile Strength (UTS) is summarized in Table 3. The tensile stress-strain curves reveal that the tensile stress increased with the increase of tensile strain to a maximum stress of about 620 MPa, and then, the tensile samples fractured suddenly and the stress decreased rapidly. The curves didn't reveal yielding phenomenon during the tensile testing. The ductility of tensile samples was extremely low. Further investigation reveals all samples fractured at the as-deposited Wallex 50 region. Therefore, the as-deposited Wallex 50 alloy shows brittle failure mechanism.

The average UTS of the repaired samples with 45° and 75° V-shaped defects is approximately 618 MPa and 624 MPa, respectively. The tensile testing shows the influence of sidewall inclination angle on the UTS is barely recognizable. There is a relatively big variation of UTS in the tested result. This variation was possibly attributed to the unevenly located defects in the deposited regions. Some micropores in deposits may affect the UTS and result in such standard deviation.

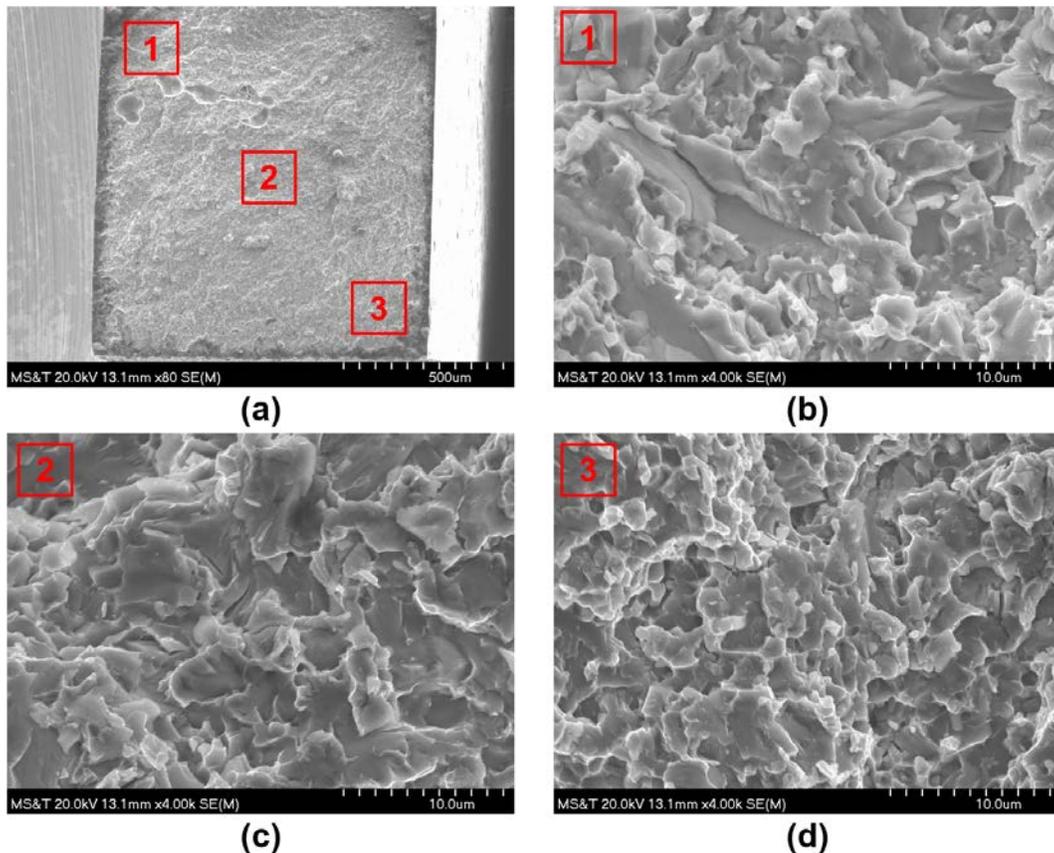
Fig. 12 Tensile fracture morphologies; (a) Overview of the fracture surface; (b) Magnified view of area 1 in (a); (c) Magnified view of area 2 in (a); (d) Magnified view of area 3 in (a)

The micrographs of tensile fracture surface are presented in Fig. 12a-c. The overview image reveals a relatively flat surface which is perpendicular to the tensile loading direction. Magnified view in Fig. 12b-d shows microscopically unsmooth areas. Microcracks were observed at such magnified views. There is a very limited population of voids and dimples, indicating the fractured region is very brittle. This is because the Wallex 50 is a Co-based alloy and also consist of a relatively large number of hard elements including Cr, W, Si. Cr, W, and Si can form a very hard phase that results in the brittle failure mechanism of as-deposited Wallex 50 during tensile testing.

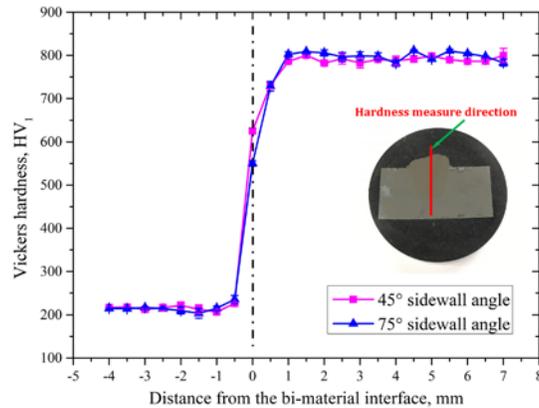
Fig. 13 Vickers hardness tested on the cross-section of the repaired samples

Vickers hardness was measured on the cross-sections of the repaired samples starting from the top of deposits to the substrate. The step between two adjacent indentations is 0.4 mm. The Vickers hardness tested on two samples was plotted in Fig. 13.

A first observation is that the hardness of deposits is much higher than the hardness of substrate. The hardness of the H13 substrate is approximately 210 HV, while the hardness of deposits is 810 HV, almost four times of the hardness of substrate. However, H13 tool steel used for die casting dies is in quenched and tempered condition and usually shows a hardness range of 480 -520 HV. The reason that the hardness of the substrate utilized in this study is only 210 is owing to the condition of the received H13 tool steel material. The as-received H13 substrate is in the annealed condition and has not been hardened, causing the low hardness. However, one can see that even the hardened H13 tool steel which condition is exactly used for casting dies is also much lower than the hardness of as-deposited Wallex 50.

hardening. The hardness at bi-material interface jumped from 250 HV to 800 HV rapidly. The transitional hardness values at interface indicate the dilution in the heat-affected area. The transitional range is approximately 1.5 mm.
