Development of a standalone in-situ monitoring system for defect detection in the direct metal laser sintering process.

Abstract

Development of the Monitoring System

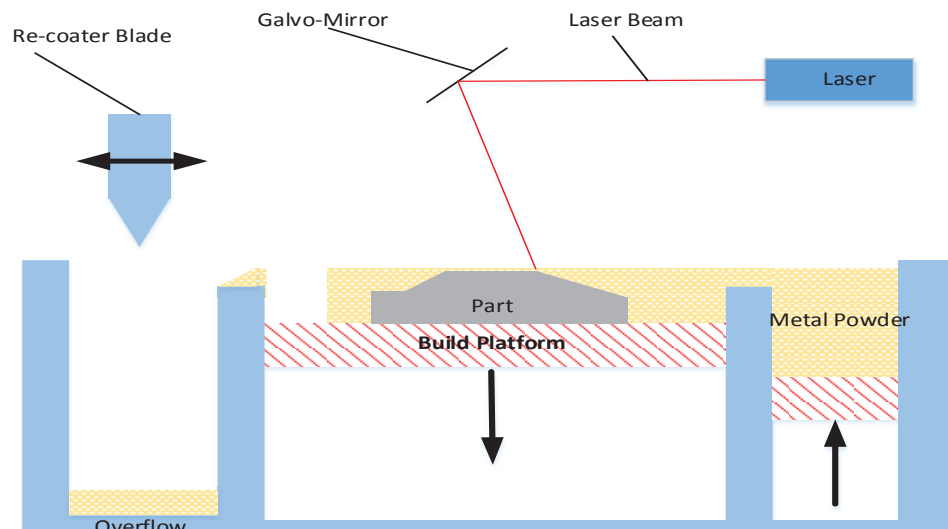
Figure 1: DMLS process, showing the powder dispenser, build platform, laser system and AM part

Additive manufacturing (AM) allows for the manufacture of high-value complex components and as such has gained popularity in a range of industries. Due to this, research into the AM process has received increased attention. The AM process is a layer-by-layer process allowing for the production of high value, complex components in industries such as aerospace, automotive and medical device [1], [2]. The process presented in this research is a powder bed fusion (PBF) process called Direct Metal Laser Sintering (DMLS). The process selectively melts a powder bed, layer-by-layer to build a final part. The powder layer is deposited on the build platform by the re-coater blade. The laser then melts the powder layer and a new layer of powder is deposited, as depicted in Figure 1. The process repeats layer-by-layer until the part is complete.

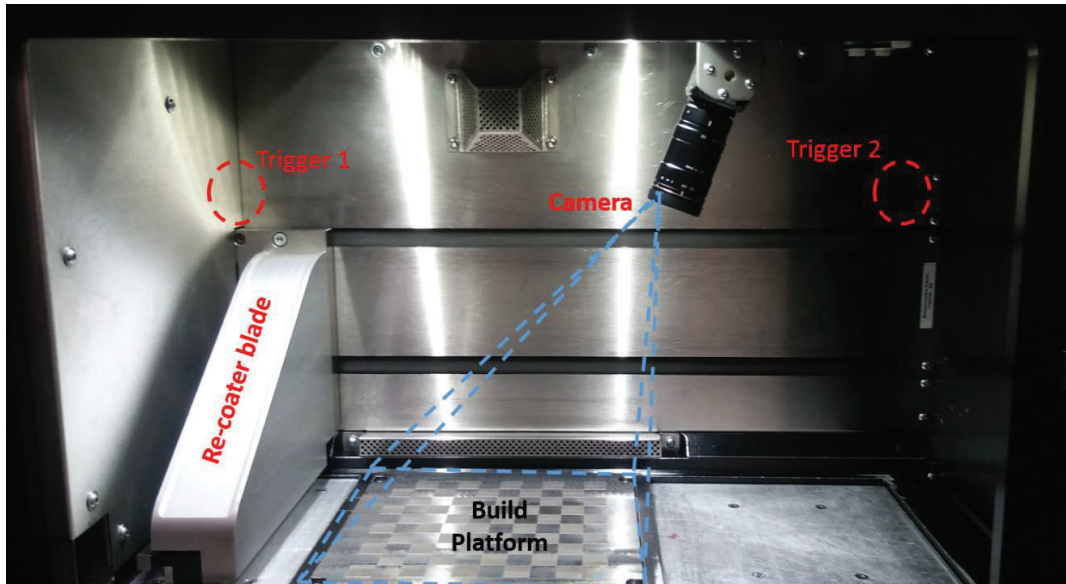
Figure 2: In-situ standalone monitoring system installed in the build chamber of the EOS M280 machine.

The chosen system consists of a 21 MP complementary metal oxide semiconductor (CMOS) monochrome camera with a 16 mm lens attached. This is mounted in the chamber above the build platform, as shown in Figure 2, to capture images of the build platform during the AM process. The camera is triggered using two laser trigger sensors mounted behind the machine panels, as shown in Figure 2. These sensors utilize the motion and position of the re-coater blade to trigger the camera and capture the image. The images are then collected by the camera controller unit and stored to an external hard drive.

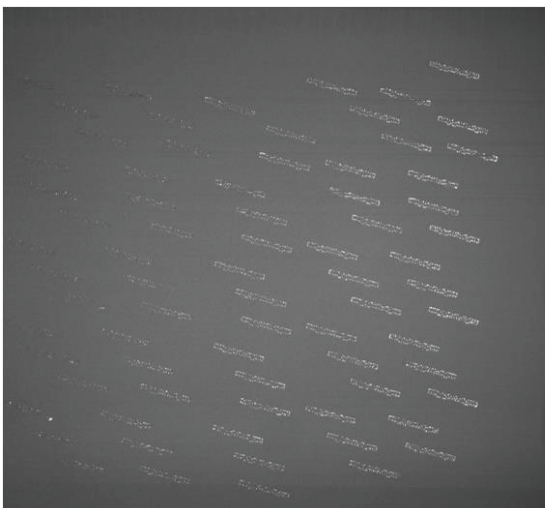
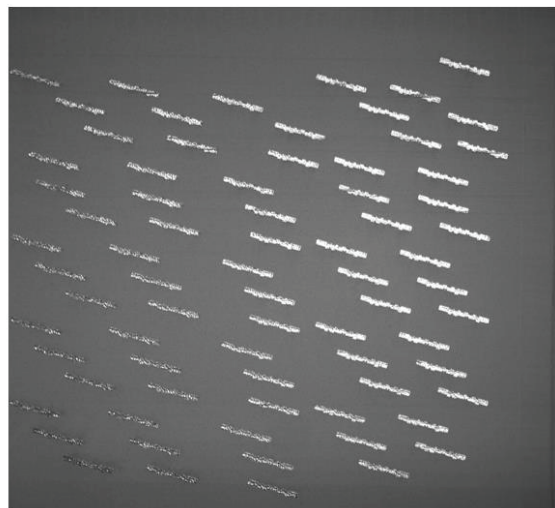
(a) After Powder Deposition

(b) After Laser Exposure

Figure 3: Captured images (a) after powder re-coated and (b) after laser exposure

The monitoring system captures two images per layer of the build process. An example of a pair of these images is shown in Figure 3 below. The first captured image, Figure 3(a), is the deposited powder layer, after re-coating, and the second image, Figure 3(b), is captured after the laser exposure. The first image enables the quality of the powder deposition to be assessed using the image analysis methods described in the next section.

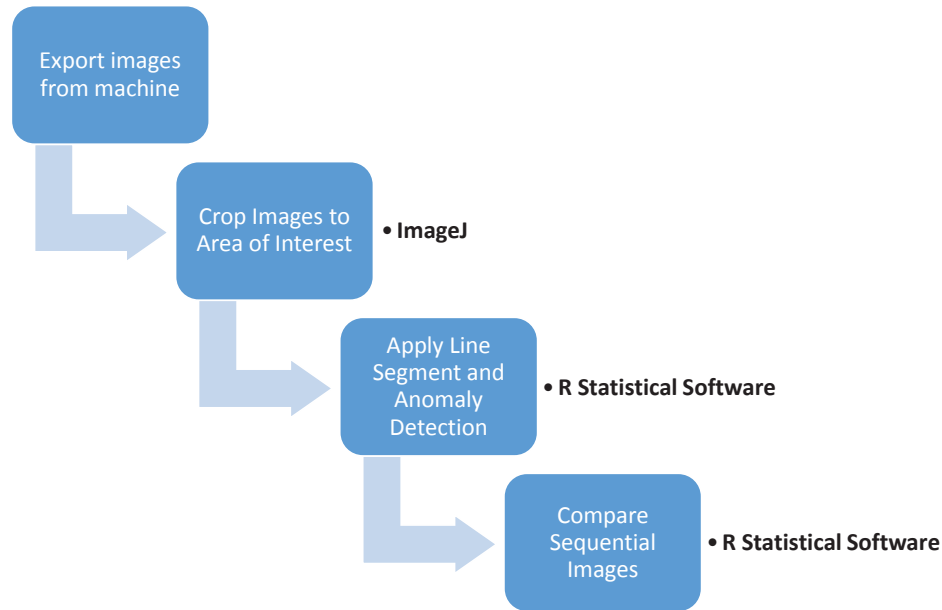
Figure 4: Flowchart of the image processing operations

At present, the images are exported to a desktop PC for ex-situ analysis after the build process is completed. Future work will enable the acquired images to be analyzed in real-time during the AM process. Figure 4 shows a flowchart of the current operations carried out on the images acquired.

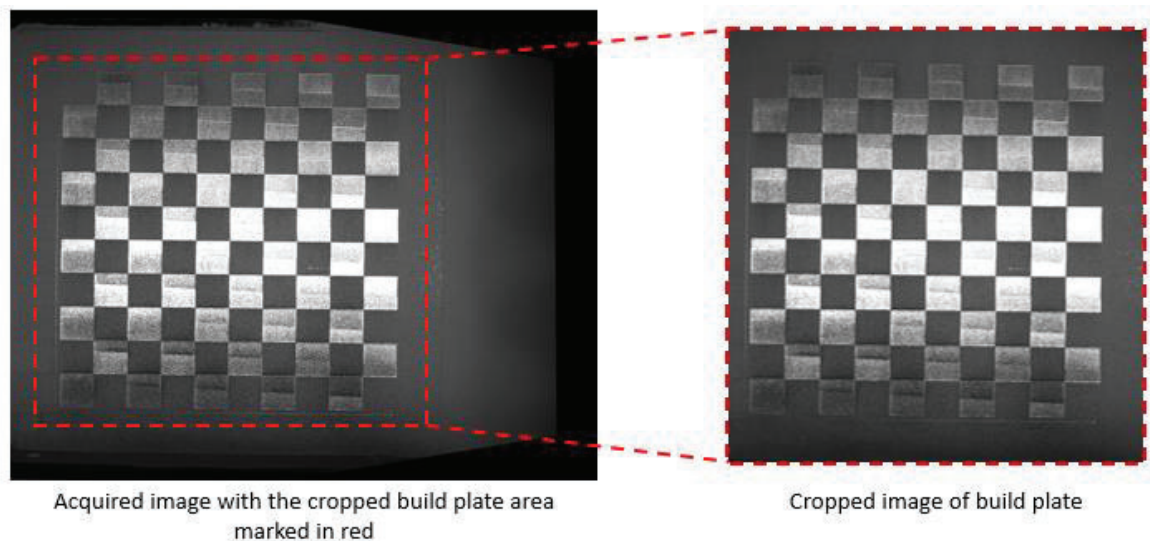
Figure 5: ImageJ cropping tool

Software packages ImageJ and R statistical are the used to process the images once they have been exported from the camera controller. ImageJ is an open source image analysis program [29]. A macro script is used to apply a batch crop on all of the images acquired from the camera. This allows for the regions of interest to be selected and the other areas to be removed. This is shown in Figure 5 below.

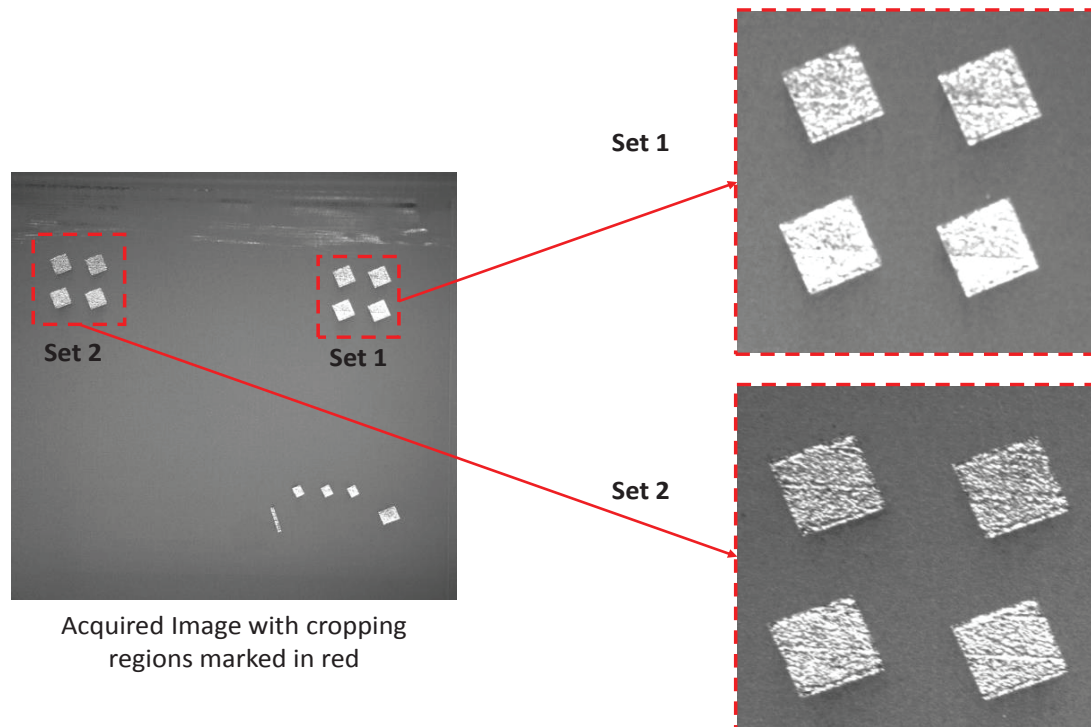
Figure 6: Cropping Regions for Set 1 and Set 2 of parts

The aim of this study is to evaluate the effectiveness of the installed monitoring system and of the newly developed image analysis methodology to identify instances of short feeding of powder, which leads to a lack of powder deposition on the parts being produced. In this study, multiple builds consisting of two sets of four 10mm² cubes were manufactured. The parts were positioned on the build plate in the locations shown in Figure 6. The two sets (Set 1 and Set 2 in Figure 6) of cubes were then cropped as shown in Figure 6, before being analyzed using the line segment detection and anomaly detection scripts.

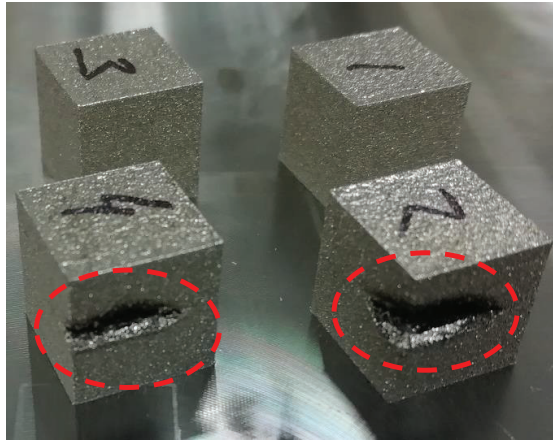
Figure 7: Set 2 parts - with damage due to short-feeding highlighted

Set 1 is the control set of samples and are built without any deliberate defects. Set 2 is deliberately subjected to some short-feeding of powder during the build between the build height of 4.5 mm and 6.5 mm. The short feeding will be induced by reducing the volume of powder that is fed to the re-coater blade before a new layer of powder is deposited. This will result in a region on the cubes in Set 2 with a shortage of powder deposited. This lack of deposited powder will result in the re-melting of previous layers causing voids and delamination in the part. The damage to the final part due to the short-feeding is presented in Figure 7. This type of damage can have a detrimental effect on a part, if not detected within two or three layers of the start of the short-feeding.

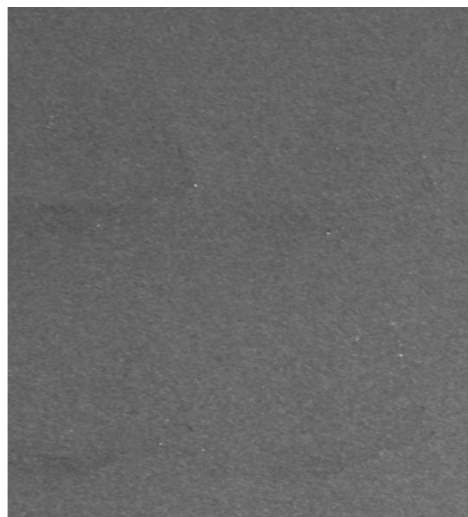
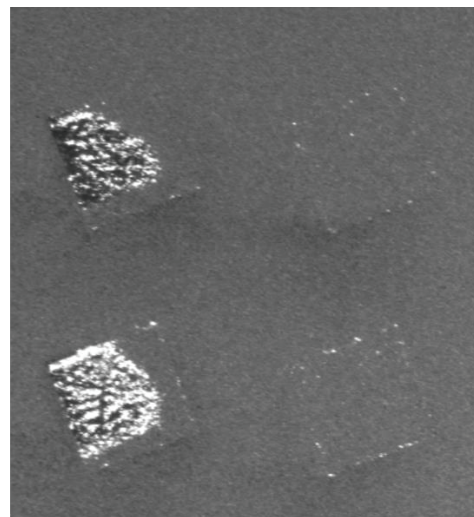
(a) New Powder Layer – no short feeding

(b) New Powder Layer – short feeding

Figure 8: In-situ camera images showing (a) an example of correct powder distribution on the cubes in Set 2 after recoating and (b) an example of short-feeding resulting in insufficient powder being deposited on the cubes in Set 2.

For example, images that capture unusual lines or patches of powder can be seen on the build plate. Figure 8(a) shows a typical image where a consistent layer of powder was deposited correctly on Set 2 parts prior to the introduction of short-feeding. Figure 8(b) shows an example of where short-feeding has occurred on these parts. This can be seen as an area on the part where there is no deposited powder, which exposes the previously melted layer. Typically, two to three problem layers can cause a defect in the built part.

The line segment detection tool has been used to identify this issue of short feeding, shown in Figure 8(b). When the short feeding of powder begins, the area with a lack of powder will show an increase in the number of line segments detected. This is indicated by a spike in the plot of the number of line segments per image, as shown in Figure 9. The anomaly detection tool is then used to track any deviation in the quantity of line segments detected and then inform the machine operator of the increase in the line segments detected.

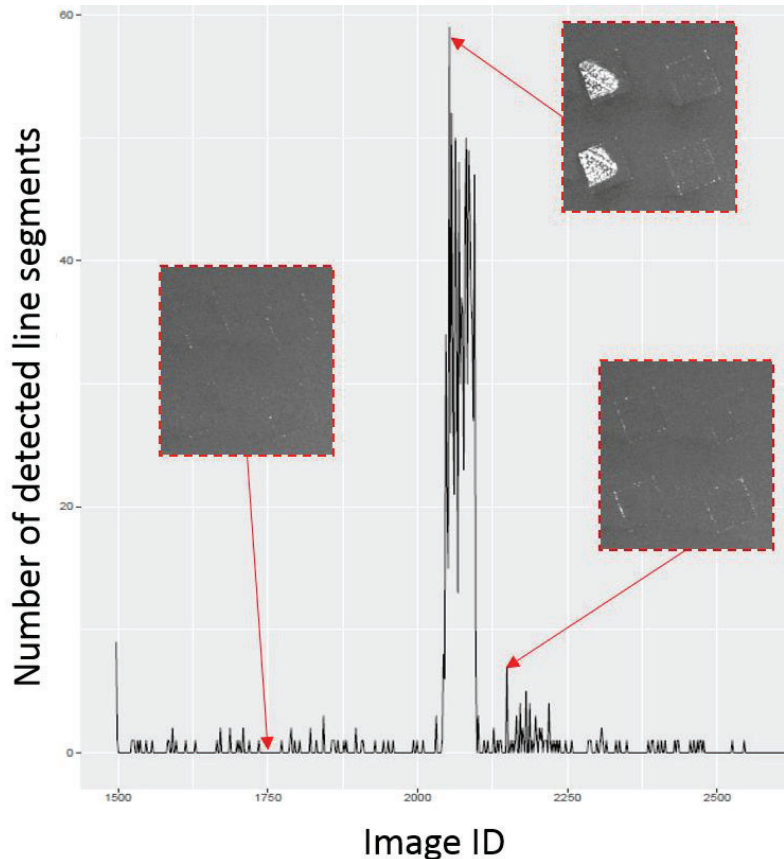
Figure 9: Line segment detection tool output with cooresponding Set 2 build images.

In Figure 9 it is clear from the number of line segments detected where a defect has begun to develop. The spike in the graph occurs 5.4 mm (Image ID 2041) into the build process. The deliberate short feeding of powder has reduced the quantity of powder deposited on the build plate, leaving an area on the parts without new powder. This exposes the previously melted layer which is then re-melted by the laser. This issue of short feeding can be rectified by operator intervention, if noticed in time. The operator can, once the defect has been identified, increase the quantity of powder fed to the re-coater blade. This intervention was applied in the study after 6.0 mm (Image ID 2101) of the build by increasing the amount of powder fed to the re-coater blade. This is shown in Figure 9 by a decrease in the line segments detected as the powder deposition recovers (Image ID 2130).
