## ON THE NATURE OF RECOATER DAMAGE POWDER SPREADING MECHANICS

Caroline E. Massey\*, Christopher J. Saldaña\*

\*George W. Woodruff School of Mechanical Engineering, Georgia Institute of Technology, 801  
Ferst Drive NW Atlanta, GA 30332

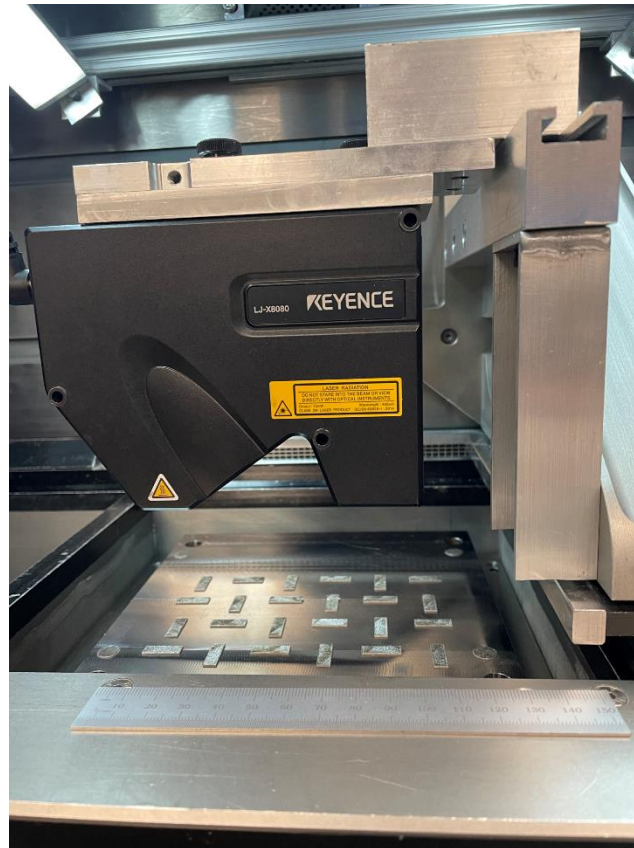
Figure 4: Keyence LJ-X8080 setup in EOS M280 capturing the part surfaces of experiment 1

The as printed parts were scanned with a Keyence LJ-X8080 laser line profiler using 8000 lines and a 12.5 micron x, y, and z resolution. The laser line profiler was affixed to the recoater arm assembly by a custom mount and is shown in Figure 4 below. The laser line profiler was able to capture a sample first layer profile of the spread powder in experiment 2. The output profile was analyzed using modified MATLAB code that had been developed by previous researchers [8]. A Dyno-lite digital microscope was used to capture images of the part surfaces.

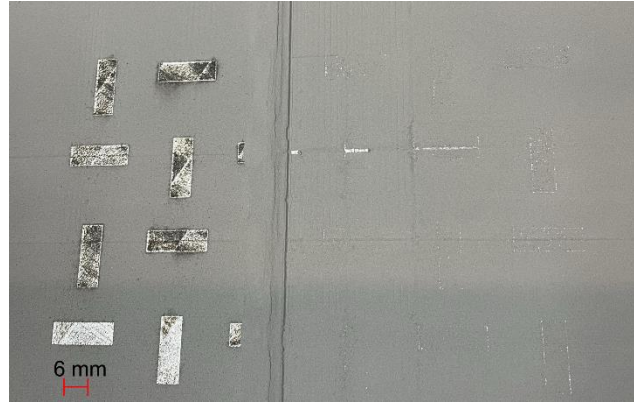
Figure 5: Location of build failure region in experiment 1

In the first experiment, build failure occurred in the region of the largest recoater damage, as shown in Figure 5 below. Hard recoater blades by their nature will work to shear any part deviations above the layer thickness. In the worn region where significant notch damage is present, any deviations will be allowed to pass until they form above the tallest section of the notch, or spatter or other bed defects get caught in the notch opening. Based on inspection of the post-mortem images, it appears that once spatter or superelevated debris got trapped in the notch, it at some point interacted with the superelevated regions and appeared to roll and pick up molten superelevated material or spatter, forming a bead. As the bead picks up material, it will leave the previous region with a dimple formed from removed material. The bead will become so large that it will collide with the recoater bar and cause failure.

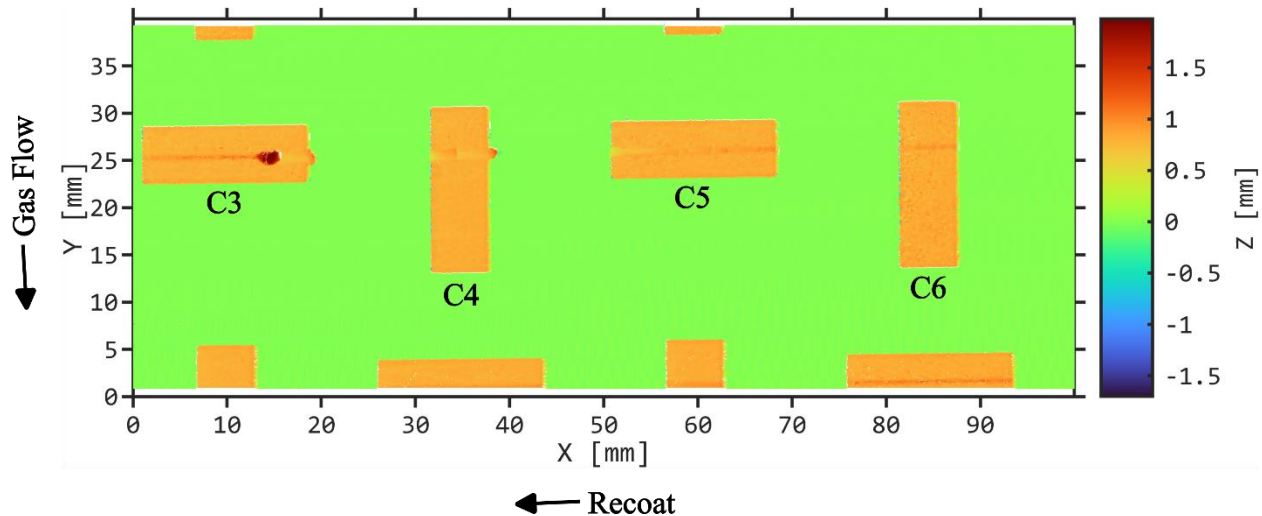
Figure 6: Topography profile of parts for experiment 1 in the region of highest recoater damage

In the case of experiment 1, approximately 0.80 mm of the build was successfully lasered prior to failure. The laser line profilometry scan of the parts in the band of highest recoater damage is shown in Figure 6. The part surfaces captured with a digital microscope are shown in Figure 7. In the region subject to recoater damage and to the right of the part at failure (part C4), the formation of the rolled ball bead caused a local topographical loss of 0.0705 mm relative to the flat part of the fused surface. The difference is about 1.5 times the layer height so there is a potential for porosity to form in this region as result of the difference in surface topography. The rolled bead formed at the failure location caused a local topographical difference of 0.6534 mm above the fused surface, which is larger than the length of the recoater notch that it would be able to pass through (0.461 mm). To the left of the failure part section, the recoater damage caused about 0.1741 mm difference in height, which is about four times the layer height, but roughly a quarter of the length of the notch (0.461 mm). Part C6, which is to the right of the failure region has a form deviation of around .0992 mm, which is less than the region ahead of the damaged section. This means that perhaps the spatter that was stuck in the recoater notch could have sheared parts of the profile or there could also be deviations in the topography profile due to variability between parts.

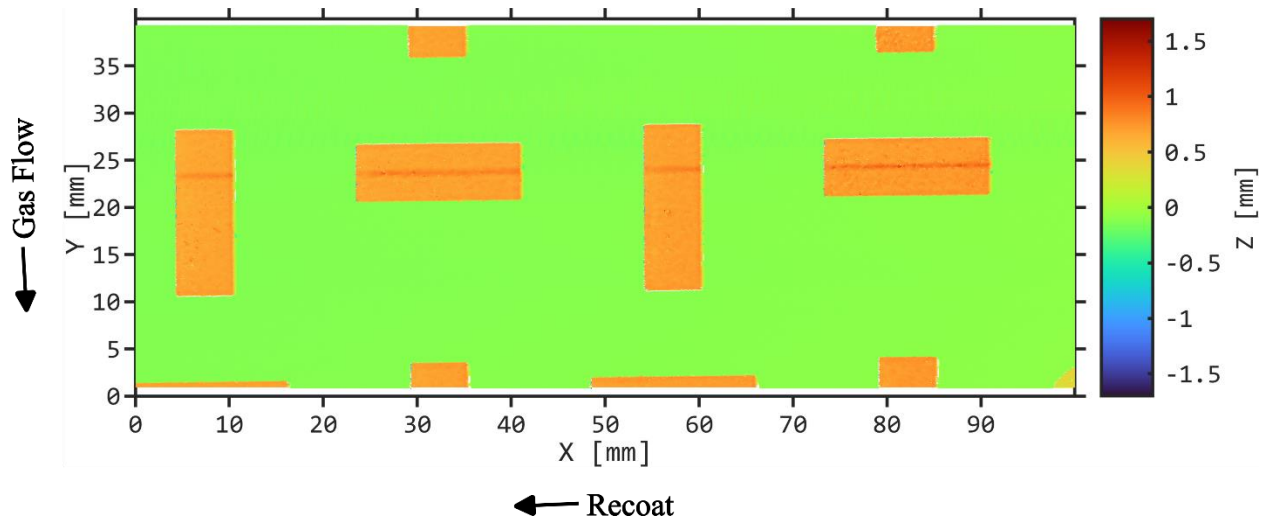
Figure 8: Topography profile in the smaller recoater damaged section of experiment 1

In the area subject to the smaller notch, the surface topography results are shown in Figure 8. In the inspection of the recoater after failure, there was a bead stuck in the recoater notch section, which is shown in Figure 9. This was likely spatter or superelevation that got caught in this section of the damaged recoater. The topography deviation in the recoater damaged section averaged over four parts in the region was 0.1388 mm, which is a bit smaller than the portion of the failure part ahead of the failure region. This deviation is much less than the length of the notch (0.394 mm). The topography deviation in the lased portion of the recoater damaged region is likely most dependent on the dosing, layer thickness, and charge amount, since the size of the notch is potentially greater than the largest forward moving front of the powder spreading profile.

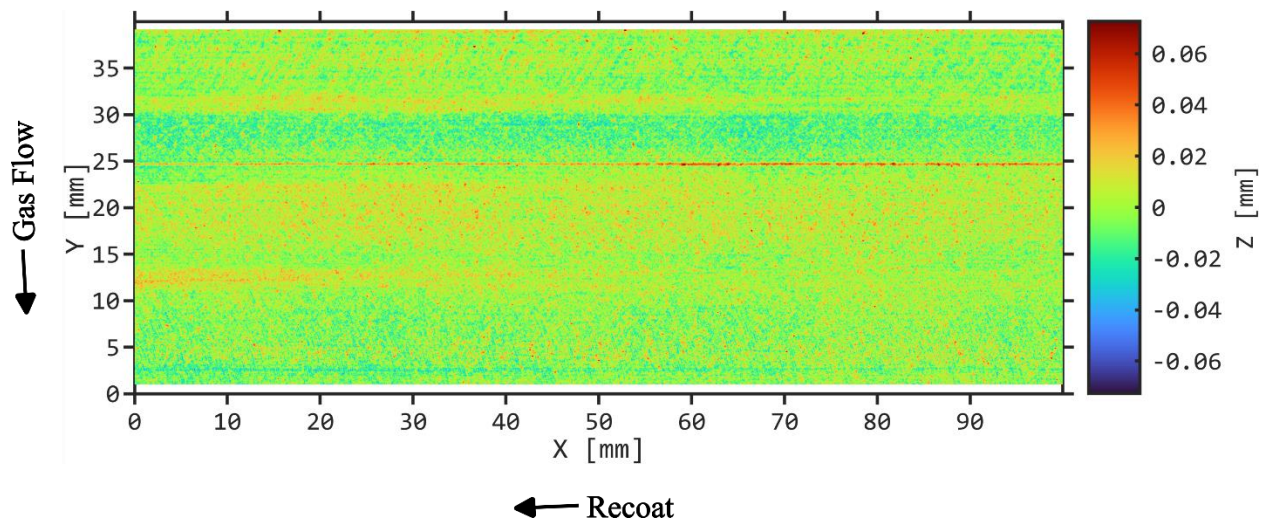
Figure 10: Sample first layer profile in recoater damaged section in experiment 2

For experiment 2, a sample scan of the bed topography of the first layer was taken prior to starting the lasing process. The results of the powder bed in a sample 100 mm wide by 40 mm long section of the powder bed in the section subject to recoater damage is shown in Figure 10 below. Looking at the average height profile of the powder bed across the middle 60 mm of the spread direction is shown in Figure 11 below. The results indicate that the largest average deviation from the form-leveled baseline is .0328 mm which is less than one layer thickness of deviation.
