## Assessing the Reproducibility of IN718 Parts on Similar L-PBF Systems Through Mechanical Properties and Dimensional Accuracy

### **Abstract**

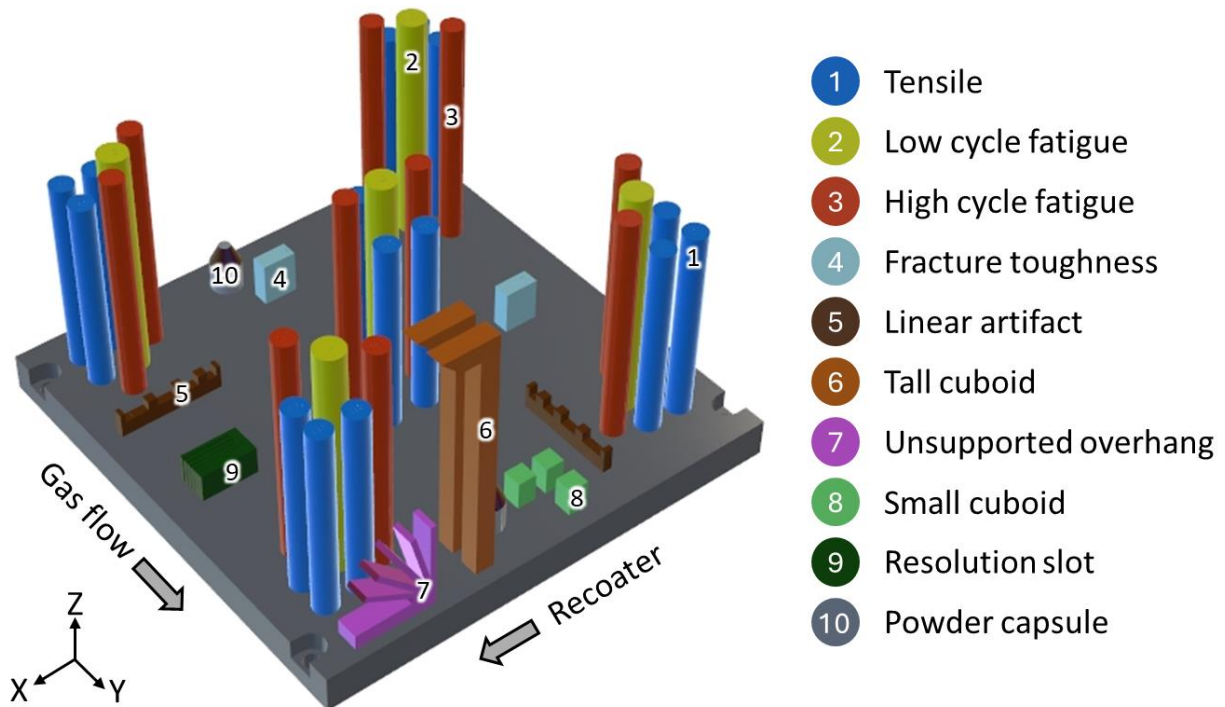
Three builds were conducted on each of three EOS M290 L-PBF systems denoted as Machine 1, Machine 2, and Machine 3, using identical build layouts as depicted in Figure 1. Process parameters recommended by EOS for IN718 were used for this study including a laser power of 285 W, scanning speed of 960 mm/s, hatching distance of 0.11 mm, and layer thickness of 0.04 mm. To ensure the success of each build, a carbon fiber brush recoater was used. Fabrication with Machine 1 used IN718 plasma atomized powder supplied by AP&C and fabrication with Machines 2 and 3 used powder supplied by Sandvik. Each powder lot had a particle size distribution in the range of 15 – 53  $\mu\text{m}$ , however, the AP&C powder had undergone six reuses prior whereas the Sandvik powder was virgin. Figure 1 includes various parts that were used for different tests, inspections, and characterizations.

Figure 1: Build layout for IN718 parts.

The parts located towards the south side of the build plate, i.e., near the gas extraction nozzle, were strategically placed to allow for removal after fabrication using a wire electro-

discharge machine (EDM) to observe the as-built microstructure. This included the unsupported overhang, one of the tall cuboids, and one of the small cuboids. Additionally, the powder capsules, which were fabricated on supports, were removed to undergo chemical composition and particle size distribution analyses using inductively coupled plasma mass spectroscopy and laser diffraction, respectively. After removal of these parts, each build plate underwent stress relief (SR) at 1065 °C for 1.5 hours. Thereafter, all parts were detached from the build plate using a wire EDM. Following removal, all parts underwent hot isostatic pressing (HIP), solution annealing (SA), and double aging. The full heat treatment (HT) schedule can be observed in Table 1.

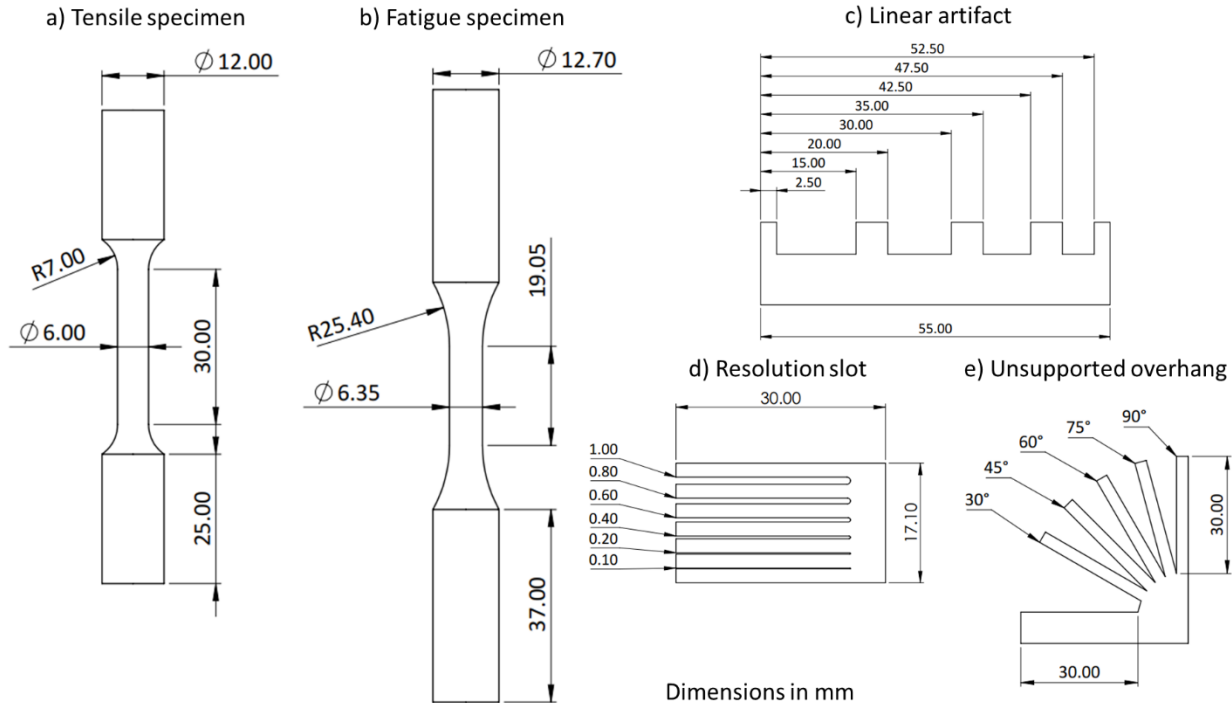
Mechanical behavior was assessed through tensile, low cycle fatigue (LCF), and high cycle fatigue (HCF) tests (geometries included in Figure 2a) and b), respectively). Fracture toughness specimens were fabricated however they were not used in this study. Both tensile and fatigue tests were conducted on servo-hydraulic load frames. Tensile tests were conducted in strain-controlled mode at a strain rate of 0.005 mm/mm/min according to ASTM E8 [14]. Low cycle fatigue tests were also strain-controlled and were fully reversed ( $R = -1$ ) with a strain amplitude of 0.005 mm/mm at a frequency of 0.5 Hz following a sinusoidal waveform according to ASTM E606 [15]. High cycle fatigue tests were performed under tension-tension loading ( $R = 0.1$ ) and in load controlled mode also following a sinusoidal waveform according to ASTM E466 [16]. Maximum stresses for HCF tests ranged from 875 to 600 MPa to obtain an more complete S-N relation. Fractography on selected tensile and fatigue specimens was conducted using a Zeiss Crossbeam 550 scanning electron microscope (SEM).

Figure 2: Geometries for various test specimens and artifacts.

Dimensional accuracy and feature resolution were assessed through the linear artifact, resolution slot, and unsupported overhang. The geometries for the various artifacts have been

included in Figure 2c) – e). Measurements on the linear artifact and resolution slot were reported as recommended in ISO/ASTM 52902 [17]. Linear artifacts from Machine 1 were measured using calipers whereas the ones from Machines 2 and 3 were measured using a coordinate measuring machine (CMM). Resolutions slots underwent a go/no-go check using feeler gages for all three machines. For the unsupported overhang, the surface roughness of the downskin surfaces of each overhang were measured using an optical method for Machine 1 and a contact profilometer for Machine 2 and 3.

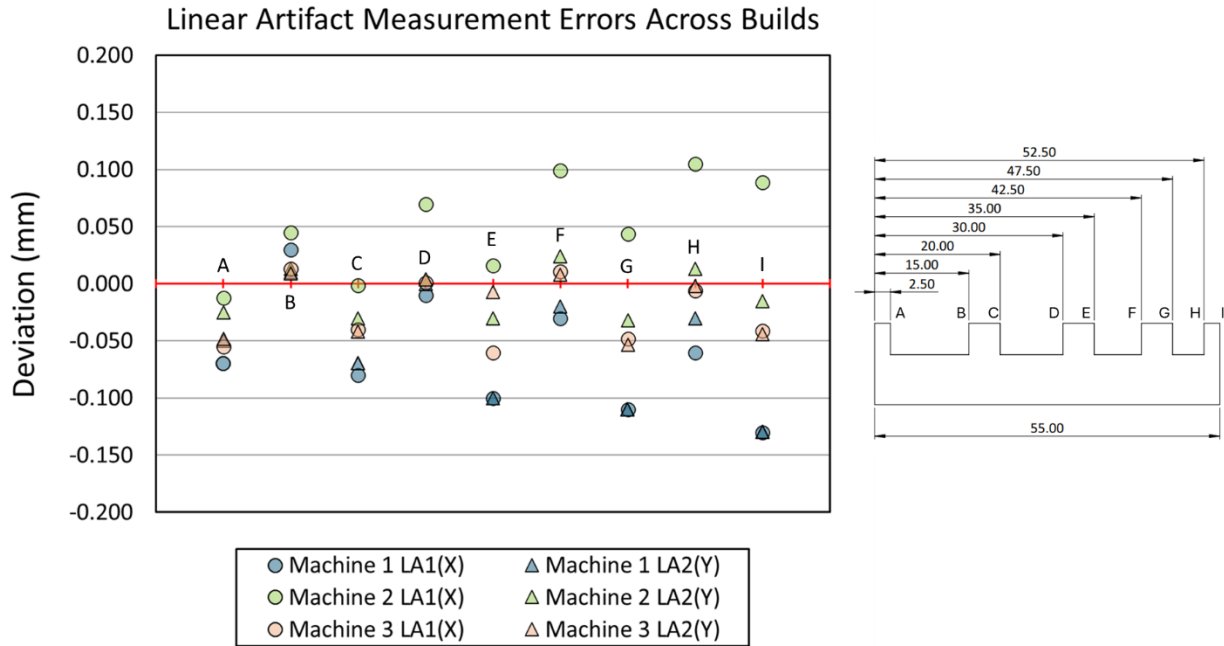
Dimensional accuracy and part resolution were evaluated for different machines using different geometric artifacts and measurement techniques. Firstly, linear positioning accuracy was evaluated with the use of two linear artifacts oriented along the X and Y directions. The deviations from the nominal design values have been plotted in Figure 3. In general, Machine 1 dimensions can be observed to be slightly below the nominal values in both the X and Y directions. Machine 2 dimensions in the X direction can be observed to be above the nominal values whereas the Y direction appears to be quite close to the nominal. Machine 3 dimensions show more consistency than the other machines with slightly lower values than the nominal in some cases. The measured deviation is compounded further away from the datum. Machine 1 dimensions were measured using a calibrated caliper with an accuracy of  $\pm 0.02$  mm. Although multiple measurements were taken and averaged, user error may have affected the measurements resulting in slightly inaccurate readings when compared to those measured with the use of CMM. Although CMM was used for

Figure 3: Linear artifact dimensions in two directions for all three machines.

both Machines 2 and 3, the measurements still vary from the nominal, especially for Machine 2. A possible explanation for these deviations may be the offset and scaling values input into the build file. EOS M290 machines require a “fine tune” build to be conducted that is used as a calibration to offset the laser beam for a specific material and process parameter set, as well as to create compensations in the X and Y scaling to ensure geometric accuracy is maintained. If these values were not correctly input into the build file due to operator or measurement error, it may result in the observed differences.

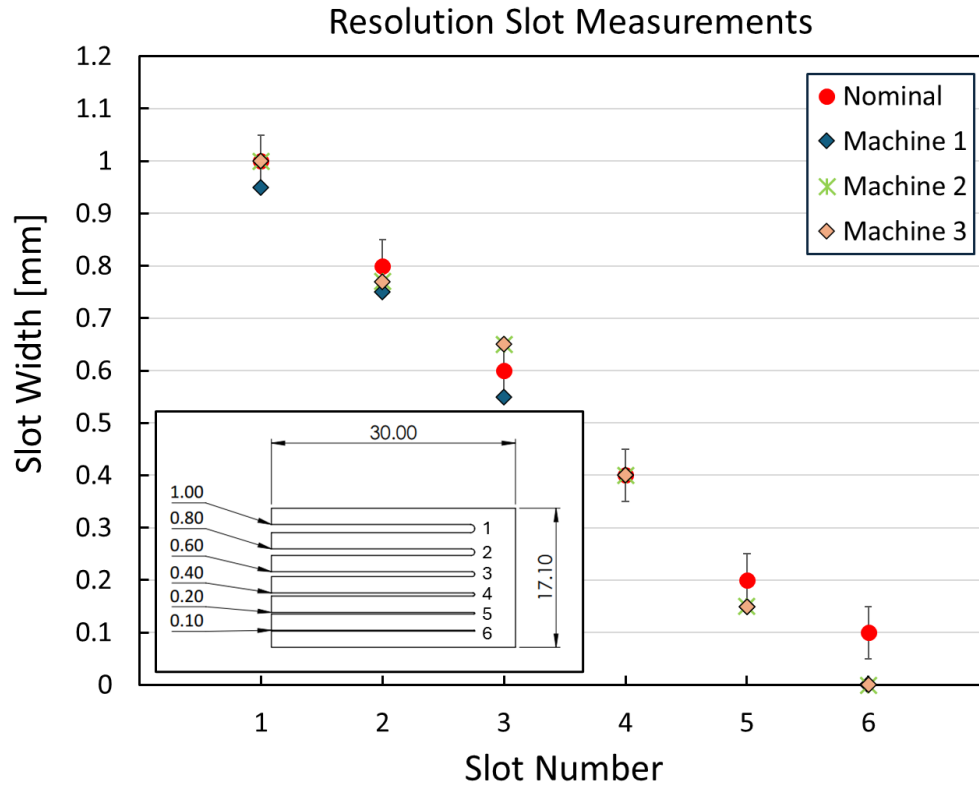
The resolution slot allows for determination of the minimum slot width that can be fabricated on an L-PBF system along with the accuracy of fabricated slots. For this, feeler gages were used to determine each slot width. The reported slot width corresponds to the thickest feeler gage that was able to pass through the slot. All machines show comparable measurements. In general, Machine 1 slots tended to be slightly undersized compared to the others. Slots were measured after SR and it was observed that some powder particles were impinged on the internal surfaces of the Machine 1 slot effectively decreasing the overall slot width. This could be as a result of inadequate powder removal during the depowdering stage. Lastly, for the narrowest slot (0.1 mm), no feeler gage was able to pass through.

Figure 4: Resolution slot measurements for all three machines compared to the nominal designed values.

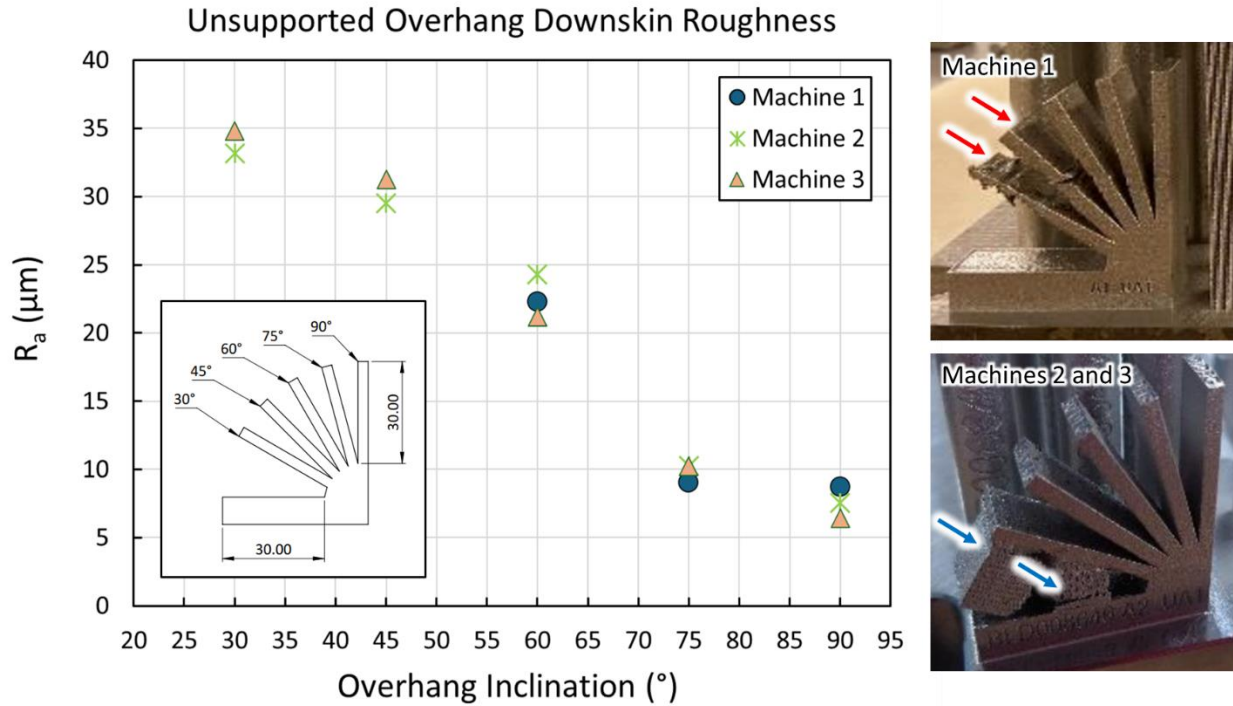
The downskin surface roughness represented by the line arithmetic mean roughness,  $R_a$ , for each machine has been provided in Figure 5. In general, a decreasing trend in  $R_a$  for increasing inclination angle can be observed which is typical of L-PBF parts [18]. Red arrows in Figure 5 point to the 30° and 45° overhang for Machine 1 which did not fabricate successfully causing significant damage to the carbon fiber brush recoater. As a result, supports were added to the 30° and 45° overhangs for Machines 2 and 3 to prevent the same occurrence (as pointed to by the blue arrows). Due to the issues in printing on Machine 1, the surface roughness for the 30° and 45° overhangs are evidently much higher than the other machines and the data points have not been included in Figure 5. However, the 60°, 75°, and 90° overhangs are comparable which provides evidence for good reproducibility in downskin surface quality. Furthermore, consistency can be observed for measurements taken using both contact and non-contact methods, i.e., profilometer for Machines 2 and 3, and optical method for Machine 1.

Figure 5: Downskin surface roughness results for unsupported overhangs at different inclination angles for all machines.

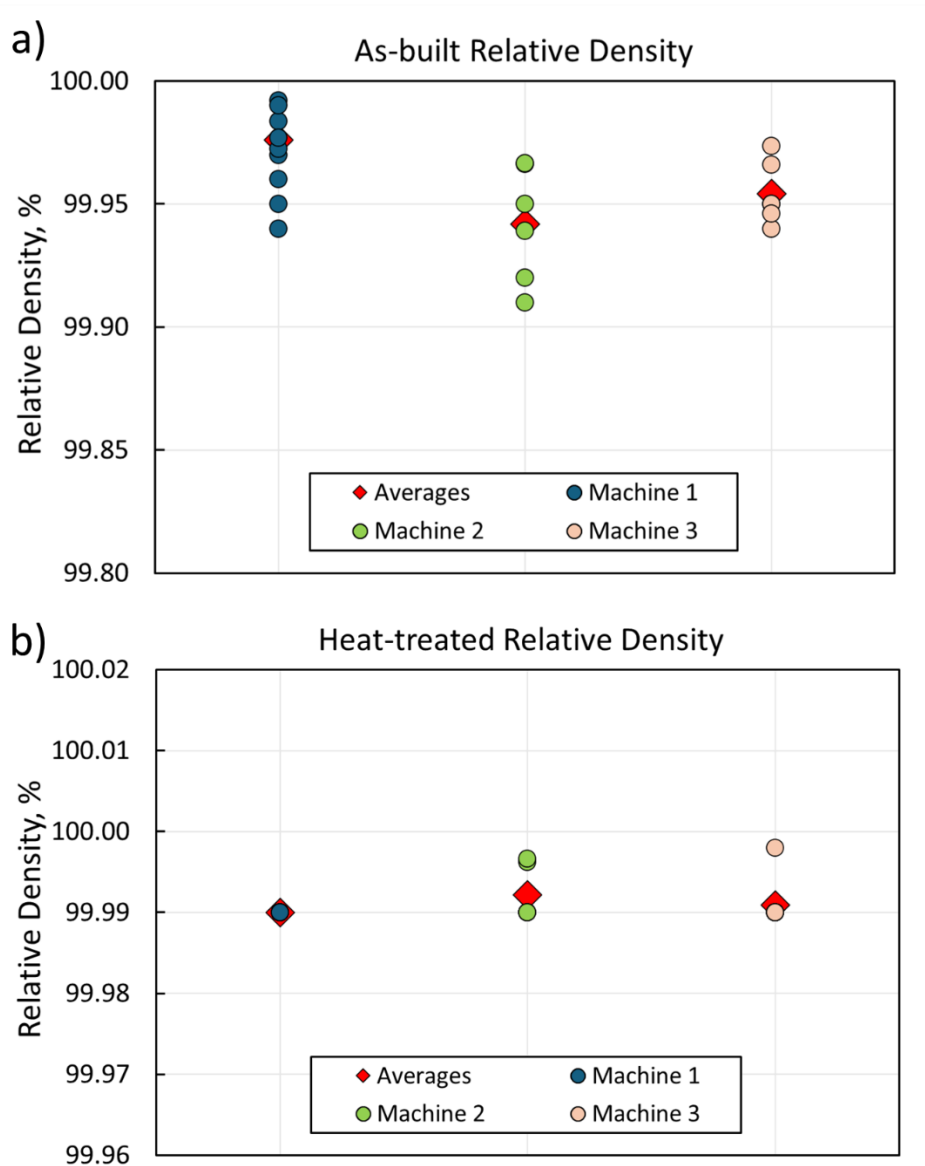
The relative density of both the as-built and HT material is shown in Figures 7a) and b), respectively. The as-built material possessed typical process induced volumetric defects in the form of gas entrapped pores and small lack-of-fusions. On average, Machine 1 showed the highest as-built relative density whereas Machine 2 showed the lowest. All machines were up to date on maintenance therefore, machine health was not the cause of the observed difference in relative density. The likely cause may have been the different feedstocks used. Machine 1 utilized reused powder from AP&C whereas Machines 2 and 3 utilized virgin powder from Sandvik. There have been reports in literature that reusing powder can often lead to better achievable packing state compared to virgin powder as the particles become irregular in shape allowing them to fit better together than spherical ones [19]. After HT, most defects were eliminated which would have occurred during the HIP cycle. The relative density for all machines was 99.99%. Measured relative densities were not rounded up to 100% since some small defects were not completely removed during HIP.

Figure 7: Relative density comparison of different machines in a) as-built and b) HT conditions.

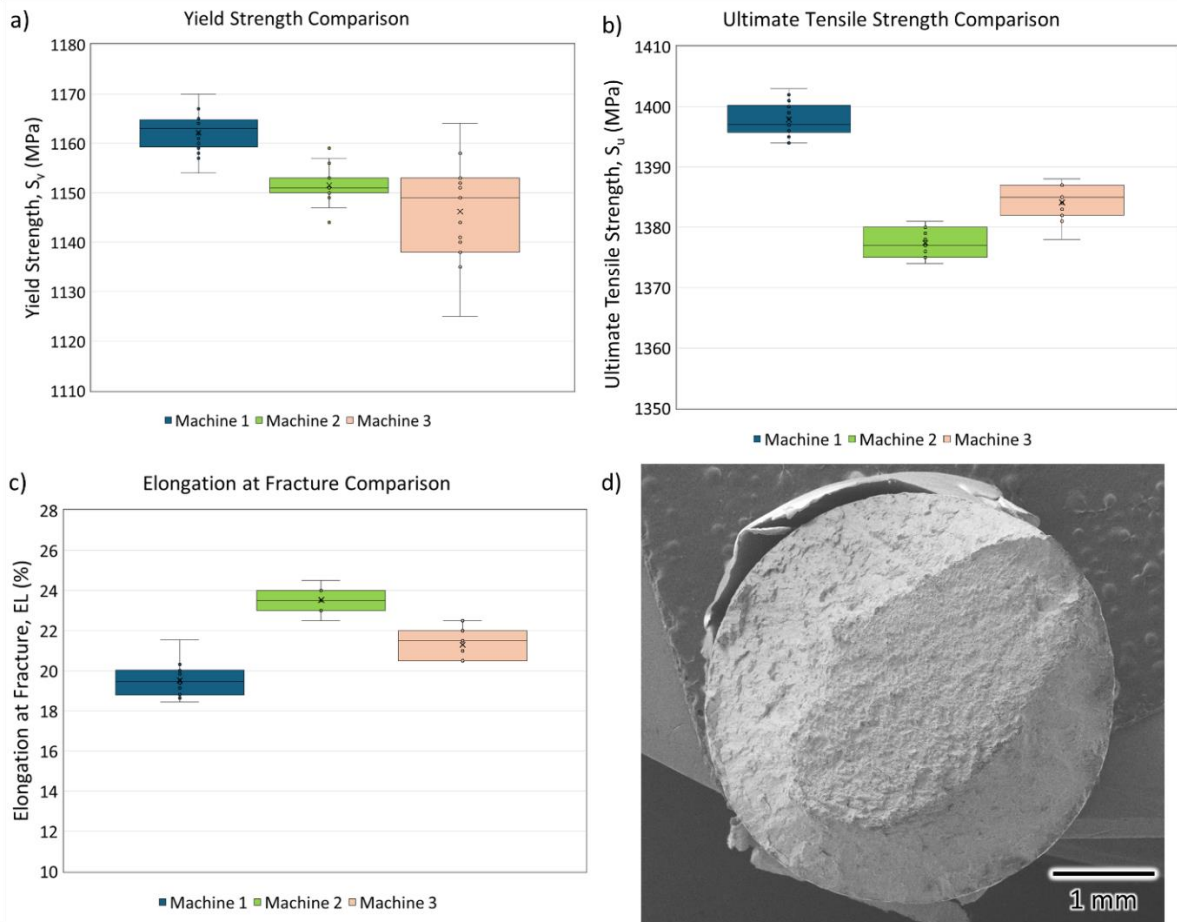
The tensile results for each machine have been included in Figure 8. Higher yield strength,  $S_y$ , and ultimate tensile strength,  $S_u$ , can be observed for Machine 1 whereas the elongation at fracture, EL, for Machine 1 can be observed to be lower than the others. Tensile strength can often be linked to grain size; however, based on the results presented in Figure 6, grain size was comparable. Since IN718 is a  $\gamma'$  and  $\gamma''$  strengthened alloy, differences in the resulting precipitate distribution after HT may affect the strength of the material, particularly the  $S_y$ , more than differences in grain size. Precipitate distribution, however, could not be determined in this study, but since Machine 1 material was HT at a different site as Machines 2 and 3, potential for inconsistencies in the heating and cooling rates as well as the hold times during aging exist. The

Elongation at fracture differs slightly for each machine, with an opposite trend to strength observed in Figure 8c). Fracture surfaces for different machines were comparable with a well-defined central region and shear lips at 45° to the fracture plane. As such, only one fracture surface was included in Figure 8d) for reference. Fracture occurred in a ductile manner leaving fine, micron-sized dimples on the fracture surface. Possible explanations for the subtle differences observed in ductility, particularly the lower ductility of Machine 1 specimens, could be the presence of secondary phases such as carbides in the material which generate stress concentrations during tensile loading and early fracture [25], or the difference in chemical composition of the feedstock resulting in lower matrix strength for Machine 1 material.

Figure 8: Comparison of tensile properties presented by box and whisker plots for different machines including a) yield strength, b) ultimate tensile strength, and c) elongation at fracture; d) a fracture surface of one tensile specimen.

average strengths, however, differed by approximately 20 MPa, which was not significant and agree with similar material available in the literature [23,24].

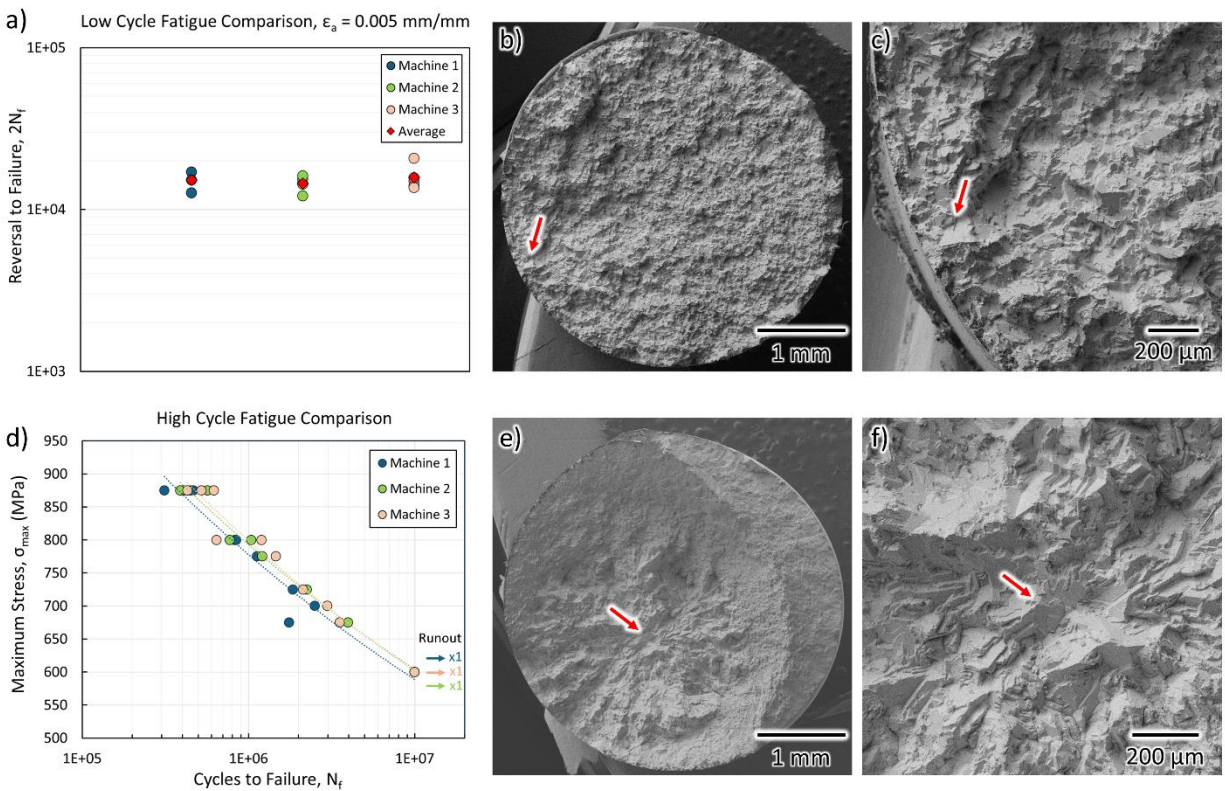
The fatigue results for both LCF and HCF from each machine have been included in Figure 9a) and d), respectively. The LCF behavior is quite consistent over all machines with average

reversals to failure,  $2N_f$ , of approximately 15,000, regardless of subtle differences in chemical composition and microstructure that may occur. Analysis of the fracture surfaces for all specimens revealed multiple crack initiation sites near the surface of the specimens (top row of Figure 9). Crack initiation sites contained crystallographic facets that are indicative of the operation of persistent slip bands, typical of Ni-based superalloys [25–27]. Process induced volumetric defects, which can sometimes initiate cracks in L-PBF materials [28,29], were mostly removed during HIP therefore, none can be observed on the fracture surfaces.

Comparing the HCF results for each machine, it can be observed that there is a small separation between the specimens from Machine 1 and the other two machines. Overall, the HCF behavior of all machines appears to be comparable, however, one outlier for Machine 1 tested at 675 MPa exists. The fracture surface for this specimen has been included in Figure 9e) and f). A large crystallographic facet near the center of the specimen can be observed at the crack initiation site. Compared to other specimens, the size of this facet was much larger. Some correlations between facet size and HCF life have been explored in literature where larger facets often correlate with lower HCF life. Nevertheless, other specimens exhibited similar fracture surfaces with single initiation sites, unlike LCF specimens. Crack initiation sites were mainly near the surface of other specimens.

Figure 9: LCF and HCF results for different machines in a) and d), respectively. Fractography of one specimen representative of other specimens for LCF in b) and c). Fractography of the outlier HCF specimen tested at 675 MPa in e) and f). Red arrows point to crack initiation sites.
