Study of Fatigue Endurance on Artificially Aged Additive Manufactured AlSi10Mg After Stress Relieved and Hot Isostatic Pressed + T6

Abstract

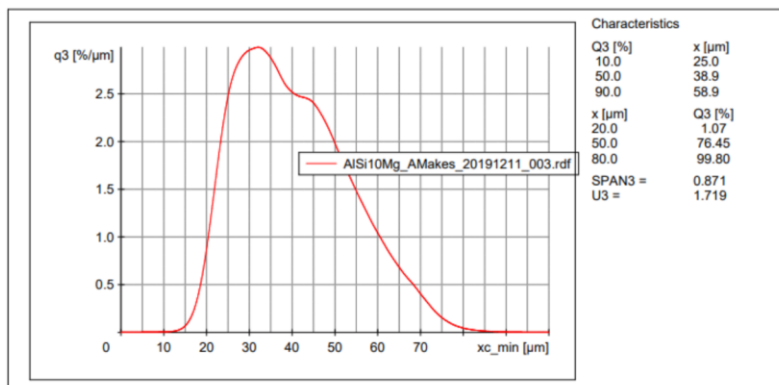
Figure 1: Valiment's Powder Distribution

The powder used was gas-atomized AlSi10Mg Valimet's AM 103 C grade. With this powder, all 96 specimens were created. Characterization was conducted using a Retsch Camsizer X2 (Haan, Germany). The powder had a size distribution with d10: 25.2 μ m, d50: 38.6 μ m, and d90: 59.2 μ m, displayed in Figure 1, values which correspond to the coarse level powder as specified by the C grade[11]. The powder exhibited an alpha-Al dendritic composition, as illustrated in Figure 2, with most particles being spherical and a few elliptical.

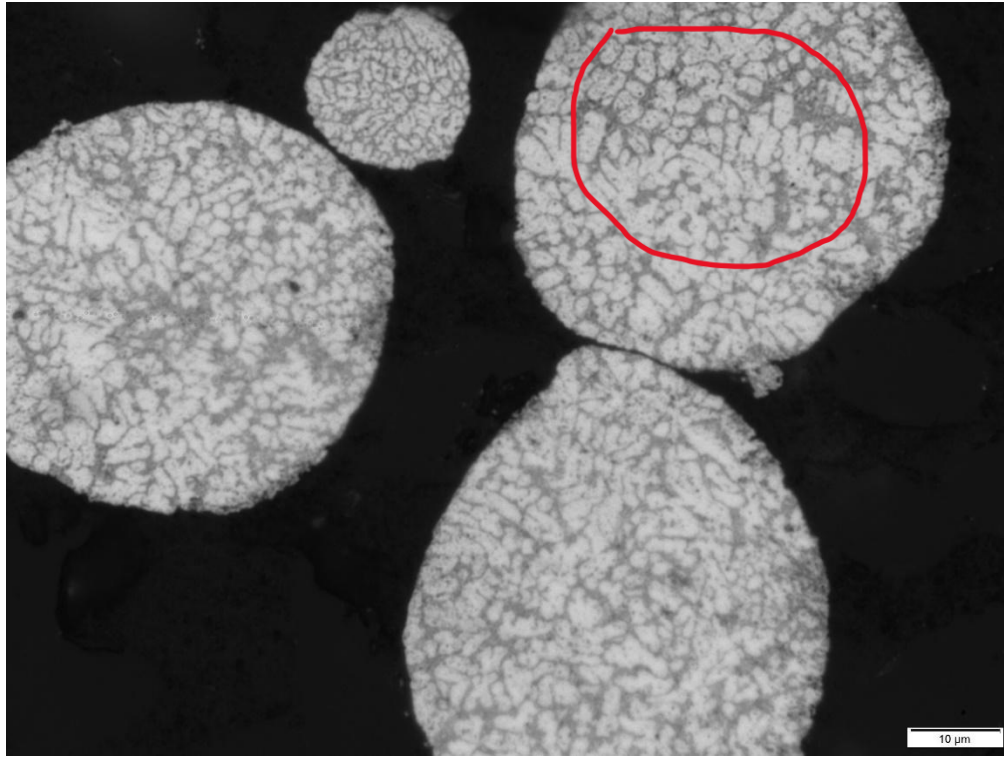
Figure 2: Powder Microstructure (alpha-Al dendritic composition circled in red)

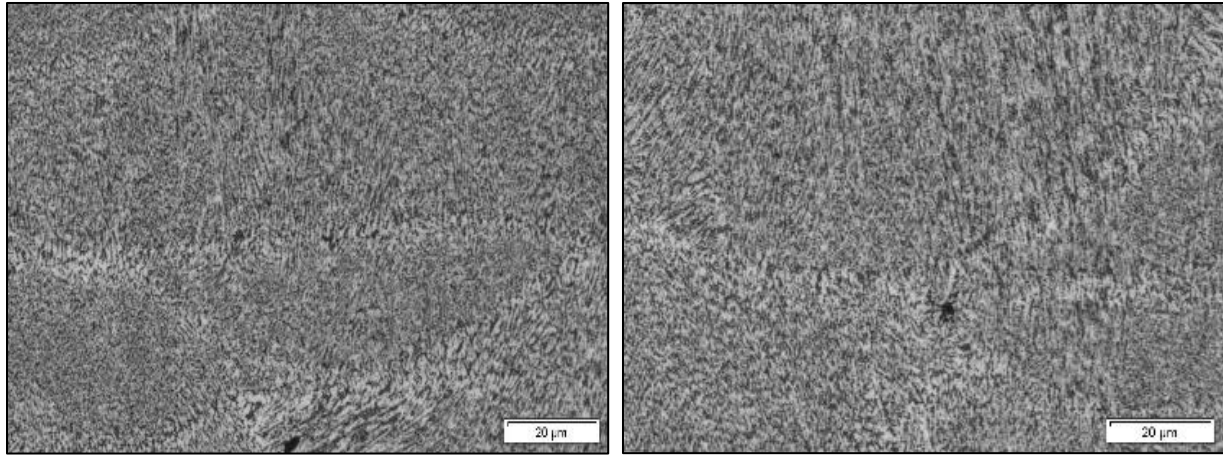
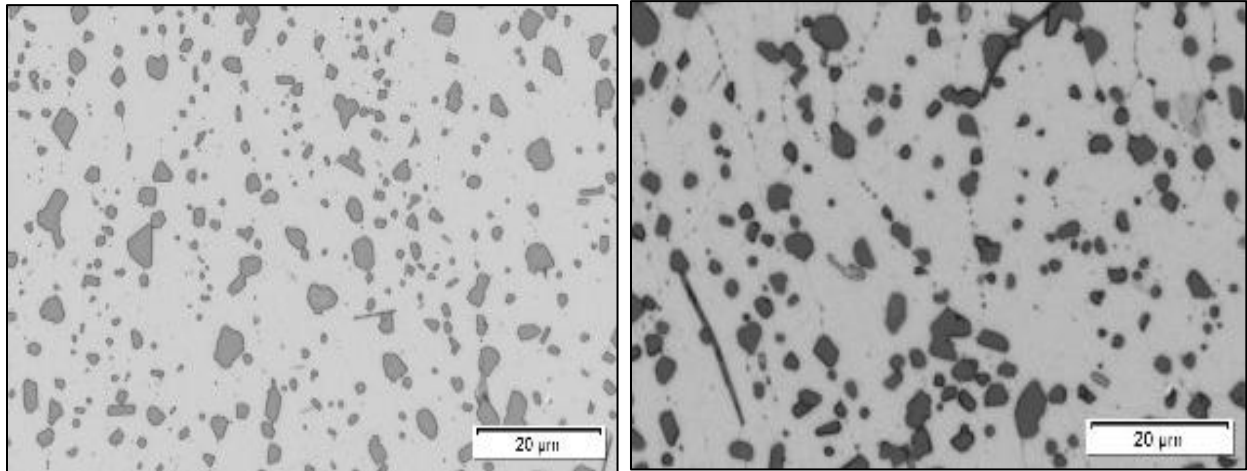
Figure 3: Microstructure of 0 hours XY and Z planes (SR1, (a) XY direction, (b) Z direction and HIP+T6, XY (c), and Z (d))

The microstructure pictures shown in Figures 3 and 4 (a-d) represent the samples at 0 aging hours for HIP+T6 and SR1 in the XY and Z directions. SR1, viewed along the XY and Z directions, displays a fine cellular near-eutectic structure from the aluminum and silicone mixture, where the melt-pool tracks are visible. The microstructure is comprised of ultra-fine cell structures that show a slight variation between the orientations. HIP+T6 microstructure is quite different, showing a distribution of size-varying coarse Si precipitates that are thermally stable through the Al composition, with slashes categorized as AlFeSi; these precipitates affect the strength of the alloy and, in large quantities, can lower the mechanical properties. The microstructure shape of the HIP+T6 samples is a direct result of the HIP heat treatment since the microstructure becomes homogenous and the melt-pools are eradicated [12].

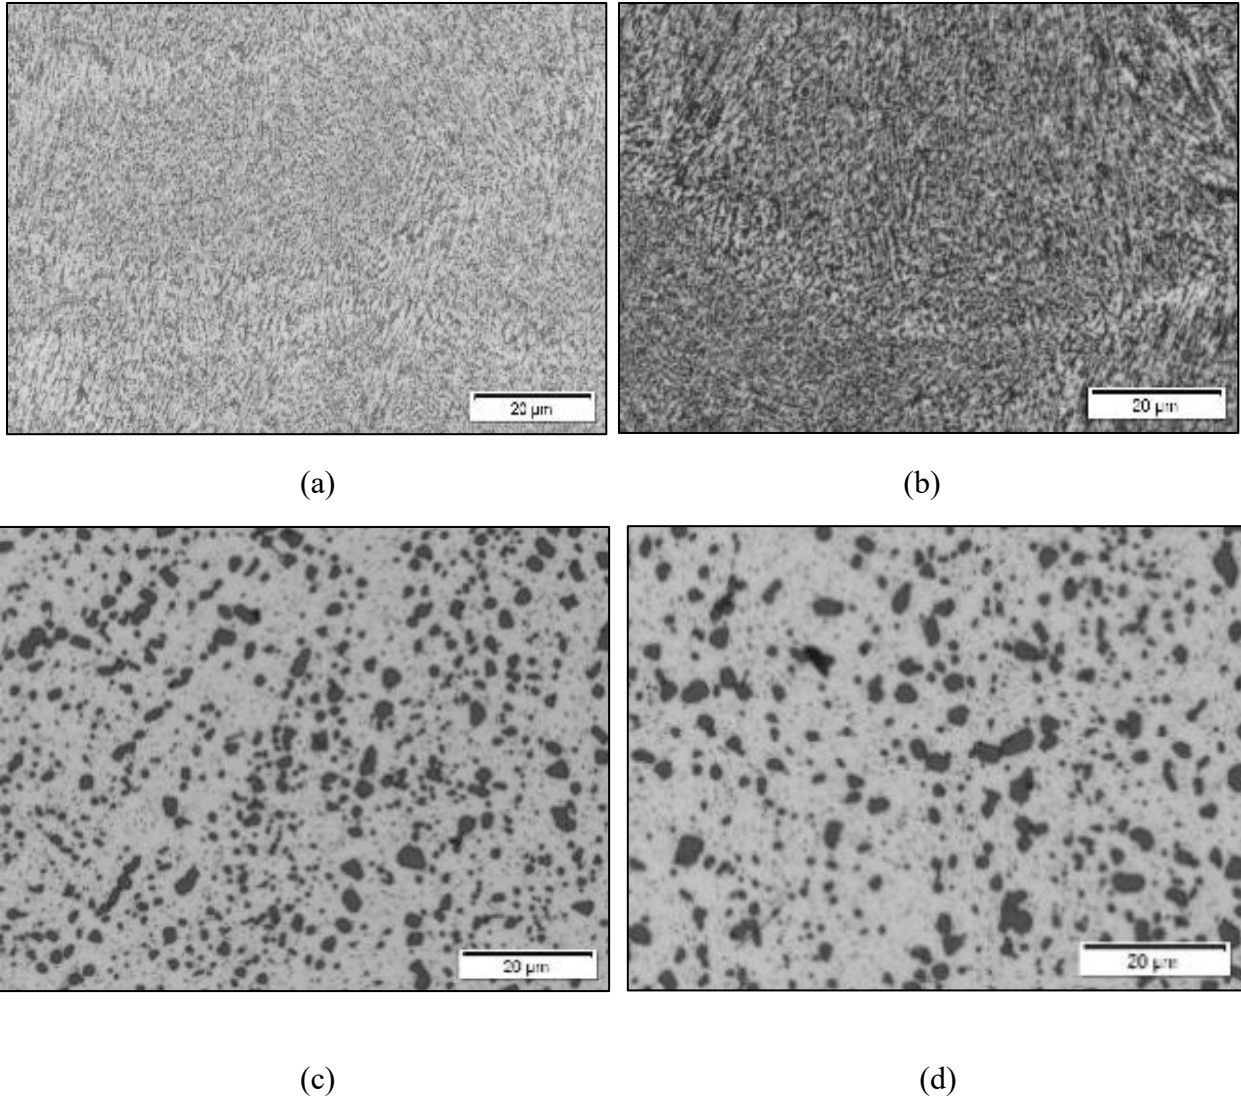
Figure 4: Microstructure of 1000 hours XY and Z planes (SR1, (a) XY direction, (b) Z direction and HIP+T6, XY (c), and Z (d))

The microstructures for the XY and Z orientations of SR1 and HIP+T6 after 1000 hours of aging are displayed in Figure 4 for comparison. No significant changes were observed except for the mechanical properties which will be discussed in the fractography section.

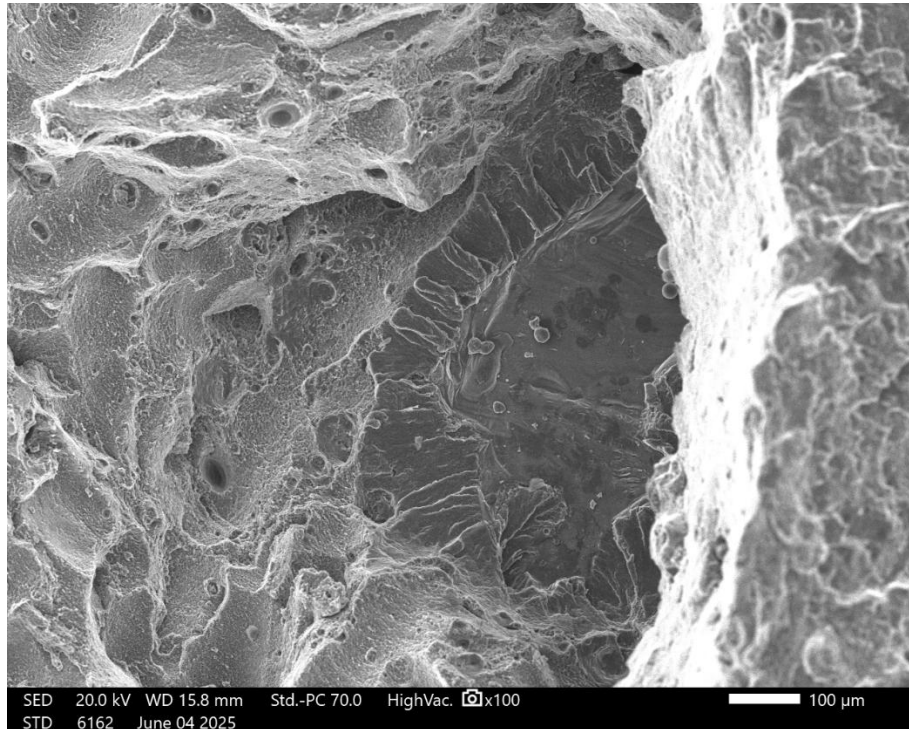
Figure 5: SEM image of Lack of Fusion

For the most part, the SR1 samples tested at 124 MPa were run-offs, yet some oddities occurred within the testing, seeing them start from 10 hours of aging. Since these results were not consistent, this can be related to residual porosity found within the microstructure, resulting in sporadic failure. SEM imaging revealed that most defects originated from lack of fusion, becoming points of crack initiation, as shown in Figure 5. The 1000-hours aging XY sample with 4,535,235 cycles was considered a failure due to fracturing at the grip, rather than the desired gauge section, the value can be discarded. The trajectory of the cycles can be analyzed on the S-N curves provided in Figures 6 and 7.

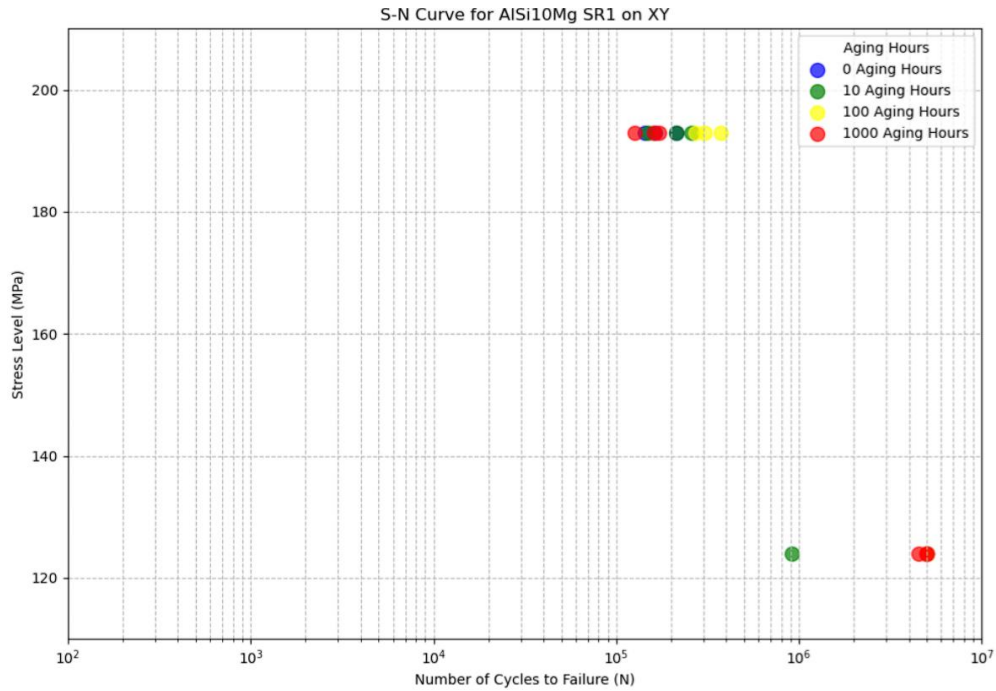
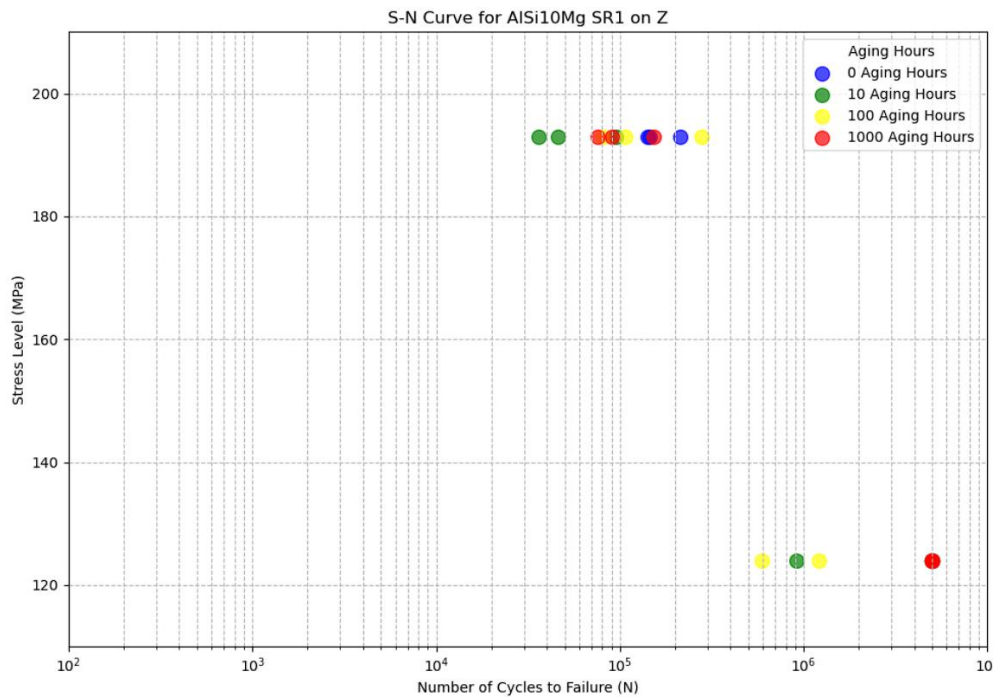
Figure 6: S-N curves for SR1 at (a) XY direction, and (b) Z direction

The SR1 results at 193 MPa showed drastically different numbers of cycles, with none of them reaching 5,000,000 cycles anymore, and none even passing the 1 million mark. The Z direction exhibited an interesting interaction between its hardness levels and the cycles it endured, which could be explained by the coarsening of the Si particles within the structure [13]. However, the correlation to the cycles endured needs further investigation to have a more concrete solution; in contrast, the cycles in the XY direction saw an increase within the cycles up to 100 hours and a sharp decline on 1000 hours, which was as expected.

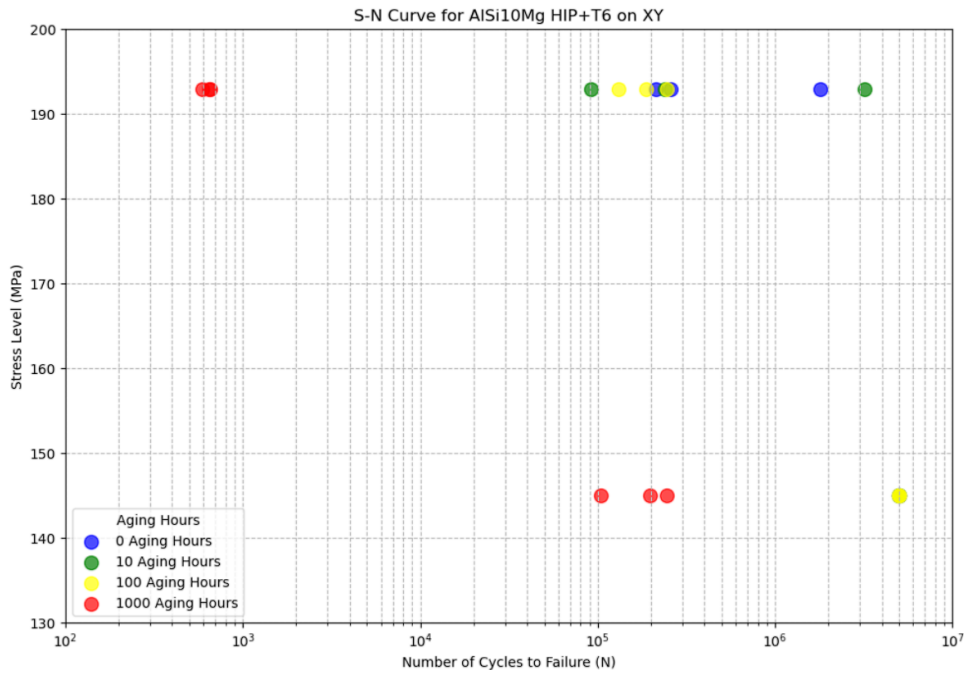
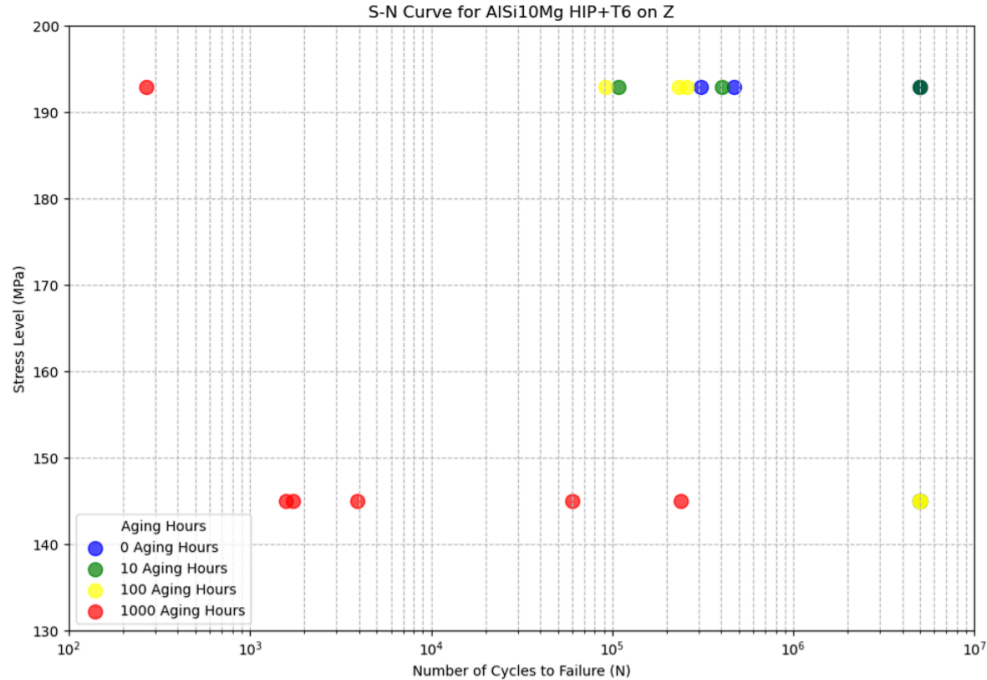
Figure 7: S-N curves for HIP+T6 at (a) XY direction, and (b) Z direction

HIP+T6 yielded dissimilar results from the fatigue testing, with all 145 MPa tests up to 100 aging hours reaching the run-off state of 5,000,000, yet a sharp decline at 1000 hours, as per

SR1. For the 193 MPa stress level, some run-offs were experienced in the Z direction at 0 hours, which stands as an oddity due to the same testing samples at the same aging hours. The testing results showed a limited number of coupons and cycles survived. The built plate placement can be assessed to point out the variance in results, where the recoater can push finer powder particles in a single direction while other particles fill out the rest. Another element of the matrix to note, as stated previously, is the lack of test samples at 1000 hours and 193MPa. This was due to early testing resulting in a low number of cycles that did not reach the desired stress level. These samples were subsequently moved to the 145 MPa stress level, to obtain more accurate testing results.

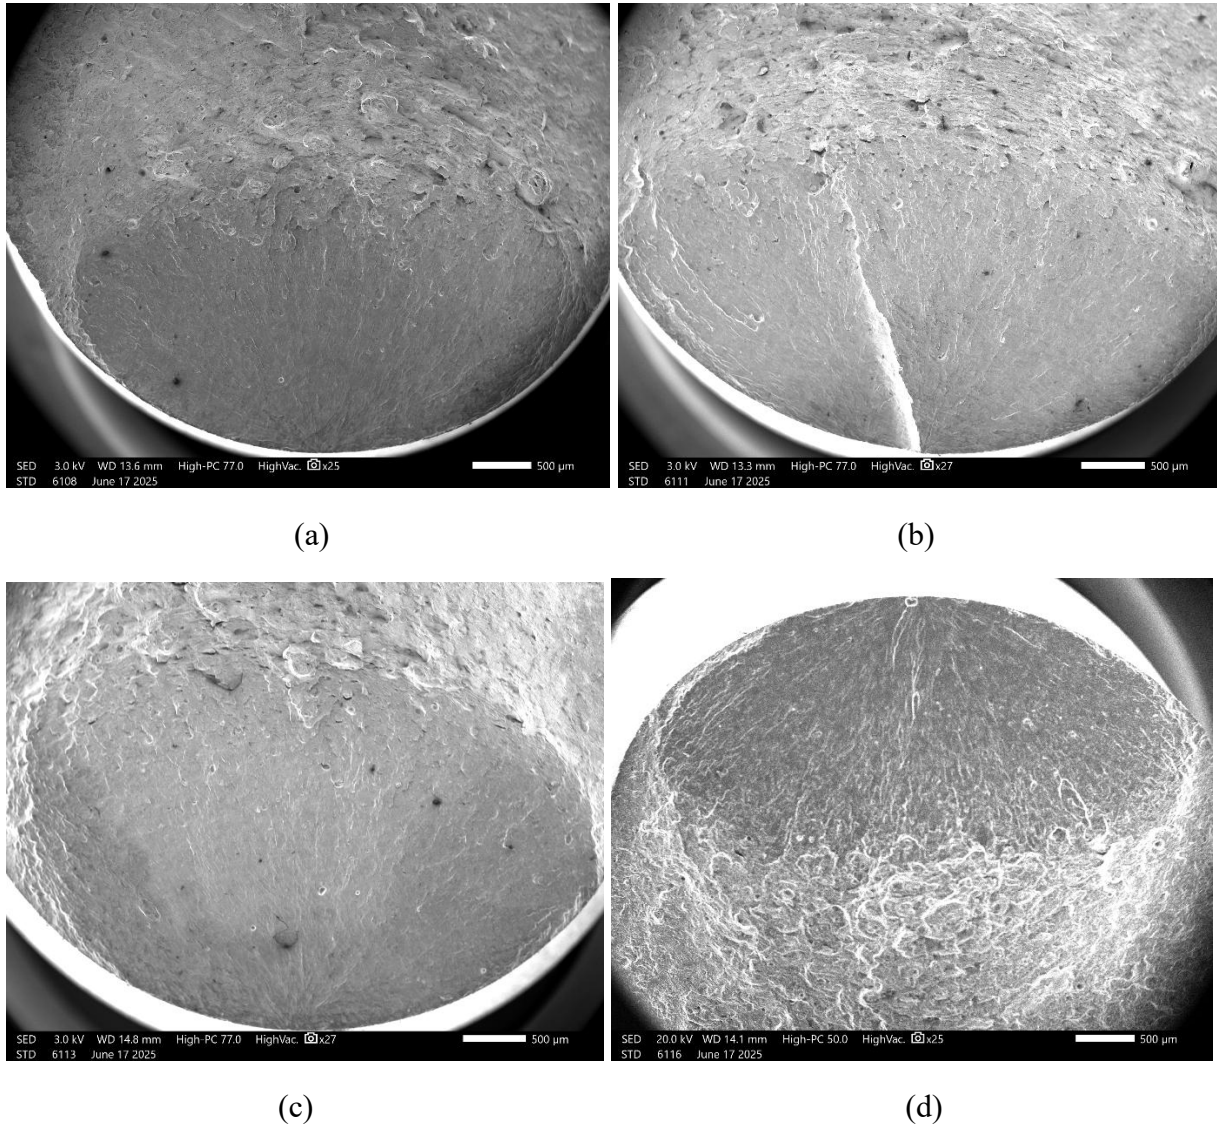
Figure 8: SR1 fractography images (0 (a), 10 (b), 100 (c), and 1000 (d) hours)

Fractography revealed the crack propagation and behavior of the specimens during fatigue testing. The SR1 images shown in Figure 8 exhibited clear fracture initiation points along the surface; all analyzed fractures proved to have originated from surface defects. The elastic fracture, compared to the HIP+T6 samples, exhibited a larger area of fracture propagation compared to the brittle fracture area, which explains the higher resistance to fatigue cycles. Upon examination, the surfaces exhibited a large amount of porosity, and points of lack of fusion. These are considered print parameters errors that can be mitigated and assessed through scan strategies to achieve far better results. A deeper analysis of the crack propagation was undertaken, by measuring the areas of the crack propagation and considering the defects sizes. The analysis was based on the 193 MPa SR1 samples, at its different aging parameters. This analysis revealed a varying size of crack propagation, with the first sample (0hrs) coming with an area of 7.34 mm², this sample saw the highest cycles in the analysis. The second sample (10hrs) saw a reduction in cycles, yet after analysis, it was found to have an area of 4.49 mm², this was due to the high number of larger defects, the crack initiation was started at a defect of 300µm, compared to the first sample which had a crack initiation defect of 100µm. The third sample analyzed (100hrs) sat at 11.32 mm², yet didn't see the highest amount of cycles, this can be explained by the size of the crack initiation defect of 170µm, multiple defects were also found across its surface in higher quantities than the first sample. The final sample (1000hrs) came out with a propagation area of 9.47 mm², with a higher number of cycles than that of the third

sample analyzed. It had a smaller crack initiation defect of 150 μ m compared to the third sample, yet still higher than that of the first sample.

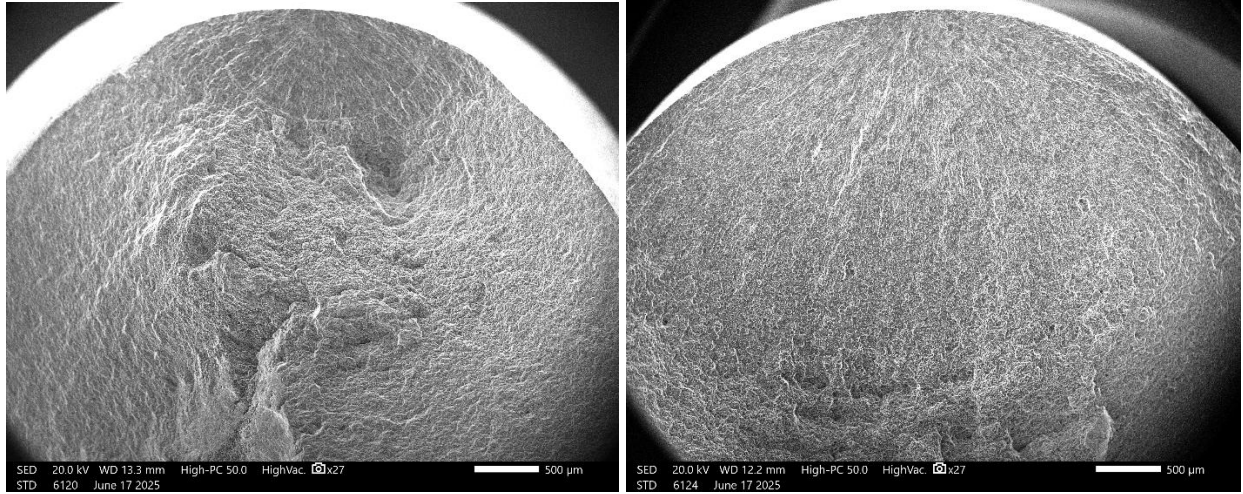
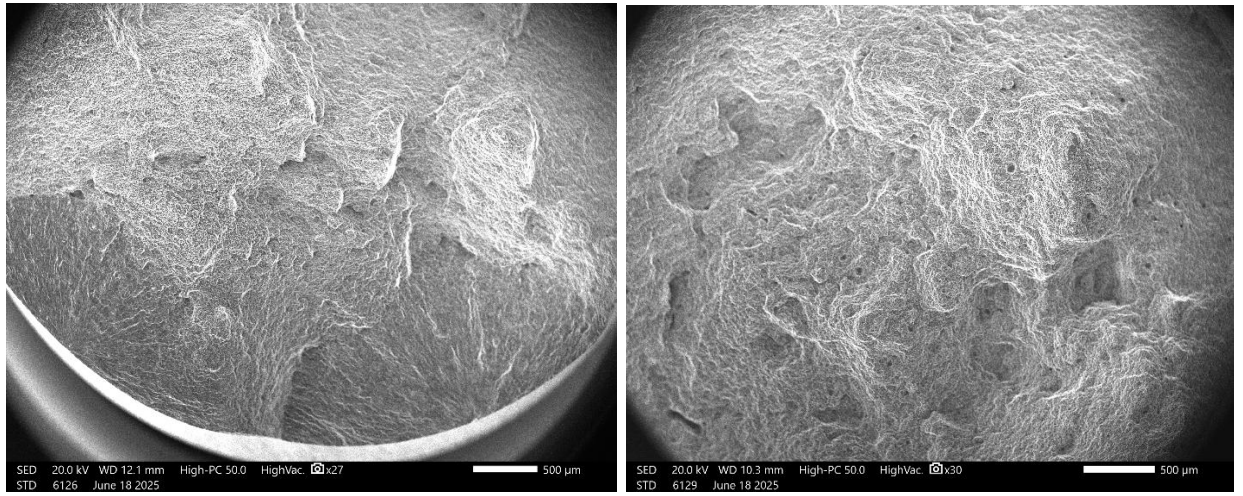
Figure 9: HIP+T6 fractography images (0 (a), 10 (b), 100 (c), and 1000 (d) hours)

The fracture propagation area of the HIP+T6 samples, as stated earlier, was smaller, represented in Figure 9. However, at 10 aging hours, the sample's fracture path seemed comparable in size to those from SR1. The 1000 aging hours also saw a reduction in diameter, caused by the ductility gained from the high temperature. Another notable representation of the gained ductility is the lack of a fracture initiation point on the 1000 hours, giving it elongated through the cycles survived.
