# SHELL CRACKING IN INVESTMENT CASTING WITH LASER STEREOLITHOGRAPHY PATTERNS

## ABSTRACT

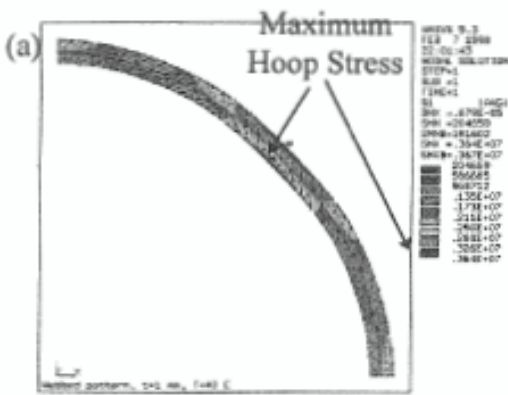
Figure 4 The stress profile from the FEA result for Part1 with 1mm ceramic shell: (a) hoop stress in ceramic shell and (b) compressive stress in webbed pattern.

The numerical result of a part ( $L=6.35\text{mm}$ ,  $b=0.3048\text{mm}$ , and  $h=1.4372\text{mm}$ ) with 1mm thickness ceramic shell is depicted in Figure 4. The FEA models used in this study are quarter models and they are automatically meshed in level #2 using the PLANE82 element and axisymmetric boundary condition. The  $\sigma_c$  and  $\sigma_x$  (or  $\sigma_y$ ) represent the principal (hoop) stress in the ceramic shell and the compressive stress in the epoxy webbed pattern, respectively. The  $\sigma_c$  value is compared with MOR to define the rupture temperature of the ceramic shell.  $P_{cr}$  is the critical pressure that causes the web link to buckle. The critical unit pressure of the buckling of square frame,  $P_{cr}$  is  $16.47EI/AL^2$  [11], where  $A$  is the cross-sectional area of web link,  $E$  is Young's modulus of the epoxy material,  $I$  is the moment of inertia of web link cross-section, and  $L$  is the web link space length.  $A = b \times h$  and  $I = hb^3/12$ , where  $b$  is the width of web structure, and  $h$  is the depth of web structure. This  $\sigma_x$  value is compared with  $P_{cr}$  to determine the buckling temperature of the web link. For this part the obtained results are  $T_u = 35^\circ\text{C}$ , and  $T_b = 52^\circ\text{C}$  (refer to Table 1). Note that Young's modulus of the epoxy resin is a function of temperature. Figure 5 shows the effects of the ceramic shell thickness on the generated stresses in the ceramic shell and webbed pattern. It is seen from Figure 5a that the maximum hoop stress decreases as the shell thickness is increased. That is, a thicker ceramic shell can better resist the thermal expansion of the SL epoxy pattern. Figure 5b shows that the shell thickness effect on the maximum
