Effect of Surface Treatments on Electron Beam Freeform Fabricated Aluminum Structures

Karen M. B. Taminger, Robert A. Hafley, David T. Fahringer, and Richard E. Martin
NASA Langley Research Center, Hampton, VA

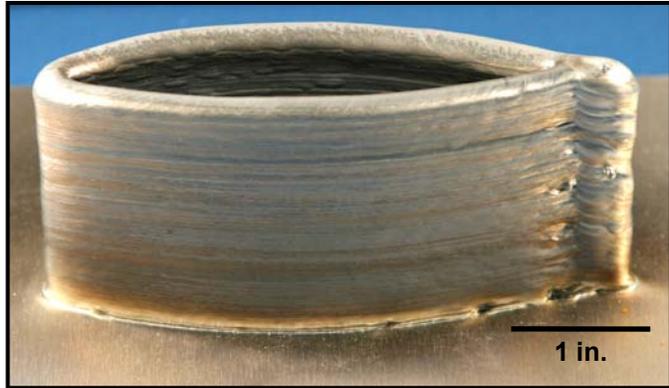
The purpose of this work was to compare different surface finishing techniques for smoothing the ridged layer-additive surface finish of parts fabricated using the EBF³ process. Five pylons were fabricated from 0.063 in. diameter aluminum alloy 2219 (Al-6% Cu nominal composition) wire using the EBF³ process. The pylons were each 4.5 in. long, 1.5 in. wide, and 2 in. high with a wall thickness of approximately 0.25 in. A pylon in the as-built condition is

shown in Figure 1. The pylons were used to demonstrate finishing techniques on a contoured component. A straight wall was also built 10 in. long, 2 in. high, and approximately 0.25 in. thick. This straight wall was cut into five 2-in. long segments, which were subjected to the same finishing treatments as the pylons. These wall segments were used for residual stress and surface finish measurements and then were sectioned for metallurgical analysis. Since all of the wall segments came from the same build, comparing data on these straight wall segments was a direct measure of the surface treatments and was not influenced by any inconsistencies that may occur in the EBF³ fabrication process from part to part. The deposition rate for the pylons and the straight wall was approximately 12 in.³/hr, resulting in a build time of 6 hr. per pylon.

Figure 1. Electron beam freeform fabricated 2219 Al pylon in as-built condition.

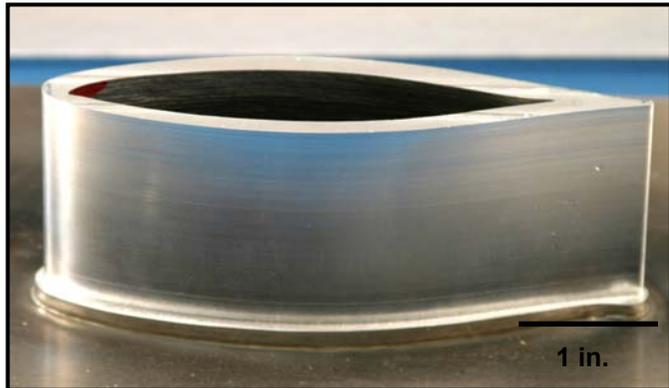
Figure 2 shows a pylon after high speed milling on the inside and outside surfaces. A 0.500-in. diameter, 4 flute, high speed steel end mill was used to remove approximately 0.01-0.02 in. from each surface at a feed rate of 15 in./min. The machining operation consisted of two passes, a roughing pass and a finishing pass, and took approximately 4 min. of actual machining time. The pylon solid model developed for the EBF³ system was also used to program the machining, so minimal time was required to program the milling operation. However, additional time was spent: (1) removing the part from the EBF³ system, (2) setting up the pylon in the high speed milling machine, and (3) positioning the near-net shape part with respect to the machining file to perform the machining. Similar machining set-up and feed rates were also used to cut the 2-in. straight wall segment down the centerline of the deposit for analysis. The operator reported that the machinability of the EBF³ material was comparable to typical aluminum.

Figure 2. Electron beam freeform fabricated 2219 Al pylon after high speed milling.

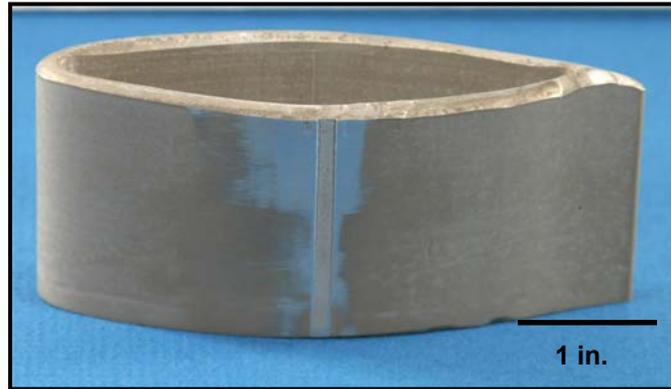
Figure 3 shows a pylon after being separated from the baseplate and wire EDM on the inside and outside surfaces. A 0.010 in. diameter wire was used to EDM the pylon. Actual wire EDM time was approximately 10 min. to remove approximately 0.05 in. from the inside and outside of the pylon. Prior to machining the pylon surfaces, a pilot hole was drilled into the baseplate in the center of the pylon because the wire must pass through the part to carry the current during wire EDM, preventing wire EDM from being effective for plunge operations. In addition, supports were left on either side near the center of the pylon to avoid pinching the wire. (The remnants of these supports are still visible as vertical stripes in Figure 3.) These supports were then removed in a subsequent machining operation. As with the high speed milled pylon, the pylon solid model developed for the EBF³ system was also used to program the wire EDM system, minimizing programming time. However, additional time was spent: (1) removing the part from the EBF³ system, (2) setting up the pylon in the wire EDM, (3) positioning the near-net shape part with respect to the machining file to perform the machining, and (4) final removal of the supports. Although wire EDM is typically followed by a grinding operation to remove the rough recast layer, the recast layer was not removed from the pylon to enable surface finishing analysis. Similar power settings and feed rates were also used to cut the 2-in. straight wall segment down the centerline of the deposit for analysis. Aside from the additional steps required for the wire EDM process, the operator reported no problems with machining the parts fabricated using the EBF³ process.

Figure 3. Electron beam freeform fabricated 2219 Al pylon after wire EDM machining.

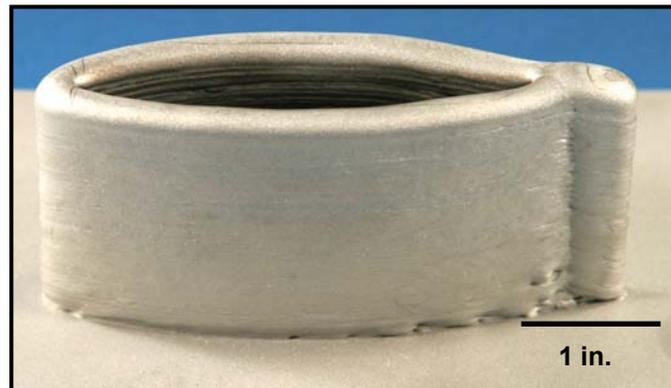
Figure 4 shows a pylon after glass bead blasting the exterior surface of the pylon. The pylon was bead blasted for 4 min. at a feed rate of approximately 5 in./min. using 0.015 in. diameter glass bead media. The set-up time was minimal since the bead blasting was manually controlled. Due to the geometry of the pylon, it was not possible to reach the inside surfaces of the pylon effectively. The 2-in. straight wall segment was bead blasted on both surfaces using feed rates and times similar to those used for the pylon.

Figure 4. Electron beam freeform fabricated 2219 Al pylon after glass bead blasting.

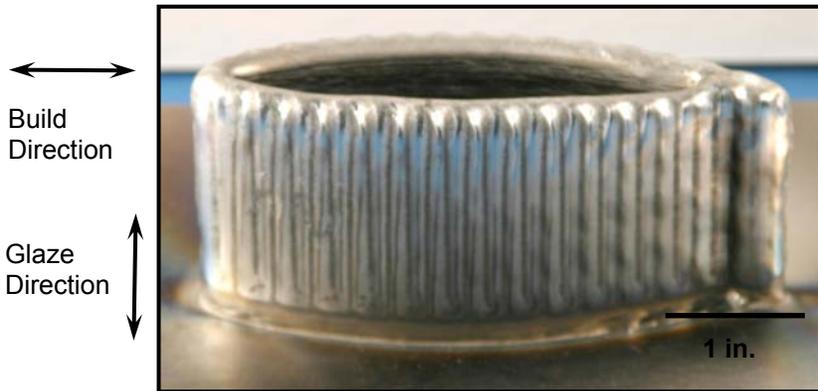
Figure 5 shows a pylon that was electron beam glazed in the EBF³ system immediately after completing the fabrication. The pylon was tilted 90° from the build orientation, and a low power, defocused electron beam was rastered perpendicular to the build direction to remove the EBF³ surface features. Total processing time was approximately 5 min., but no additional set-up time was required to perform the glazing operation. However, only the external surface of the pylon was accessible to the electron beam during the glazing operation, so it was not possible to reach the inside surfaces of the pylon effectively. Since the straight wall had to be removed from the EBF³ system to be cut into 2-in. segments, the 2-in. segment was returned to the EBF³ system and electron beam glazed using beam power and rastering rate and pattern similar to those used for the pylon.

Figure 5. Electron beam freeform fabricated 2219 Al pylon after electron beam glazing.

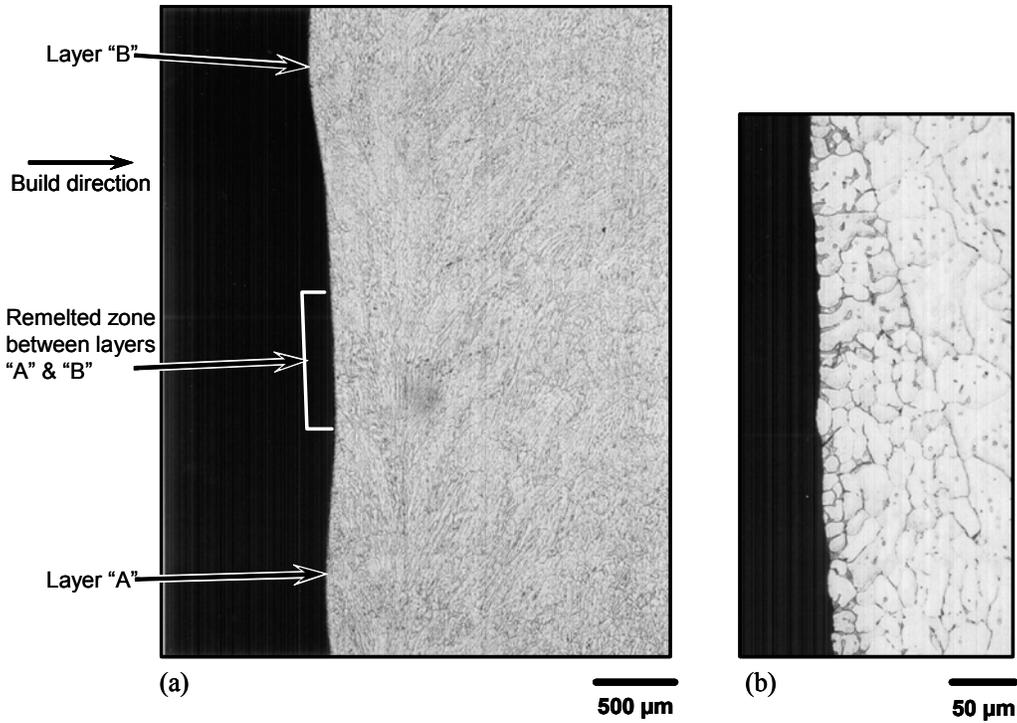
Figure 6. Microstructure of as-built electron beam freeform fabricated straight wall segment showing (a) long range waviness, and (b) surface microstructural details.

Low and high magnification optical microstructures of the near-surface regions on each of the straight wall segments are shown in Figures 6-10 for the as-built, high speed milled, wire EDM, glass bead blasted, and electron beam glazed specimens respectively. In the as-built specimen, two deposit layers and the remelted zone between those two layers are evident in Figure 6a. The localized surface is quite smooth, but there is evidence of longer range periodic surface waviness corresponding to the layer height, which is approximately $0.03\ \text{in.}$ for the parts fabricated in this study. The surface microstructure shown in Figure 6b is typical of the through-thickness microstructure, showing relatively large grains with some evidence of a solidification dendrite structure within the grains. After high speed milling, Figure 7a shows scallops on the bottom of the end mill cut, but the sidewall of the machined segment is smooth with no evidence of surface variations. Figure 7b shows that the grain structure of the 2219 Al was not affected by the milling. After wire EDM, there is no longer any evidence of long range surface waviness in Figure 8a. Figure 8b shows that the recast layer is less than $200\ \mu\text{m}$ thick, but this layer causes asperities on a fine scale. After glass bead blasting, Figure 9a shows the long range waviness associated with the prior build layers remains intact. In addition, localized surface roughness in Figure 9b appears higher than that of the as-built segment in Figure 6b. Finally, after electron beam glazing, the surface appears very smooth with no long range waviness in Figure 10a. More noticeable is the fine-grained, equiaxed microstructure at a constant $0.04\ \text{in.}$ depth associated with the heat affected zone from the glazing pass. The microstructure in the near-surface region after electron beam glazing (Figure 10b) is much finer than that of the as-built microstructure in Figure 6b.

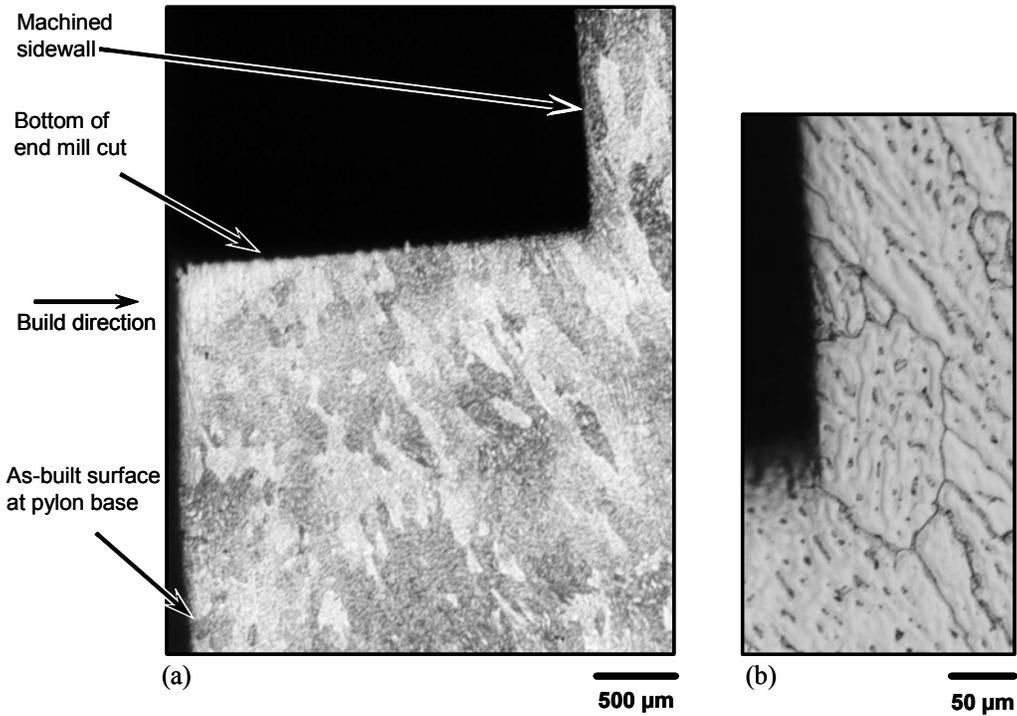
Figure 7. Microstructure of electron beam freeform fabricated straight wall segment after high speed milling showing (a) no long range waviness, and (b) uninterrupted surface microstructure.

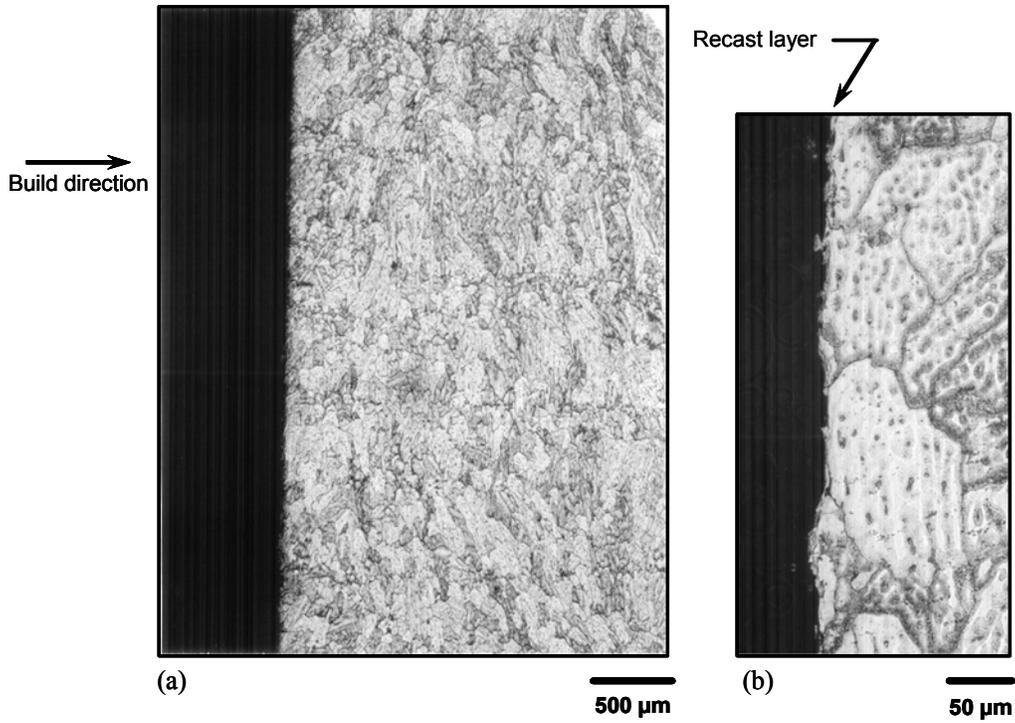
Figure 8. Microstructure of electron beam freeform fabricated straight wall segment after wire EDM showing (a) no long range waviness, and (b) recast layer on surface.

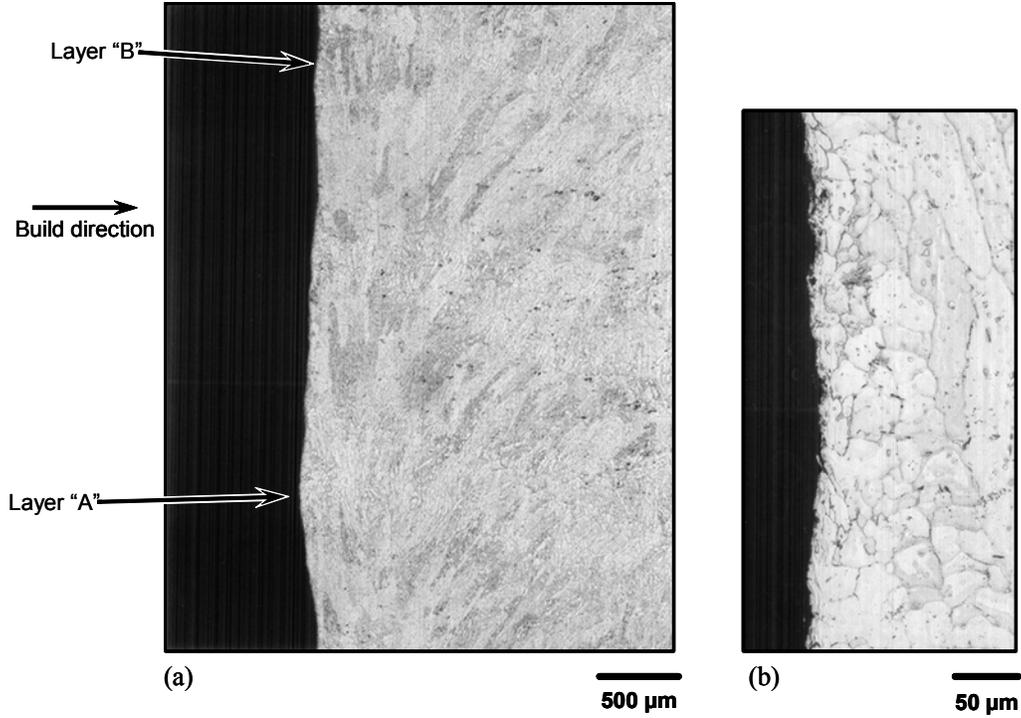
Figure 9. Microstructure of electron beam freeform fabricated straight wall segment after glass bead blasting showing (a) long range waviness and (b) surface roughness.

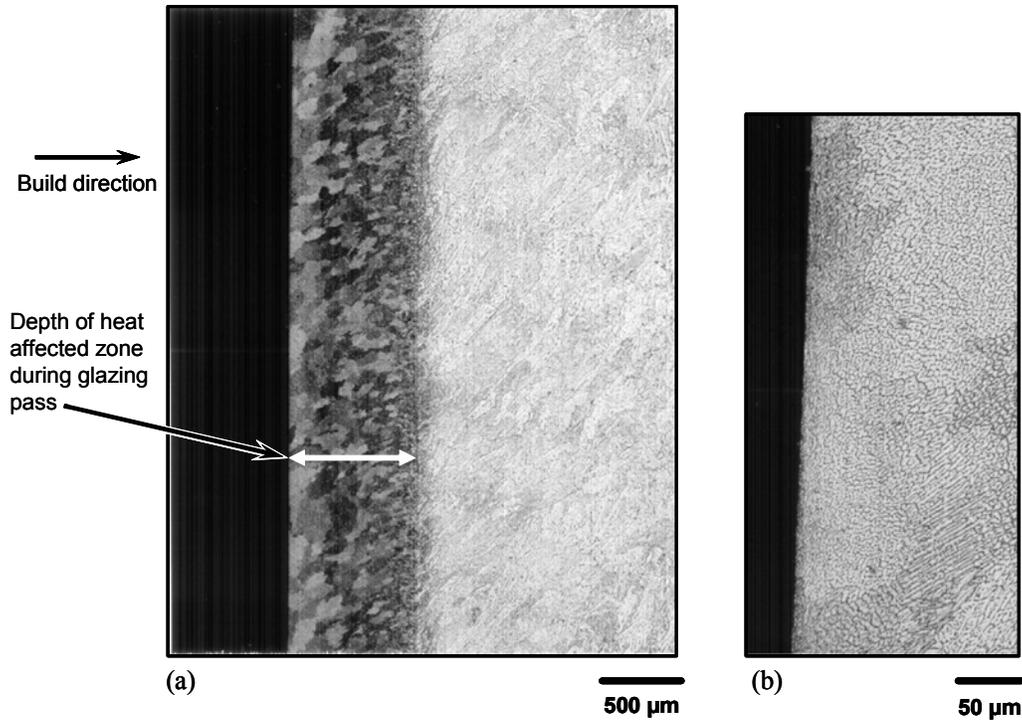
Figure 10. Microstructure of electron beam freeform fabricated straight wall segment after electron beam glazing showing (a) smooth surface with heat affected zone and (b) fine, equiaxed, near-surface microstructure.

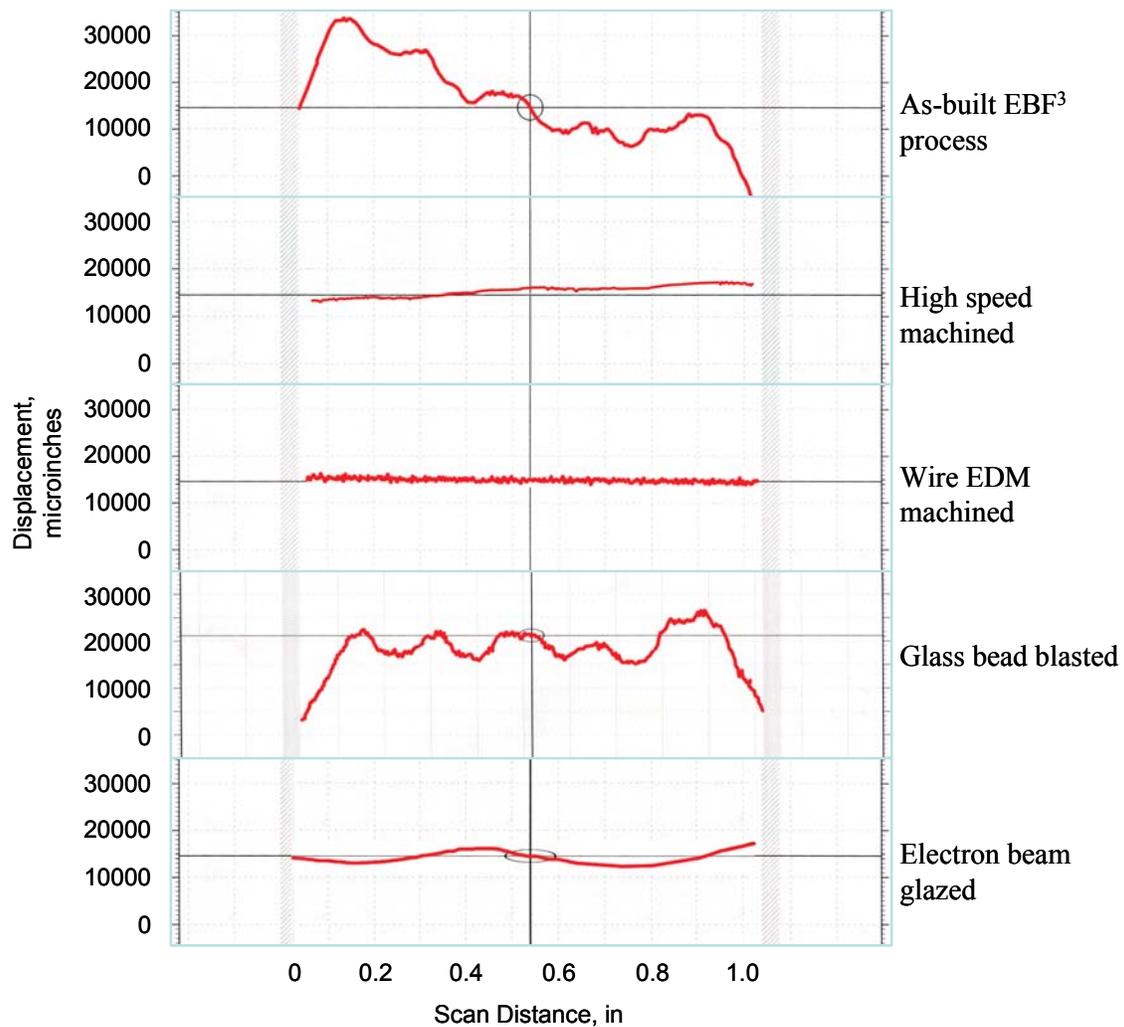
In Figure 11, all of the waviness plots are shown on the same scale, providing direct comparison of the surface conditions resulting from each of the different surface treatments. All of the surface finishing techniques except for the glass bead blasting were successful at significantly reducing the surface waviness from the prior layers in the electron beam freeform fabricated segments. The periodicity of the slight waviness that remained in the electron beam glazed segment is associated with the width of the raster pattern used to perform the glazing operation.

Figure 11. Surface waviness measurements on straight wall segments for each surface treatment studied.

The micrographs qualitatively indicate the roughness of the as-built surface as compared to that resulting from the various surface treatments. Surface roughness and waviness measurements were taken on the same straight wall segments as photographed in Figures 6-10. These results are shown in Table 1 and Figure 11. Note that lower RMS values are associated with smoother surface finishes, with a mirror surface typically having an RMS value less than 8.

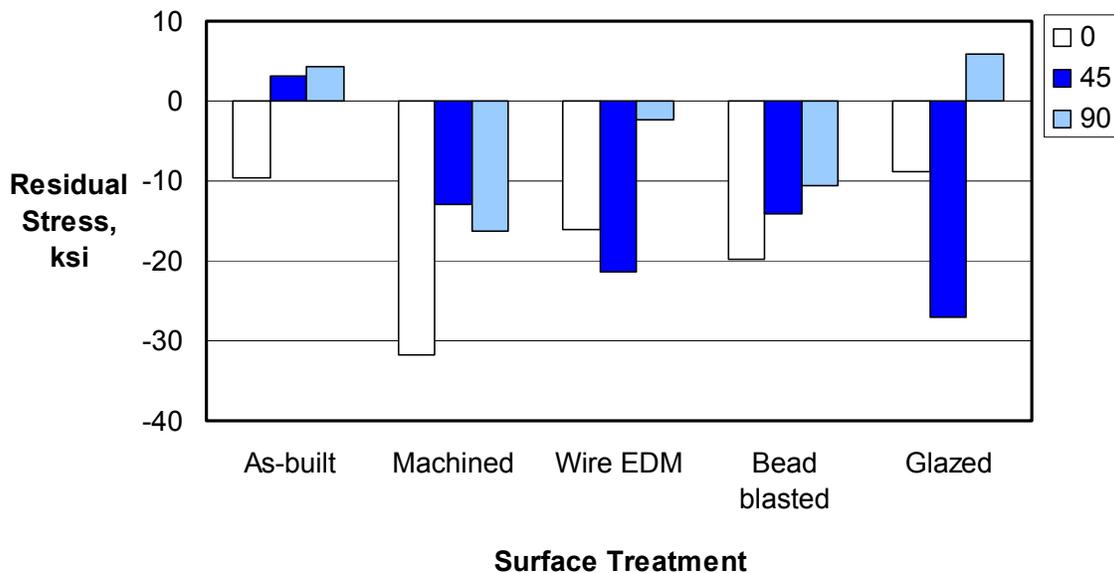
Figure 12 shows the surface residual stress measurements from each straight wall segment parallel to the build direction (0°), perpendicular to the build direction (90°), and 45° to the build direction. The residual stresses are significant, but the magnitude of these values may not be accurate since the calculation of residual stresses is based upon the bulk tensile modulus

of the 2219 Al. There are two possible sources of error in the residual stress measurements shown in Figure 12. First, the modulus of the specific $\{hkl\}$ planes of atoms measured at the atomic scale should be used to convert from residual strain to residual stress using the x-ray diffraction method. Since atomic-level moduli are difficult to determine and generally unavailable, it is standard practice to use a bulk modulus value as a best approximation. [1] However, this assumption may not be very accurate. Second, the yield and ultimate tensile strengths of as-deposited 2219 Al are approximately 17 ksi and 40 ksi respectively. [2] Thus, this conversion is invalid for stresses exceeding the yield strength of the material. Therefore, when examining the measured residual stresses, the relative values are more important than the specific magnitudes shown.

The as-built segment exhibits moderate compressive residual stresses in the 0° orientation and low tensile residual stresses in the 45° and 90° orientations. These residual stresses are the result of thermal stresses, and are comparable to residual stresses expected from welding processes. [3] High speed milling, wire EDM, and glass bead blasting all induce compressive residual stresses in all directions. These measured results are consistent with handbook values for these finishing processes. [4] Electron beam glazing does not significantly change the compressive residual stress state in the 0° orientation or the tensile residual stresses in the 90° orientation versus the as-built segment. However, electron beam glazing does induce high compressive residual stresses in the 45° orientation as compared to the slightly tensile stresses measured in the as-built segment.

Figure 12. Surface residual stresses measured via x-ray diffraction on straight wall segments for each surface treatment studied.
