# Variability in the Geometric Accuracy of Additively Manufactured Test Parts

A.L. Cooke and J.A. Soons

National Institute of Standards and Technology\*

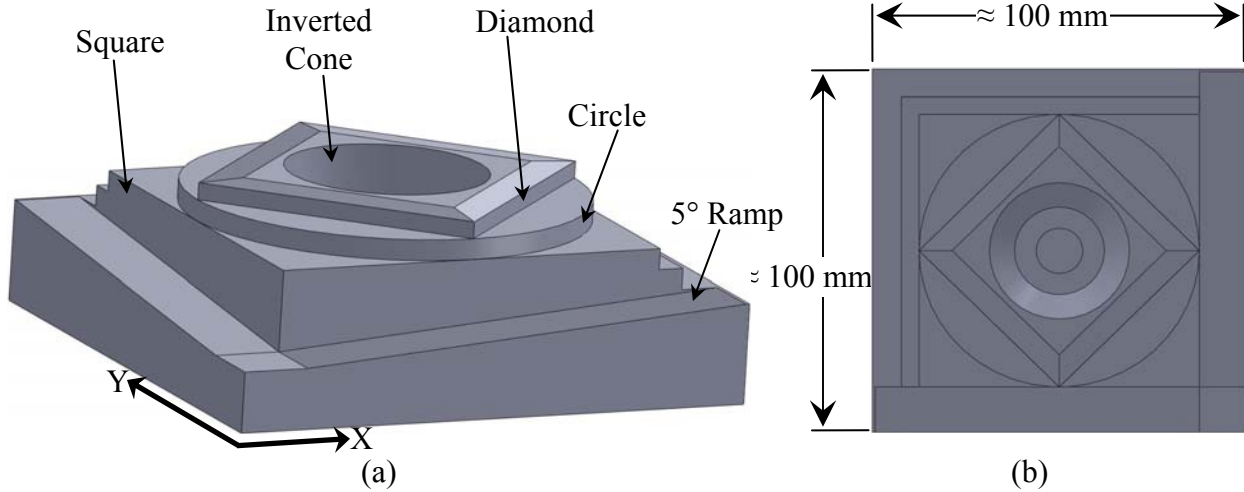
Figure 1: Circle-diamond-square with inverted cone: (a) Isometric view, (b) Top view; the height of the test part is approximately 35 mm

The test part, shown in Figure 1, is the classic Aerospace Industries Association (AIA), National Aerospace Standard, NAS 979 circle-diamond-square with an inverted cone [5]. The original circle-diamond-square, without the inverted cone, was developed in 1966 as a test part for Computer Numerically Controlled (CNC) machining centers. Machining the test part was part of a number of tests to evaluate machine performance. The standard prescribes several measurements to be taken on the part. The outside square surface and the 45° rotated square (diamond) are measured for size, flatness, squareness, parallelism, and surface finish. The 5° ramp is measured for angular deviation. The circle is measured for size, circularity, and surface finish. The inverted cone was later added to evaluate the performance of five-axis CNC machine tools [5].

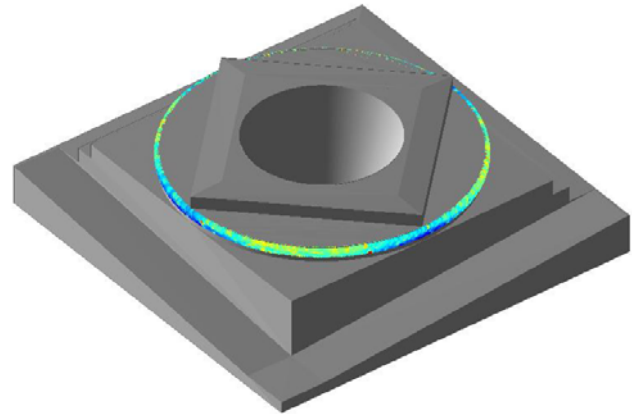
Figure 2: Highlight of the area of comparison

The first comparison addresses the circularity and size of the circle. The highlighted portion of the test part shown in Figure 2 denotes the area of comparison. With the CMM, three scans were taken along the circumference of the circle at three different heights, and the size errors and circularity (peak to valley, PV) are compared in Table 2. A range, corresponding to four times the standard deviation  $s$  of the circularity data, is also provided in the table because the PV result is strongly affected by local peaks in the data. One type of peak was observed on many features for both the laser and e-beam parts. It corresponds to small, spherical protrusions of material.

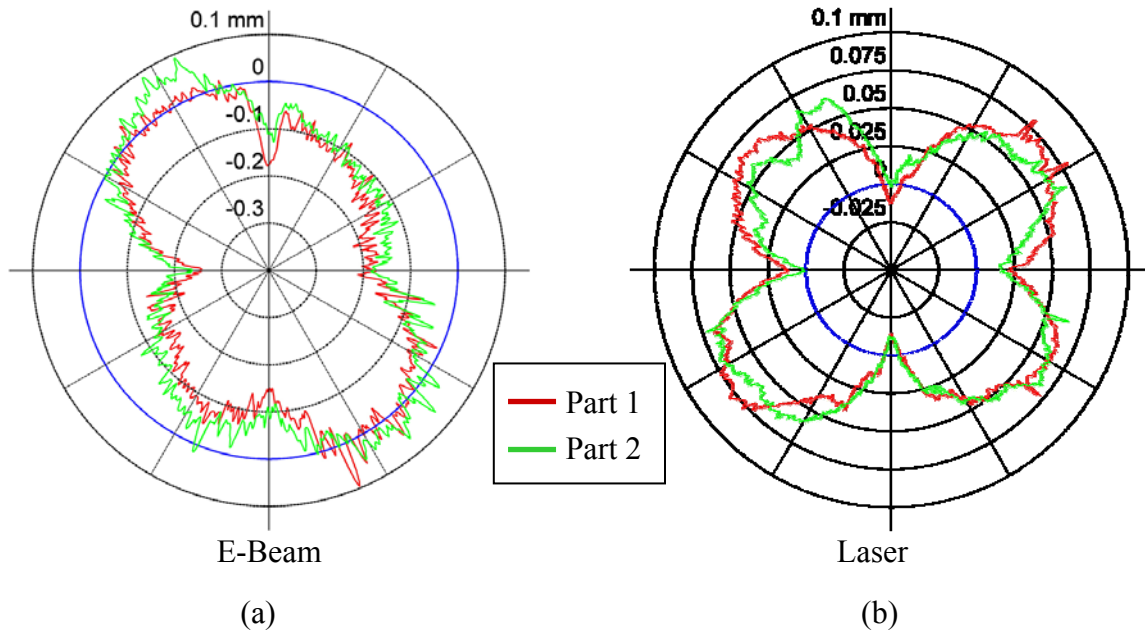
Figure 3: The average of the three error traces around the circular section of two parts made on the same system: (a) E-beam system and (b) Laser system.

Figure 3 shows the form and size errors of two parts made by the same machine using the same process parameters. The results indicate a relatively high degree of repeatability, providing opportunities for compensation.

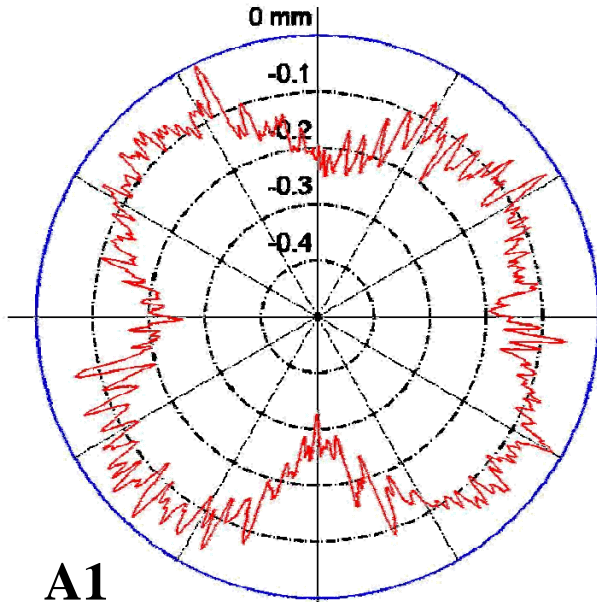
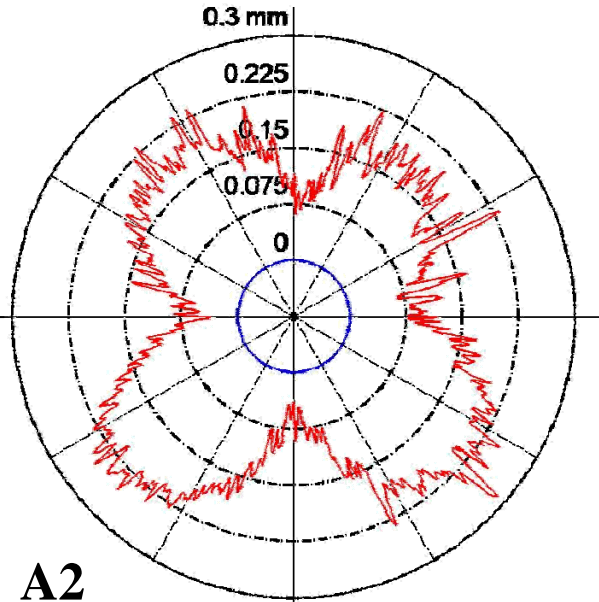
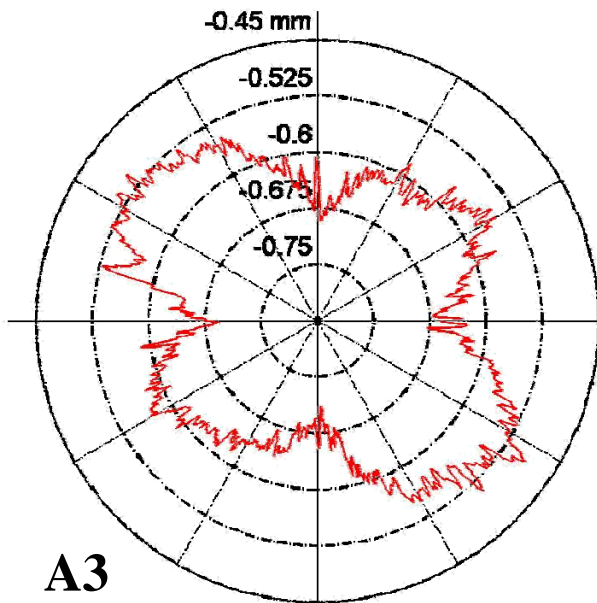
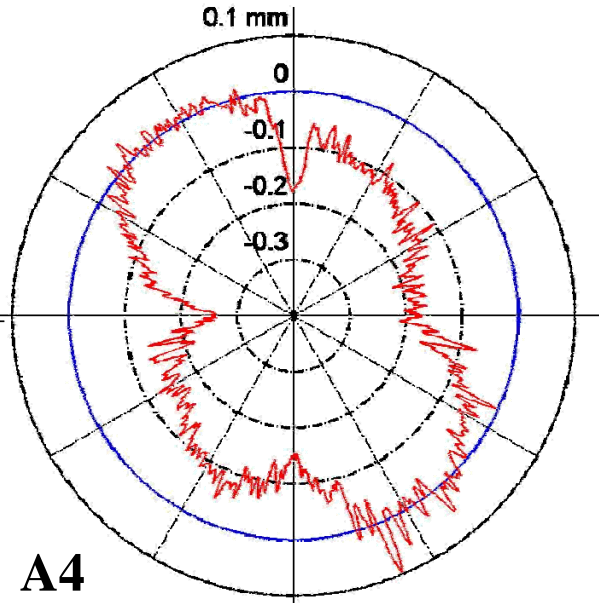
Mean radius error: -0.130 mm  
 Circularity (Peak to Valley): 0.322 mm

Mean radius error: 0.157 mm  
 Circularity (Peak to Valley): 0.249 mm

Mean radius error: -0.602 mm  
 Circularity (Peak to Valley): 0.214 mm

Mean radius error: -0.095 mm  
 Circularity (Peak to Valley): 0.352 mm

Figure 4: The average of three error traces around the circular section of the e-beam parts. Note that the plots have different scales.

The circularity errors of test parts A1-A4 and B1-B3, shown in Figures 4 and 5, have a similar cloverleaf pattern which is not present in part B4. This is probably because part B4 is a solid part, and the others are shells with a 3 mm wall thickness. The cloverleaf pattern is consistent with the inward bended shape observed for the side surfaces of the square, and seems to be due to thermally induced strains. The resulting circularity error is larger for the e-beam parts, probably due to the lack of support structures, more aggressive process conditions, and the different part material. The cloverleaf pattern was not observed for the cone feature. Test parts A3 and A4 show an elliptical error component in the circularity plot with major axes at 45°, which is indicative of a squareness error between the X- and Y-axes of the generated pattern.

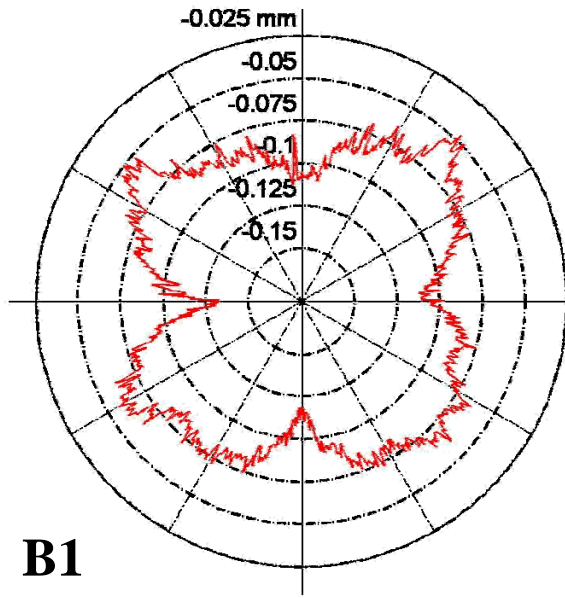
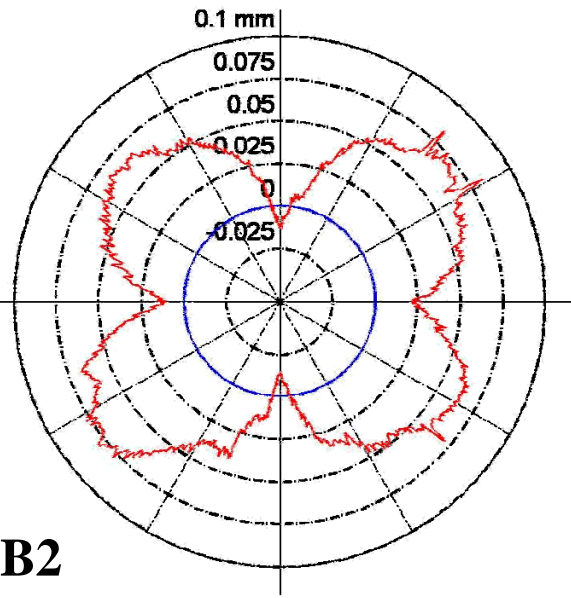
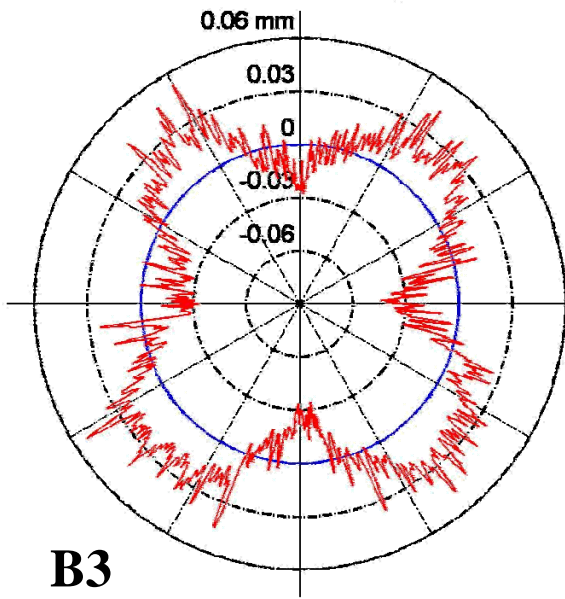
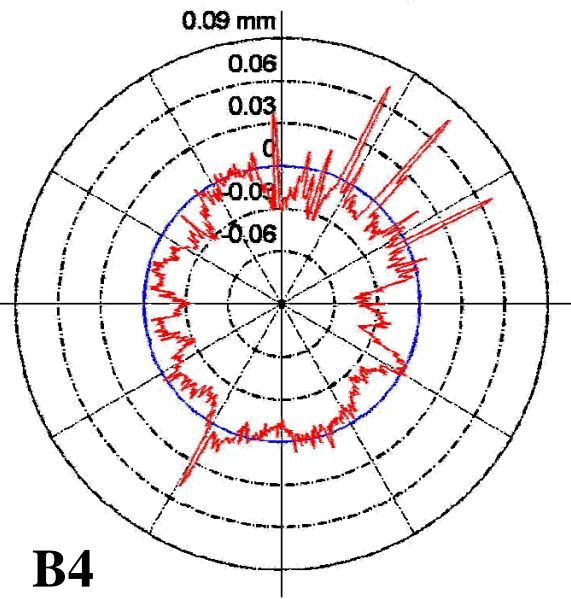
Mean radius error: -0.084 mm  
Circularity (Peak to Valley): 0.156 mm

Mean radius error: 0.043 mm  
Circularity (Peak to Valley): 0.094 mm

Mean radius error: 0.006 mm  
Circularity (Peak to Valley): 0.095 mm

Mean radius error: -0.010 mm  
Circularity (Peak to Valley): 0.121 mm

Figure 5: The average of three error traces around the circular section of the laser parts. Note that the plots have different scales.

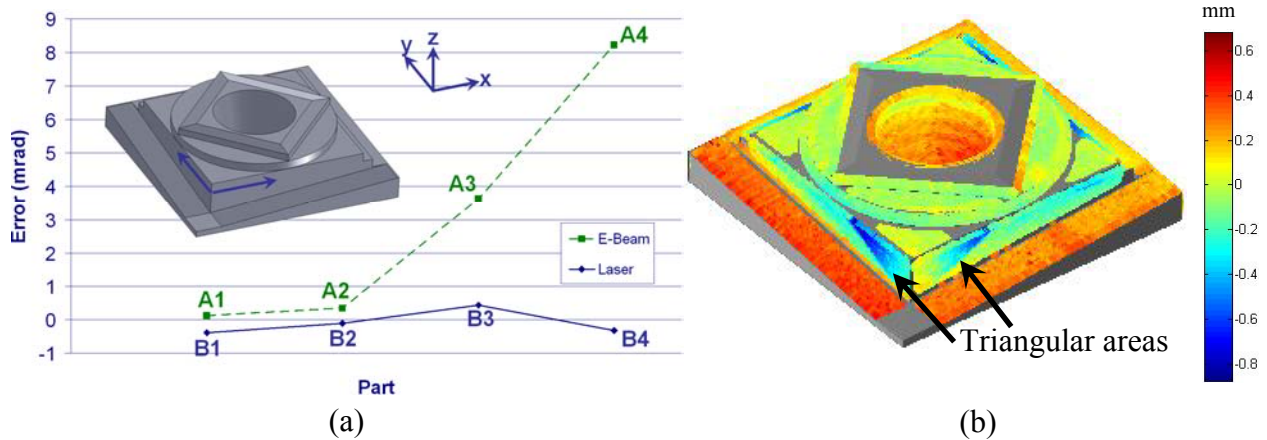
Figure 6: (a) Squareness error between the front and left surface of the square for each test part; (b) False-color representation of the surface errors of part A4.

Figure 6(a) displays the squareness error, expressed as an angle, between the front and left surface of the square. The large squareness error in part A4 is consistent, but significantly larger, than the squareness component present in the circularity plot. The false-color surface error plot of part A4 in Figure 6(b) shows relatively large surface errors within a triangular patch on each of the planes used for the squareness evaluation. These surface errors result in a large squareness error, and are consistent with an error in the machine's interpretation of the STL part model.

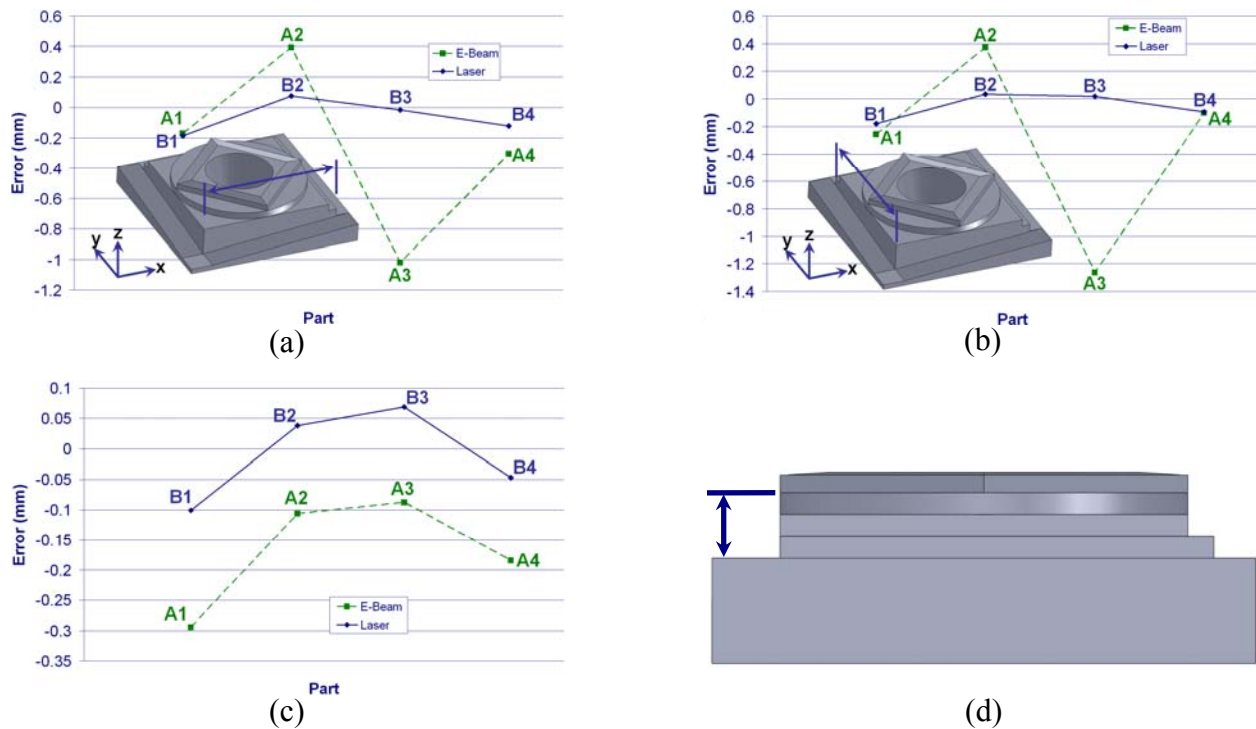
Figure 7: Size errors along (a) the X-axis, (b) the Y-axis, and (c) the Z-axis; (d) diagram indicating the evaluated size error along the Z-Axis.

Figure 7 depicts size errors of each part along the X-, Y-, and Z-axes. Each size is calculated as the distance along a line through the center of the circle between best-fit planes through the measured points. For each part, size errors along the X- and Y-axes are similar in magnitude and sign. Along the Z-axis, most parts are undersized.

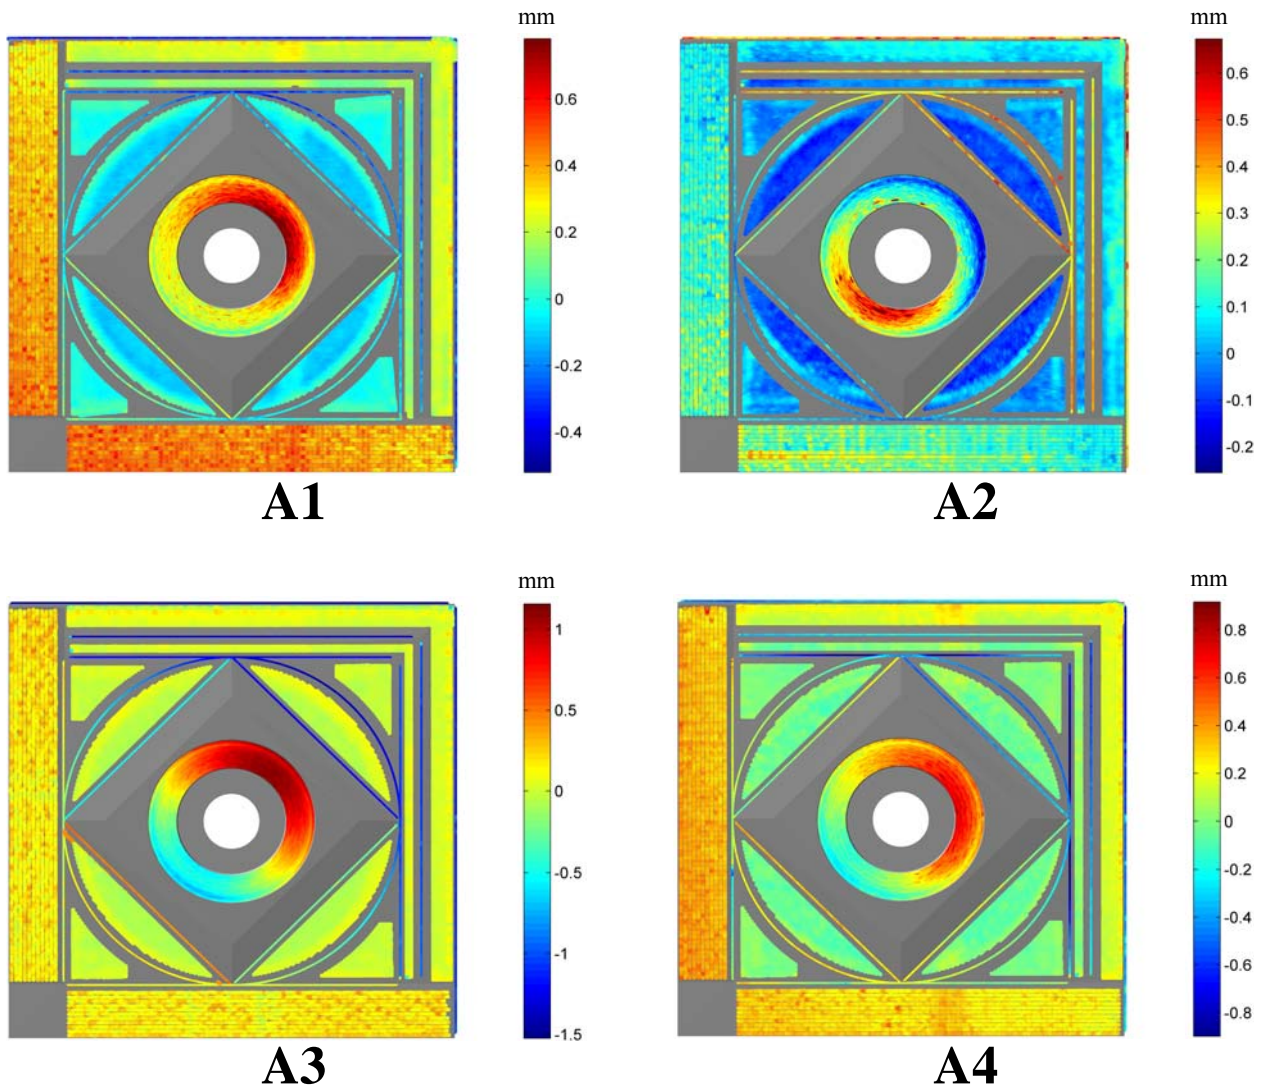
Figure 8: Top views of the false-color surface error plots of the e-beam parts.

Figures 8 and 9 display the top views of the false-color surface error plots of the test parts. In these plots, each dot represents the measured error at a point on the part in the direction of the local surface normal. Positive errors indicate the presence of excess material. The parts are aligned along planes through the part origin (Figure 10). It is evident from these plots that there are errors in the position of all the features. This is most easily seen for the inverted cone. The sloped surfaces on the side of the part show a periodic straightness error whose wavelength is approximately equal to the layer height divided by the sine of the slope angle. The amplitude was smaller than the slope-corrected layer height, in part due to the filtering action of the probe sphere.

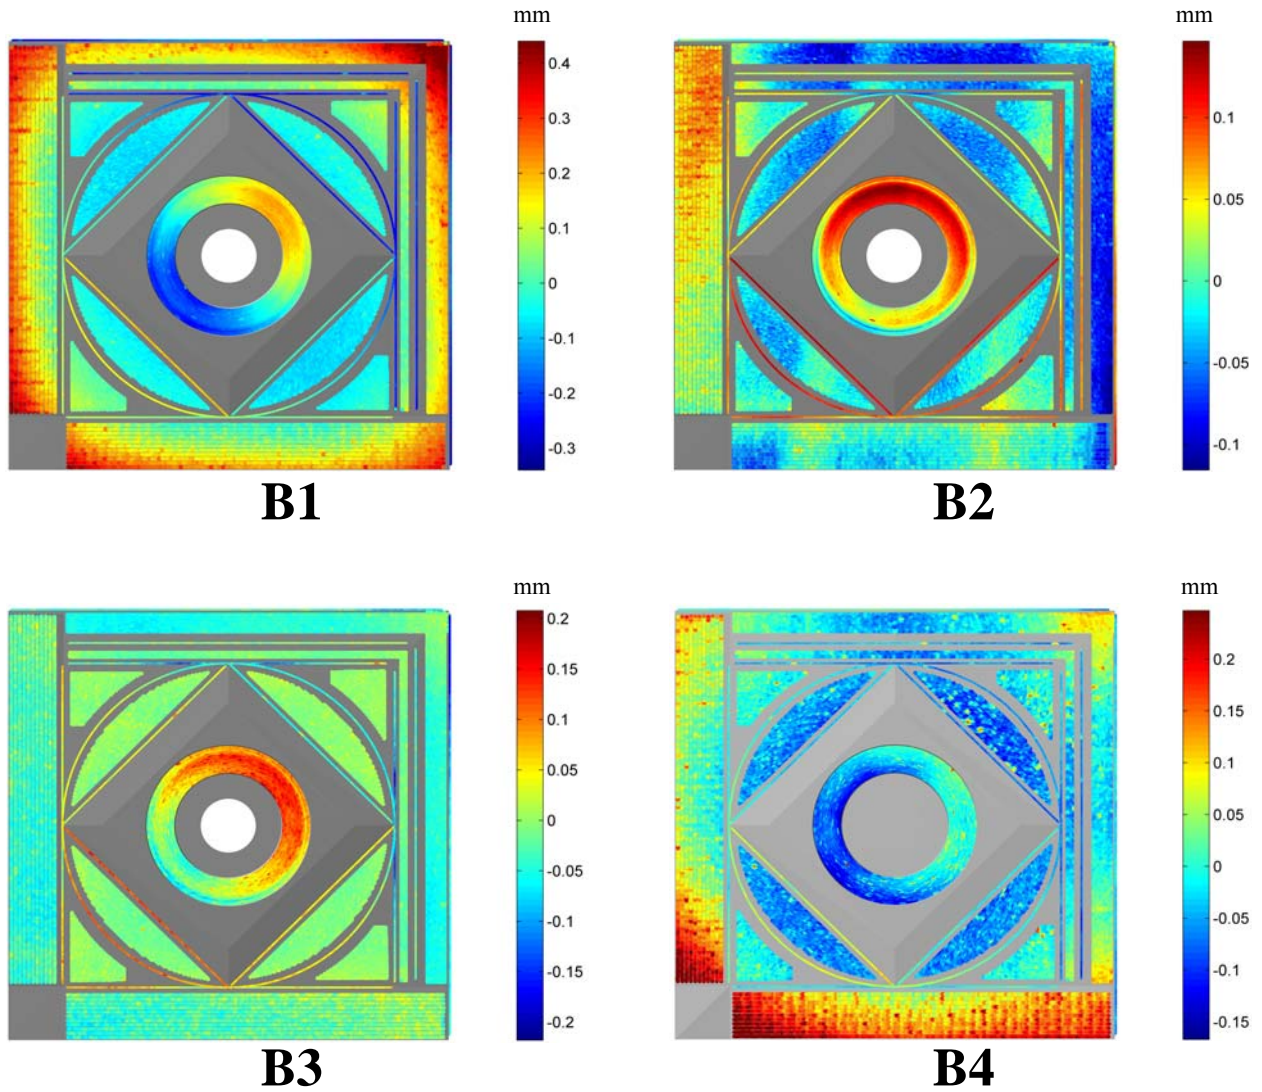
Figure 9: Top views of the false-color surface error plots of the laser parts

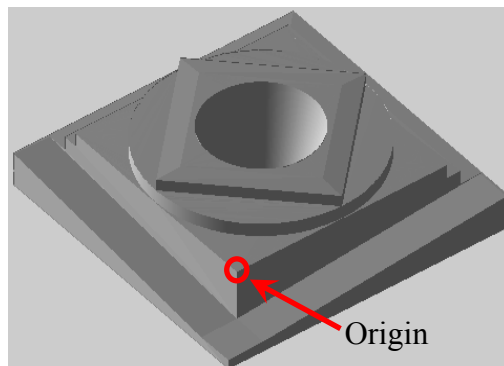
Figure 10: Location of the part origin.

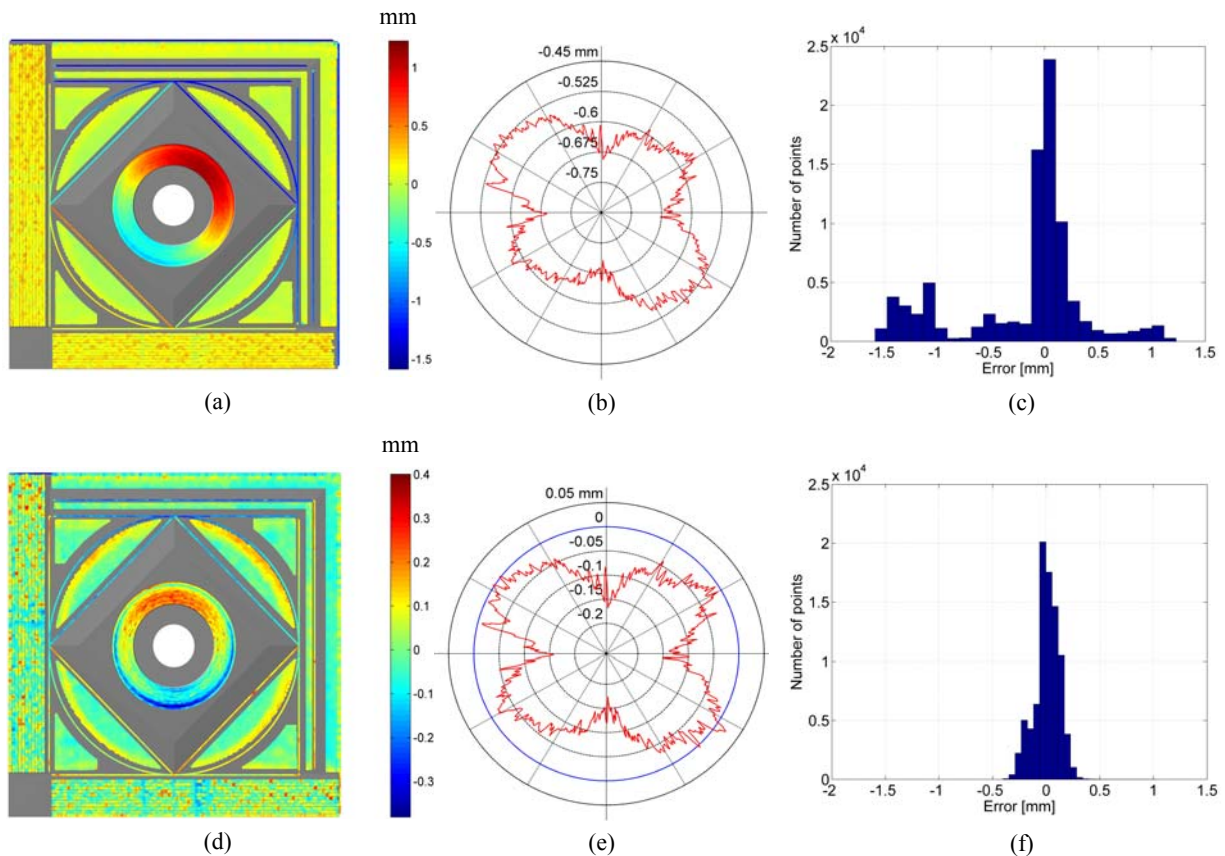
Figure 11: Errors of part A3 before and after error compensation: Top view of false-color error plot (a) Before and (d) After; Average of the three error traces around the circular section (b) Before and (e) After; Histogram of the surface errors (c) Before and (f) After.

The large errors observed for part A3 are mainly due to a constant scaling or magnification error in the XY-plane, a constant scaling error in the Z-direction, and, to a lesser extent, by a squareness error between the X- and Y-axes. Figure 11 shows the reduction of the observed part errors when these error components are removed. The parameters describing the error components were simultaneously estimated through least-squares minimization of the residual part errors. This example shows the potential of using test parts to obtain machine or process compensation parameters. However, for a compensation model to be valid for arbitrary parts, care has to be taken to avoid contamination of the estimated model parameters with part-specific process errors. Special test part designs, such as a grid pattern, can aid in this effort.
